**Evaluation of Groundwater Remediation on Local Pond and Lake Levels  
Conestoga-Rovers & Associates  
August 1992**

Highway 96 Site  
White Bear Township, Minnesota

August 1992  
Ref No. 2012-20 (19)  
This report printed on recycled paper.

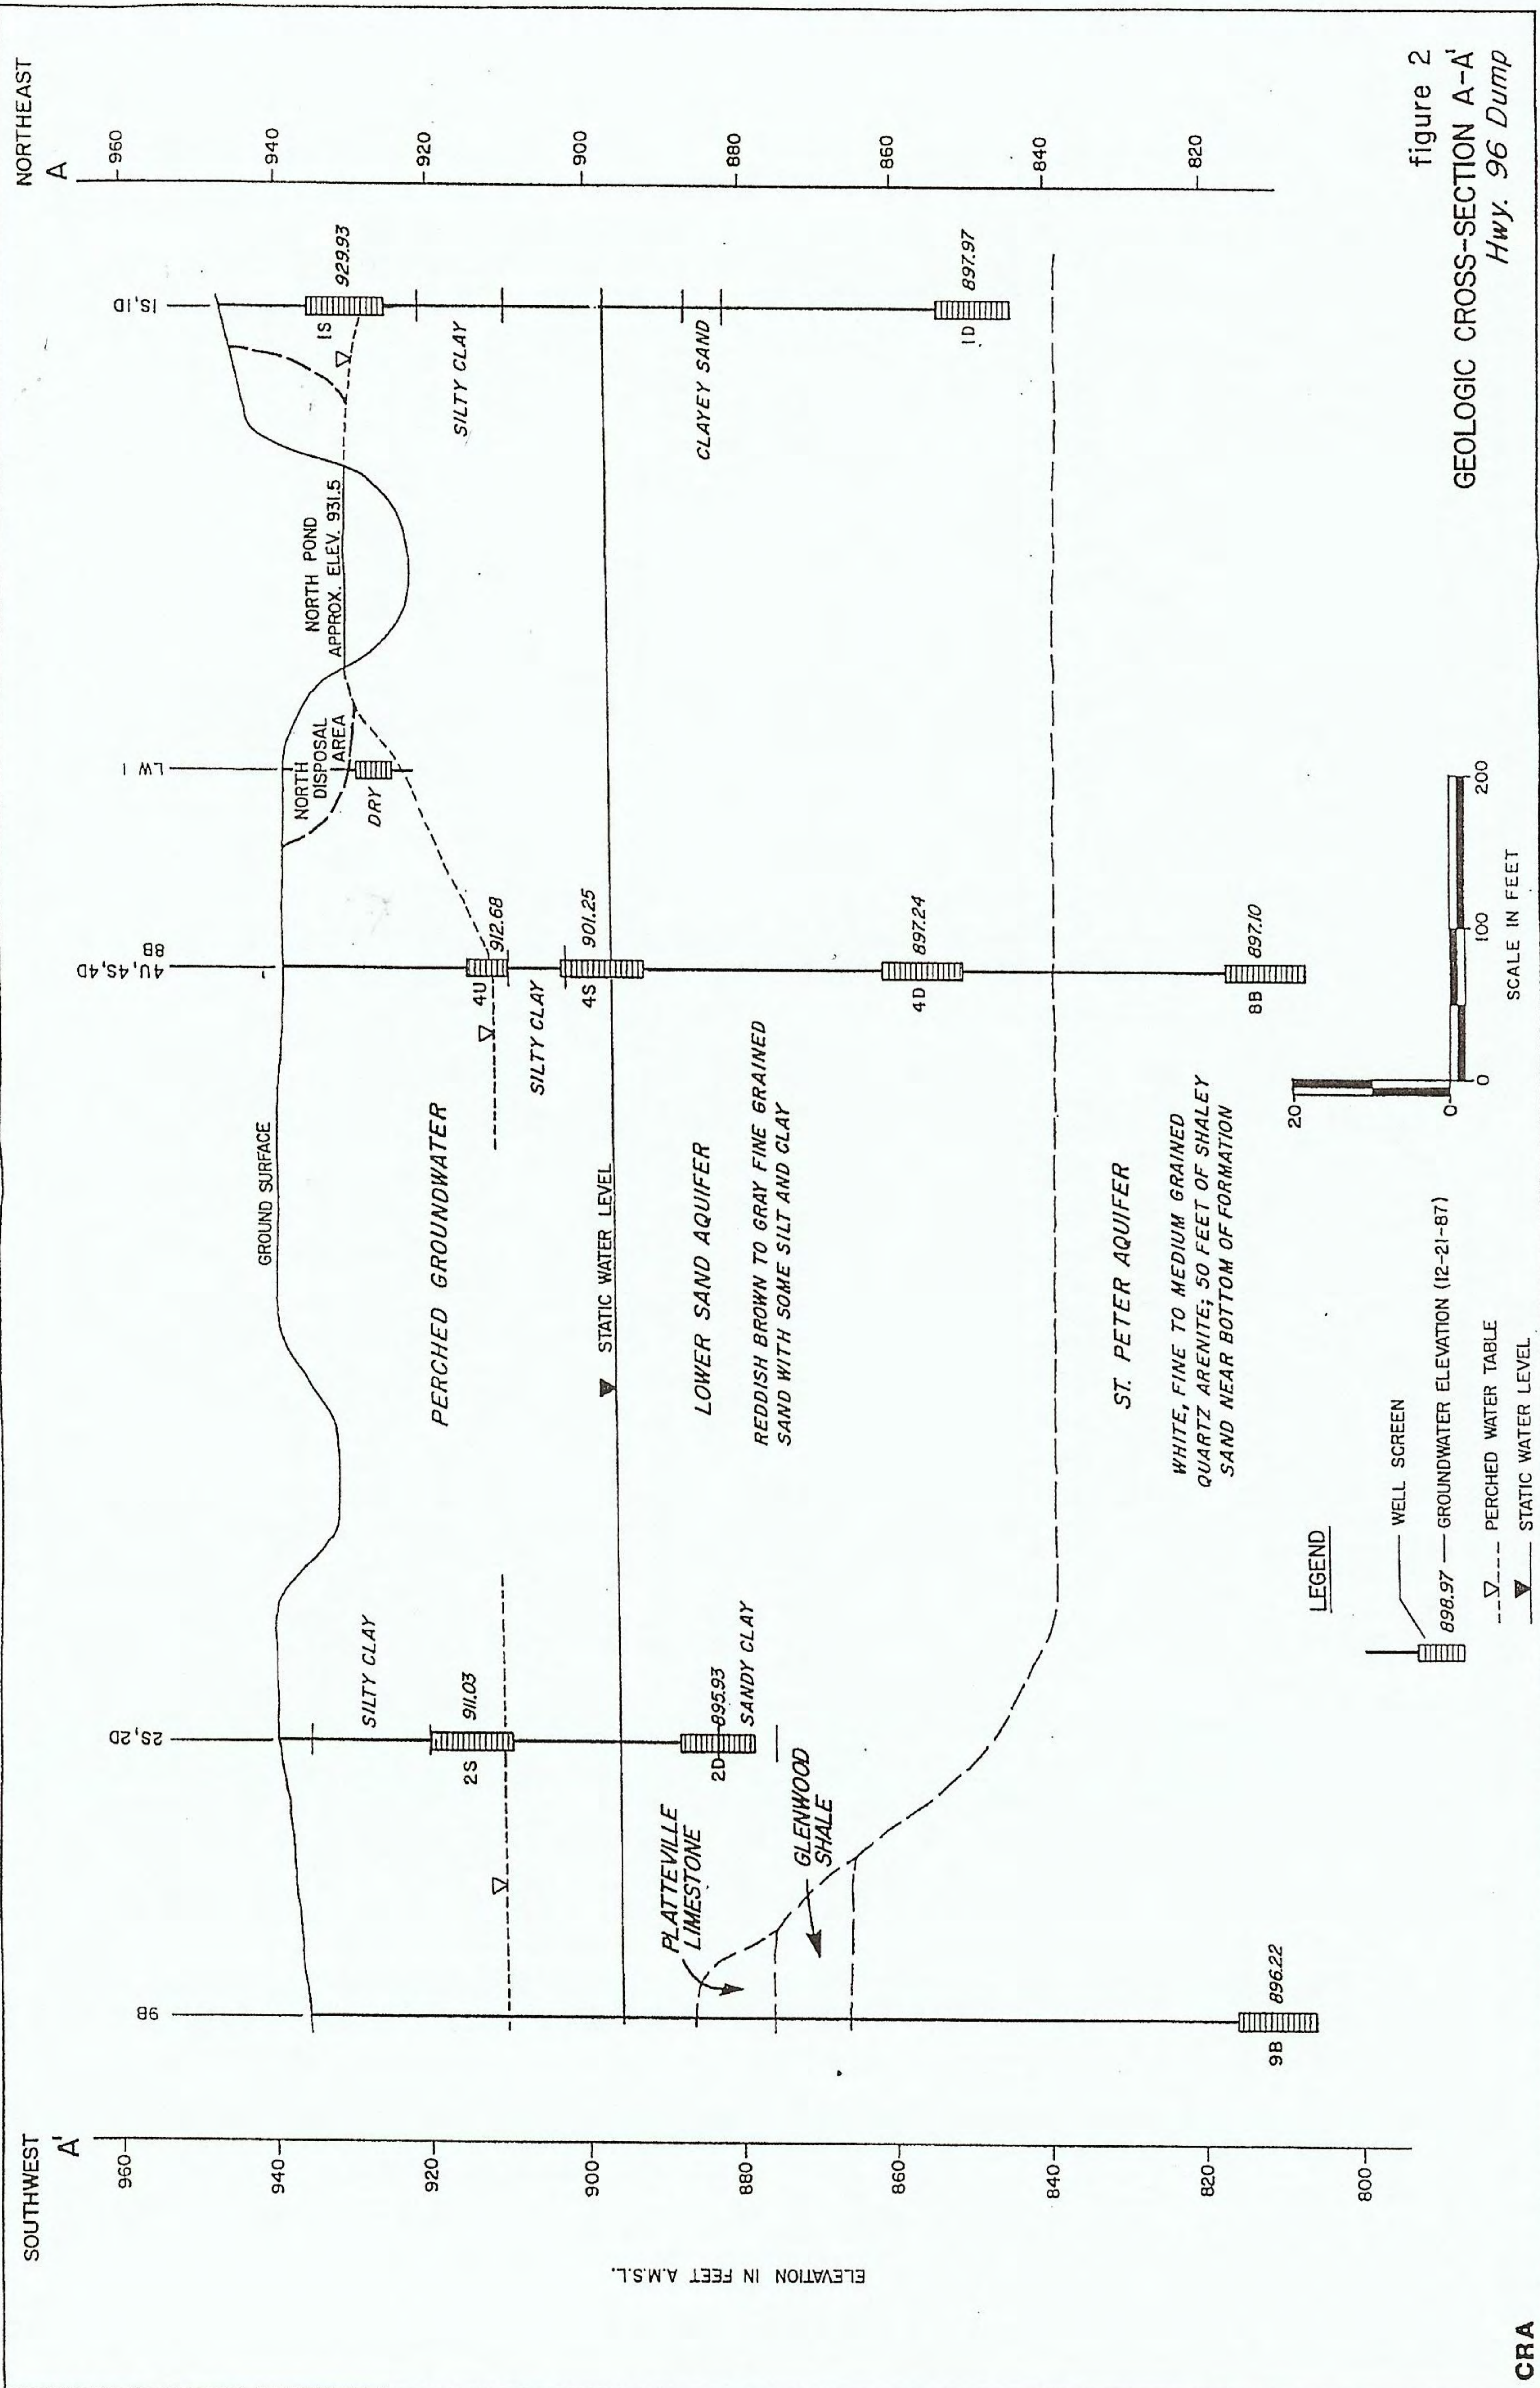
figure 2  
 GEOLGIC CROSS-SECTION A-A'  
 Hwy. 96 Dump

Perched groundwater has a lower elevation than the North Pond and Turk Lake which demonstrates that these bodies of water seep into the perched groundwater. Pond and lake levels are not affected by the hydraulics of the Lower Sand Aquifer since the Lower Sand Aquifer does not recharge the perched groundwater, pond and lake system local to the Highway 96 Site. Figure 2 presents a hydrogeologic cross-section of the stratigraphy and the corresponding aquifer.

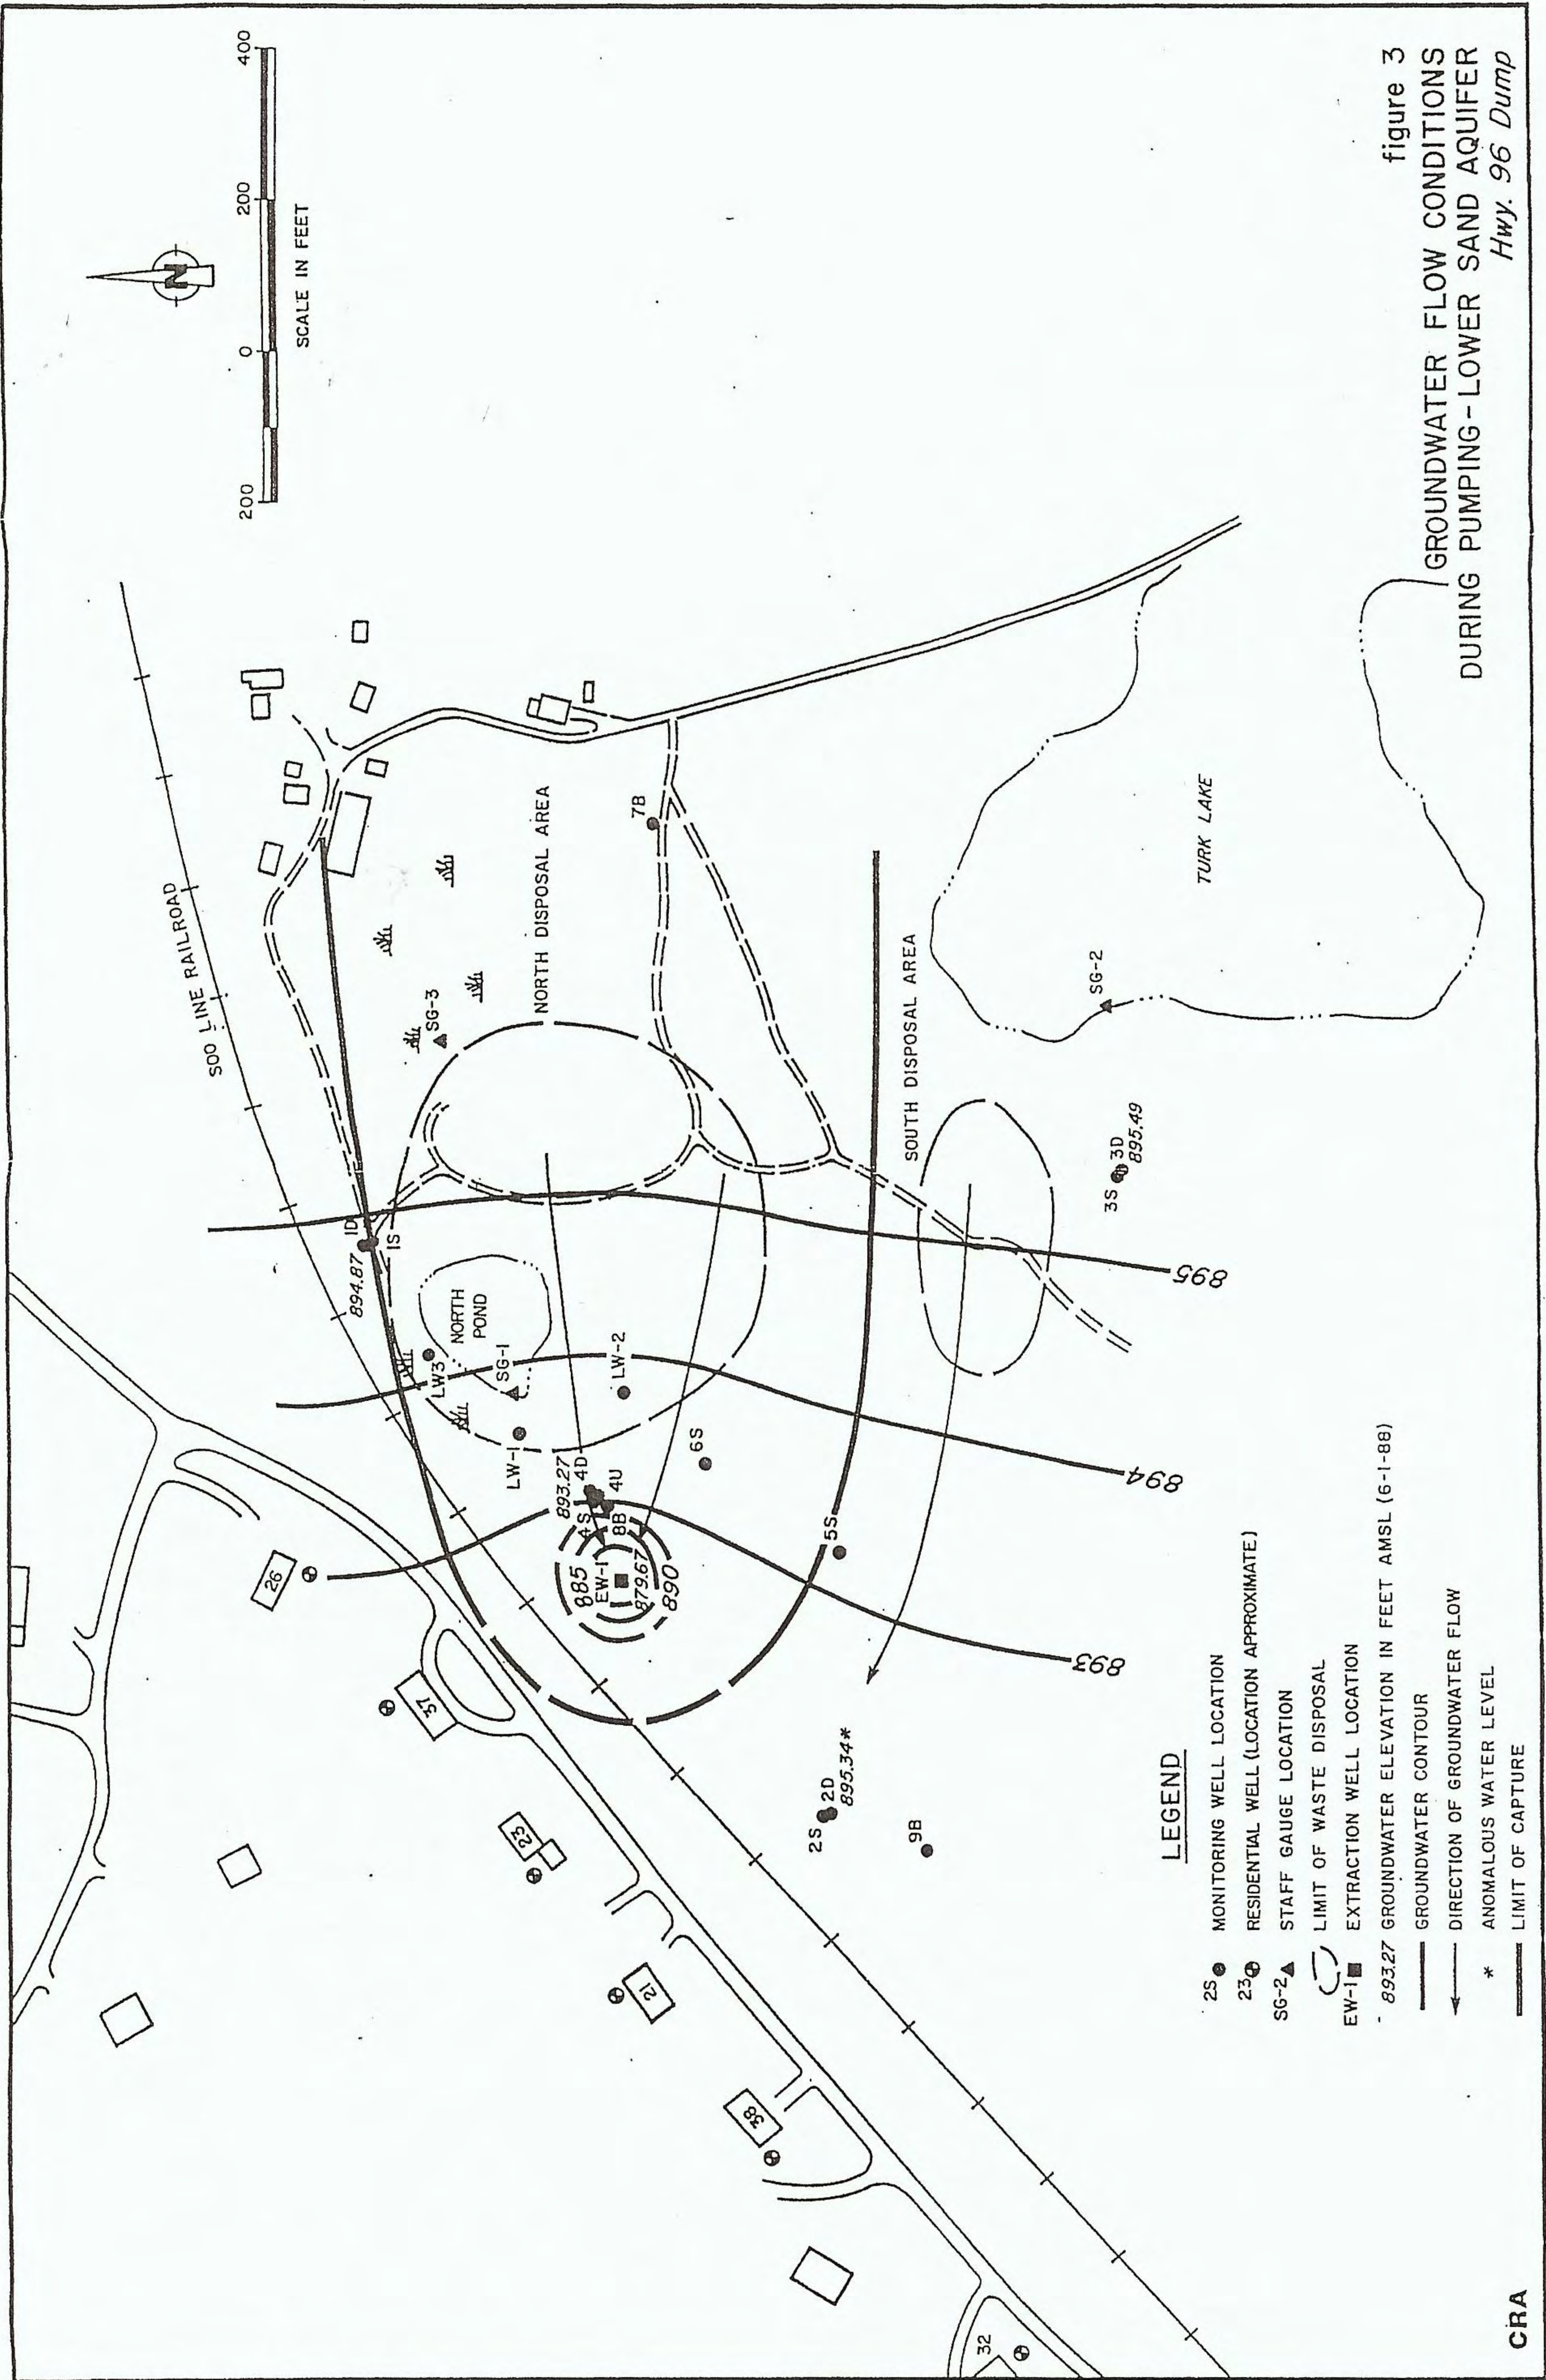
During the pumping of the extraction well, water levels monitored in perched groundwater and the North Pond did not drop due to pumping even though water levels from the Lower Sand/St. Peter aquifer dropped, as shown on Figure 3. This illustrates that the water level at the closest pond to the extraction well was not affected by pumping from the extraction. Figure 3 also presents the area impacted by pumping referred to as a, "capture zone" which affects only the Lower Aquifer in the immediate area of the Highway 96 Dump.

In comparison since 1989, pumping at the Highway 96 Site has averaged 23.7 million gallons per year from the Lower Sand and St. Peter Aquifer. Although the total amount of groundwater removed from the Highway 96 Site appears substantial, the effects of pumping influences only a localized area in the Lower Sand Aquifer, as shown on Figure 3 and does not
