# GILFILLAN LAKE

## QUICK FACTS

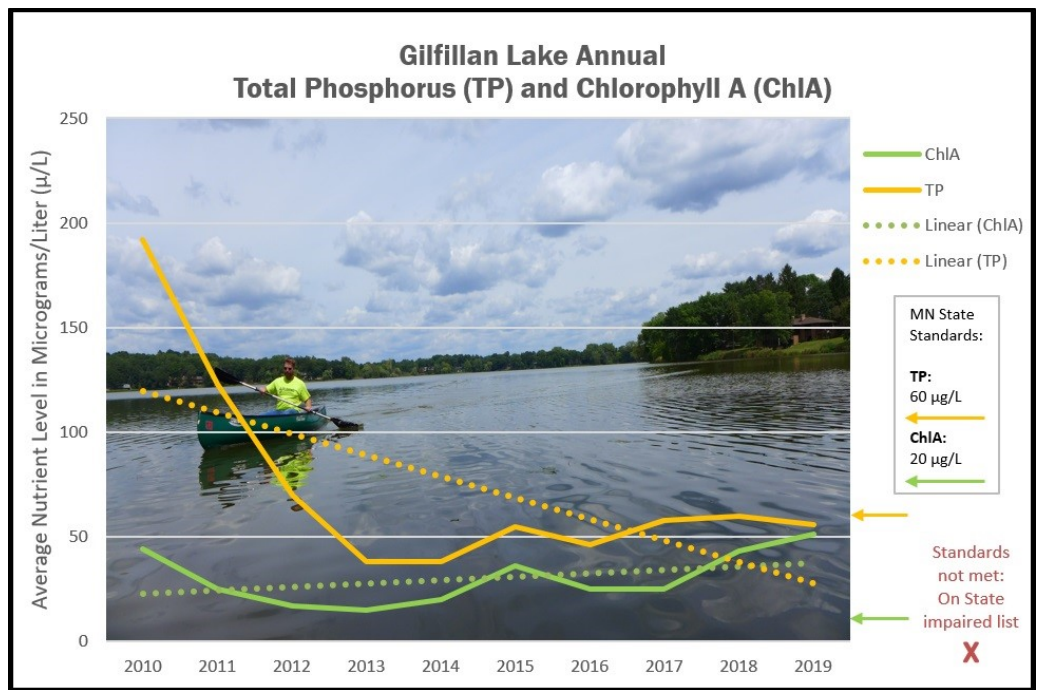
Gilfillan Lake	2019	Clear Oligotrophic		Moderately Clear Mesotrophic		Green Eutrophic	Very Green Hypereutrophic		
		20	30	40	50	60	70	80	
Trophic State Index (TSI): Overall		[Progress bar from 20 to 60]						▲	
TSI Transparency: Secchi Disk		[Progress bar from 20 to 60]						▲	
TSI Chlorophyll A: ChIA		[Progress bar from 20 to 60]						▲	
TSI Total Phosphorus: TP		[Progress bar from 20 to 60]						▲

Gilfillan nutrient levels fell significantly in 2012 due to augmentation from Pleasant Lake, but show a slight rise in recent years.
