Sustainable Lake Management Plan Gilfillan Lake

Prepared by The
Vadnais Lake Area Water Management Organization
In Partnership with the Lake Gilfillan Watershed
Association, Wenck Associates, Inc., and the Ramsey
Conservation District
(2009 – 2010)

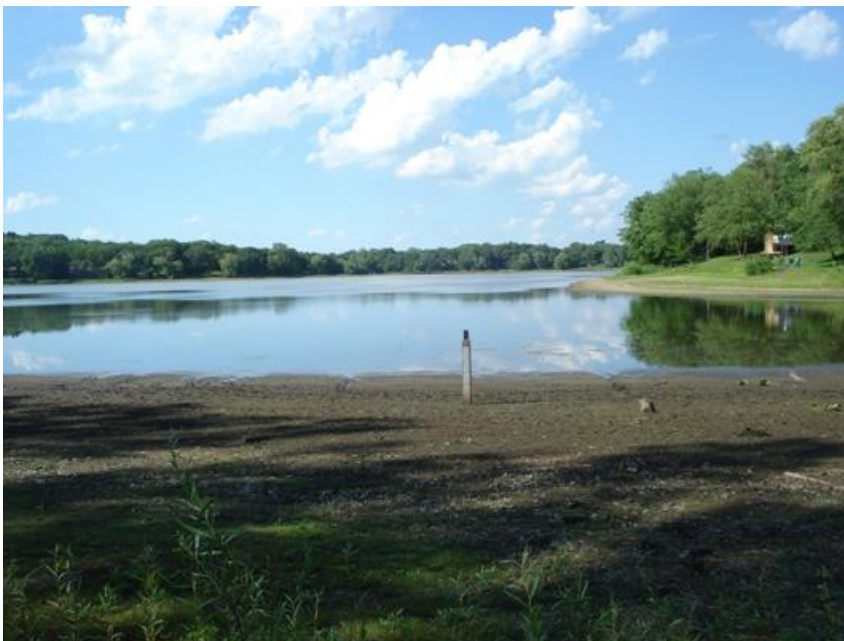
Exposed
water level
gauge and
lake
bottom,
July 2009

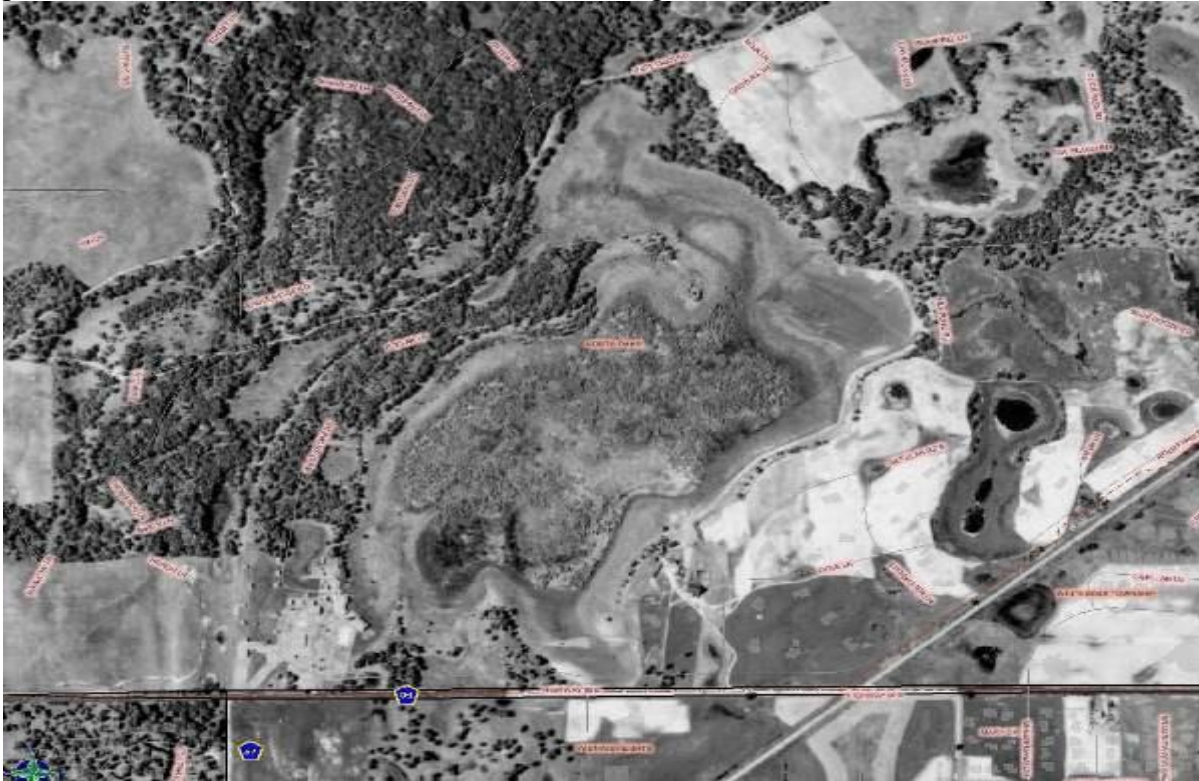
This is a **1945 aerial** photo of what is now Gilfillan Lake. There is very little standing water in the photo, the “lake” looks to be more of a wetland/bog.

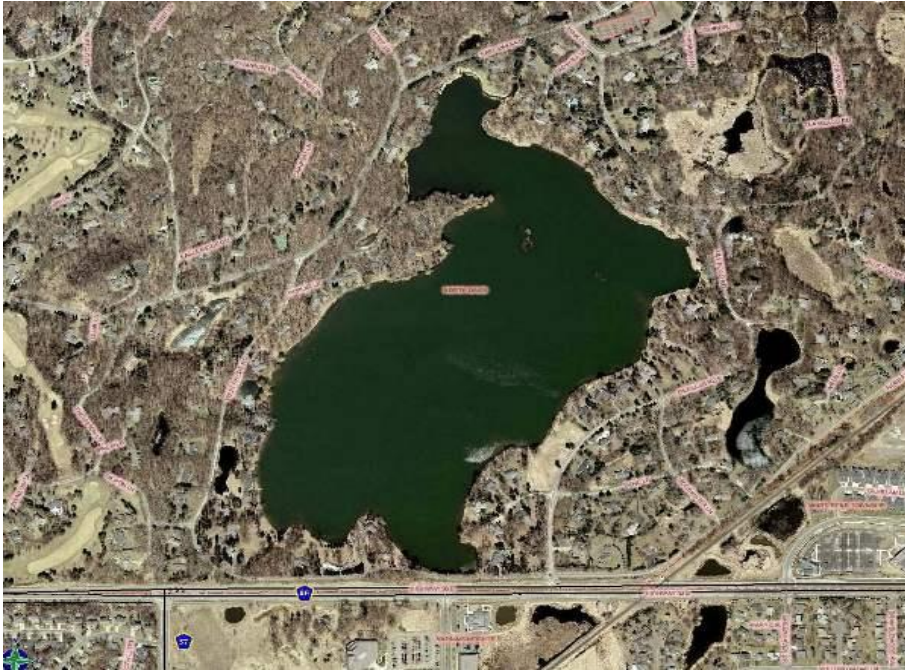
2006 aerial. Hwy 96 was widened and development around the lake has slowed. Legislation was passed by the State to stop lake augmentation in 1990. You can see the green color of the lake from the high chlorophyll levels.

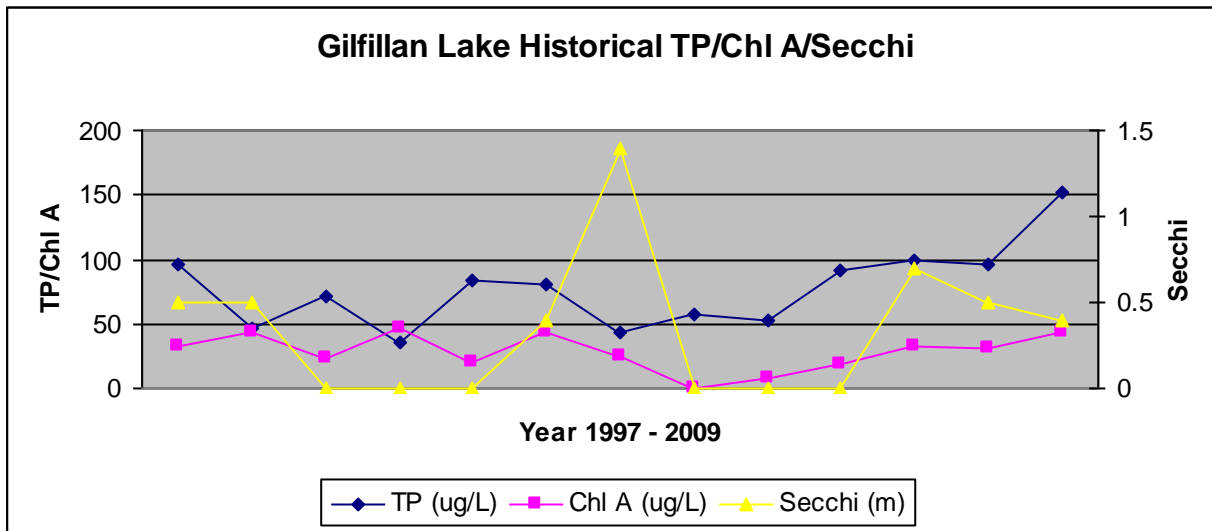
Gilfillan Lake is very eutrophic as indicated by table on page 16. It is impaired for nutrients and will be part of a TMDL study starting the spring of 2010. Gilfillan is above state standards in both phosphorus (TP) and chlorophyll (ChlA). Water quality data has been collected since 1997 and is shown below. Also included are the water quality results for samples taken every 2 weeks during the 2009 sampling season. Overall, phosphorus and chlorophyll levels are very high for a shallow lake in this ecoregion. Water transparency is very poor. The high nutrients in the lake are a bit of a mystery considering the lake receives very little runoff from the watershed and most of the properties have very good buffers between the lake and the turf. This would suggest the high nutrients are due to internal loading.

Phosphorus (TP) is the primary cause of excessive plant and algae growth in lake systems. Phosphorus originates from a variety of sources, many of which are human related. Major sources include human and animal wastes, soil erosion, detergents, septic systems, and runoff from yards and streets. The standard level set by the Minnesota Pollution Control Agency (MPCA) is less than 60 ug/L. **Gilfillan Lake currently exceeds the MPCA standards.**

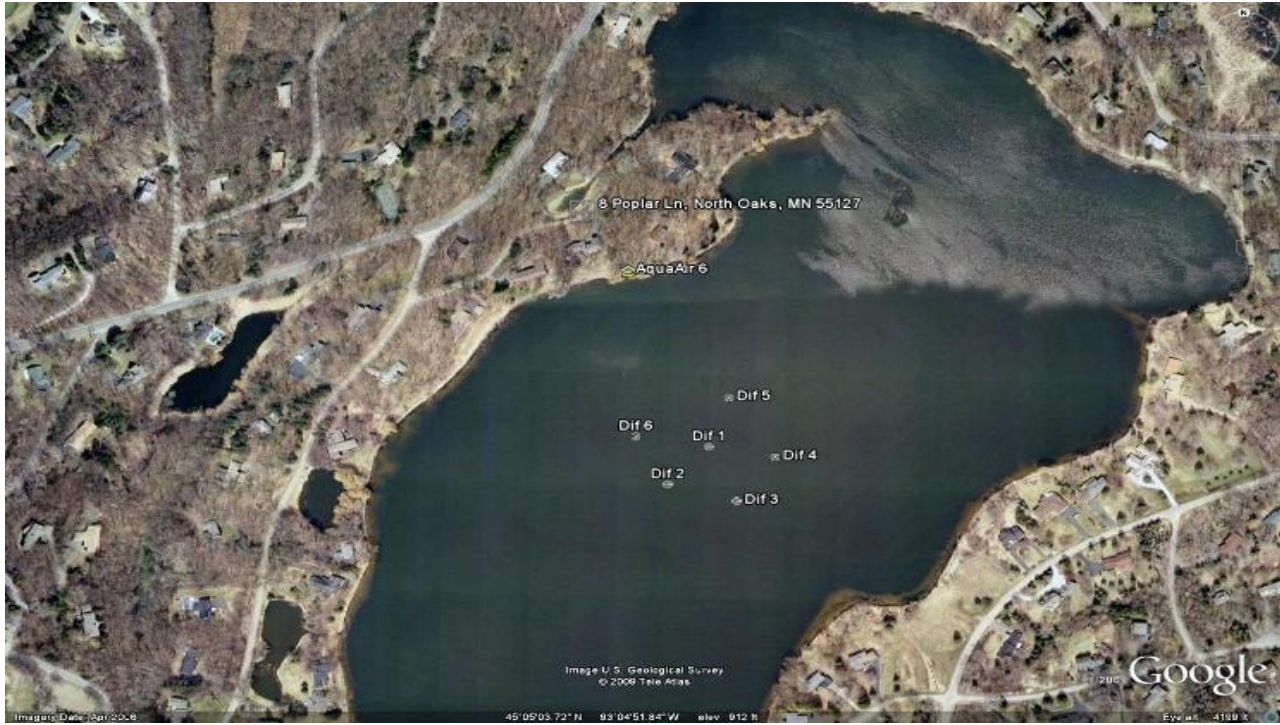
Aerator Location

In the fall of 2009, the Lake Gilfillan Watershed Association raised private funds to install an aeration system on the lake. The hope is that the aeration will keep the shallow lake well enough oxygenated and partially open through the winter to help limit the severity of potential fish kills. Also, the aeration will help with the mixing of the water table and may eventually help reduce the high chlorophyll levels in the lake by limiting the amount of time the chlorophyll is exposed to the sunlight. Below is a map showing the location of the unit.

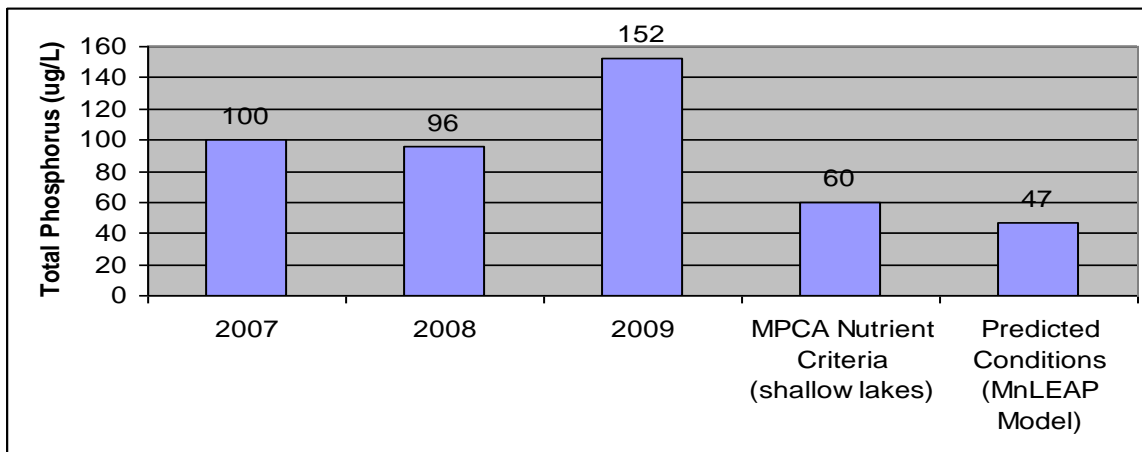
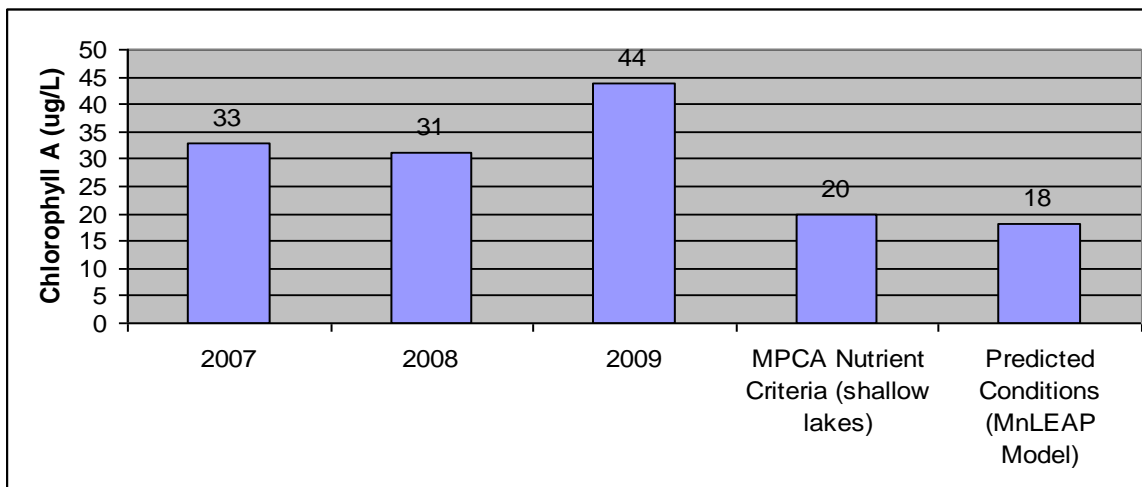
Gilfillan Lake is very high in nutrient levels. The water quality is far higher than the MPCA nutrient criteria for shallow lakes and higher than predicted by the MN Leap modeling program for lakes within this ecoregion. MN Leap (which can be found on MNPCA website) takes into account lake surface area, mean depth, watershed area and ecoregion in which the lake is located.

Total Phosphorus (ug/L)	Chlorophyll A (ug/L)	Sechi disc (m)
Existing Conditions			
2007	100	33	0.7
2008	96	31	0.5
2009	152	44	0.4
MPCA Nutrient Criteria (shallow lakes)	60	20	1.1
Predicted Conditions (MnLEAP Model)	47	18	1.4
