## MEMORANDUM

RE: Vadnais/Sucker Park Wetland Assessment

SEH No. VADLA 154641 14.00

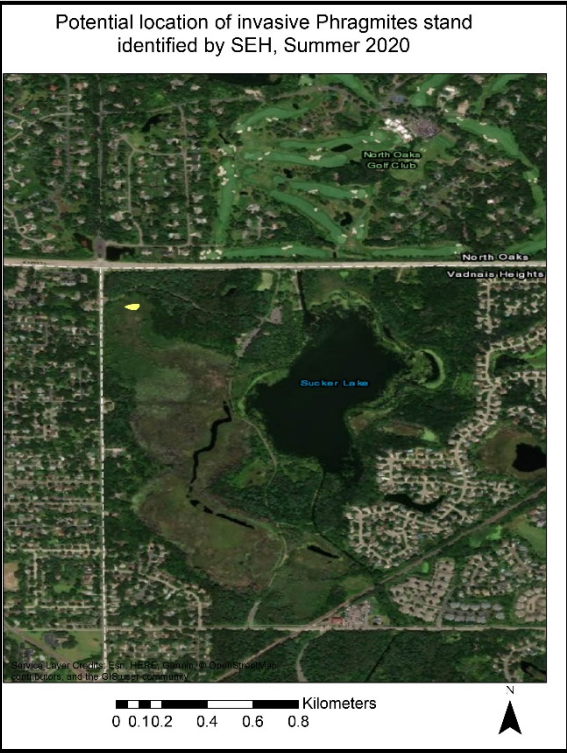
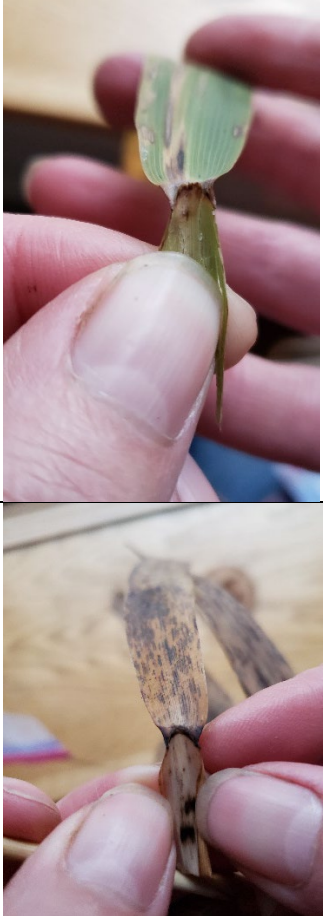
<p>This map shows the location of Wetland 5</p>	<p>The appearance of the ligule is used to definitively distinguish between native and invasive Phragmites. Phragmites currently present in Wetland 5 is native.</p>
<p>Potential location of invasive Phragmites stand identified by SEH, Summer 2020</p>

Continuing to watch this and other locations in the watershed are important in working to eradicate this invasive species and protect wetland functions for water quality.

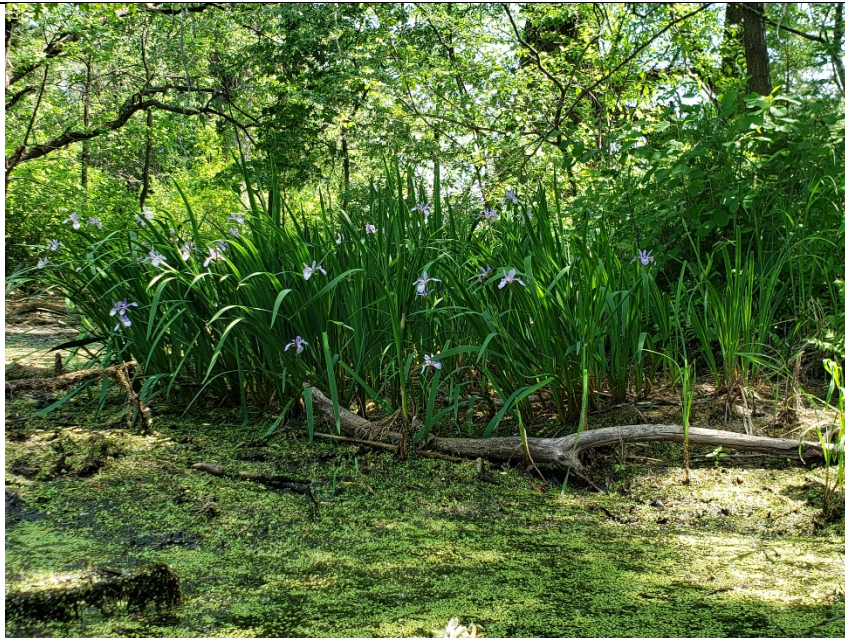
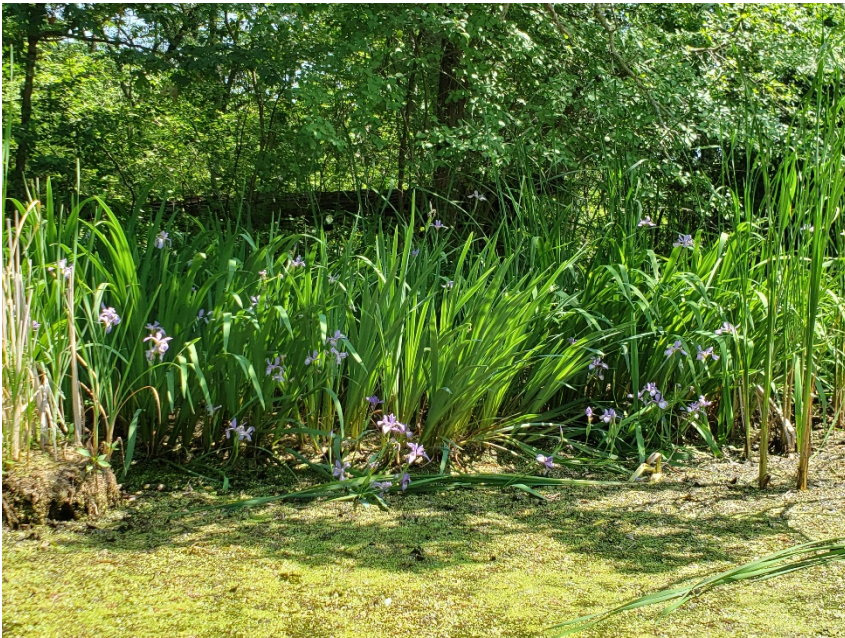
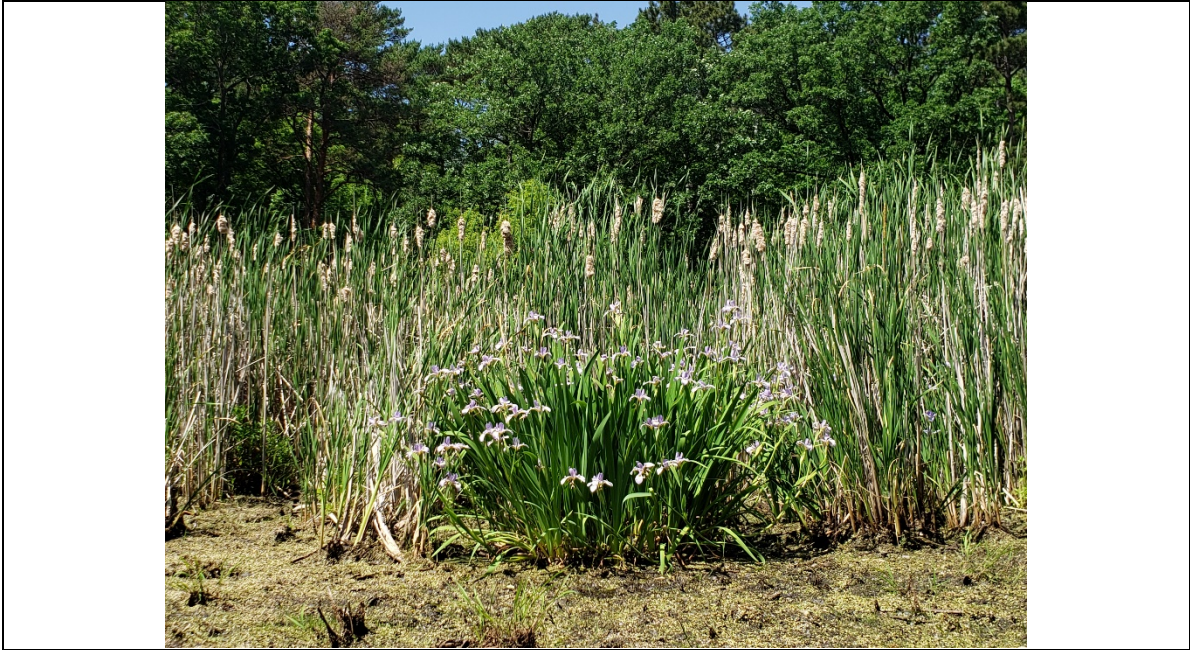
Invasive Yellow iris (*Iris pseudacorus*) was reported by SEH in Wetland 22, Shallow Marsh/Seasonally flooded basin. This location was checked on June 9, 2021. Currently, no invasive Yellow iris is present at the site.

Photos below show large stands of native Blue-flag iris that are present in the wetland and could have been misidentified as Yellow iris due to their abundance.

Continuing to watch this and other locations in the watershed are important in working to eradicate this invasive species and protect wetland functions for water quality.

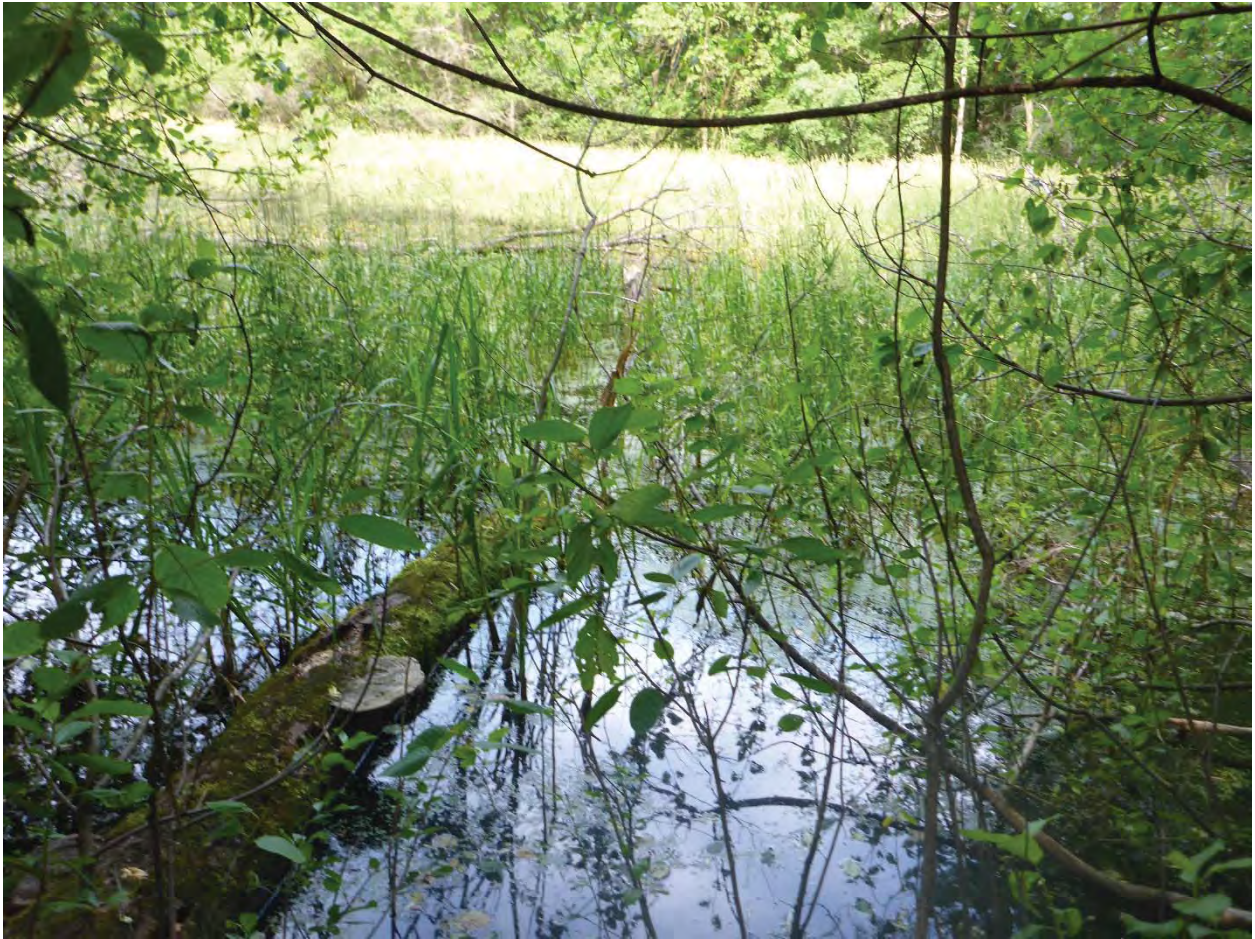
## Wetland 1

**Wetland Type:** Seasonally Flooded Basin/ Shallow Marsh  
**Sample Point ID:** 1-1W

Shrub stratum is dominated by buckthorn (European and glossy). The ground layer is overall reduced in coverage, likely due to shading from the shrub canopy, but native species are still present. Dame's rocket present in the herbaceous stratum but not abundant overall.

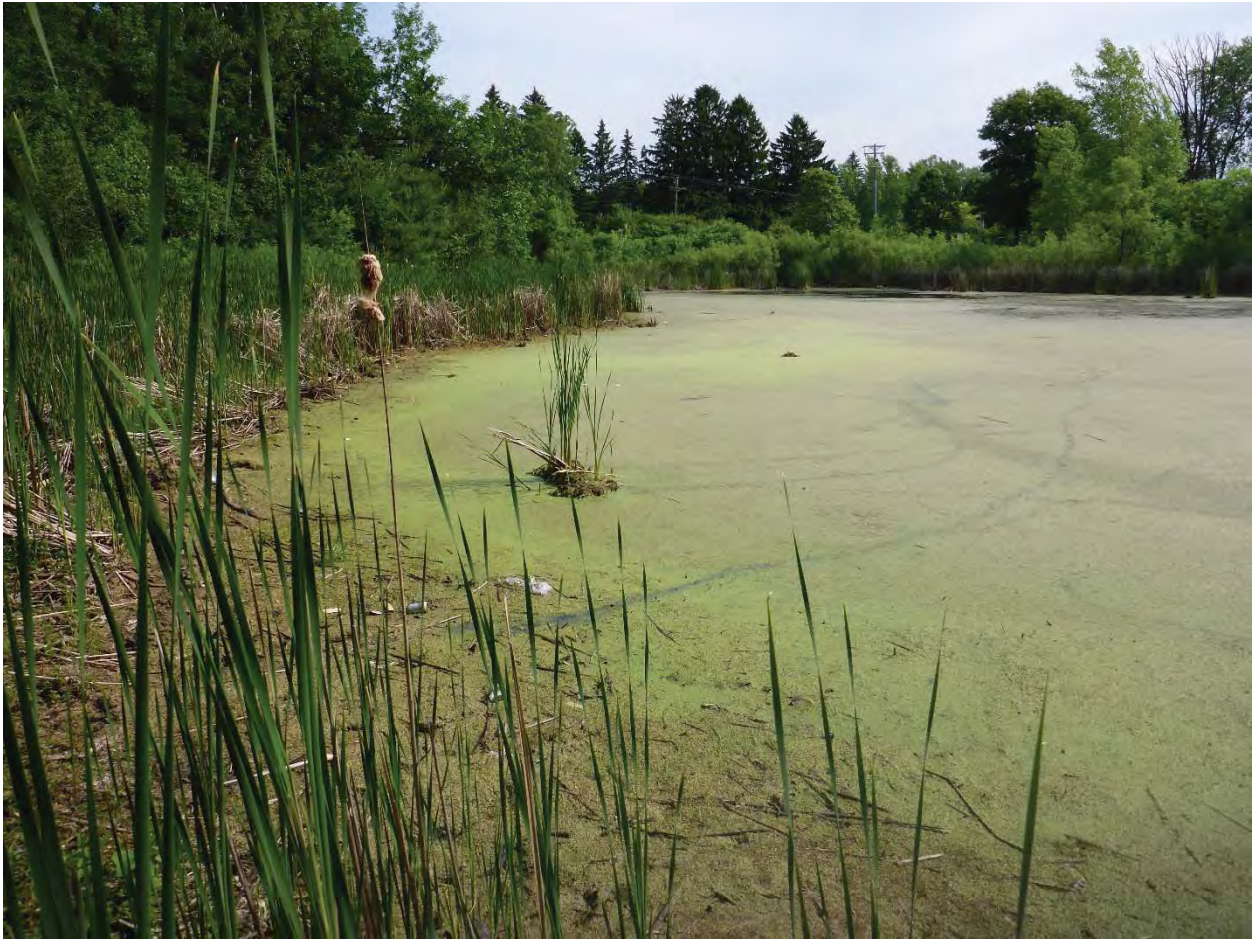
## Wetland 2

**Wetland Type:** Shallow Open Water/ Fresh (wet) Meadow  
**Sample Point ID:** 2-1W

Dominance of native species including a mix of sedges and forbs, some reed canary grass and fringe of cattails present along the open water perimeter.

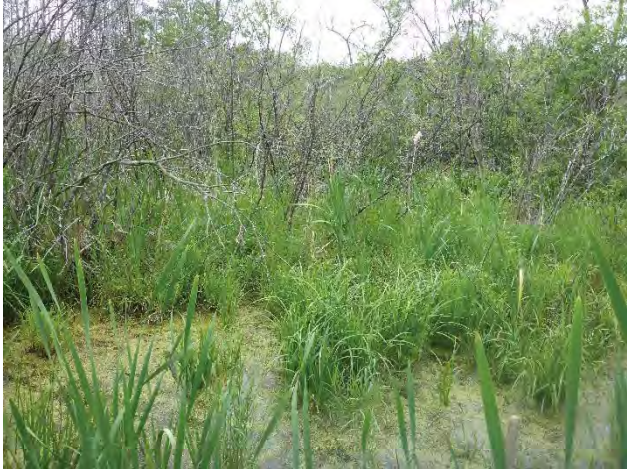
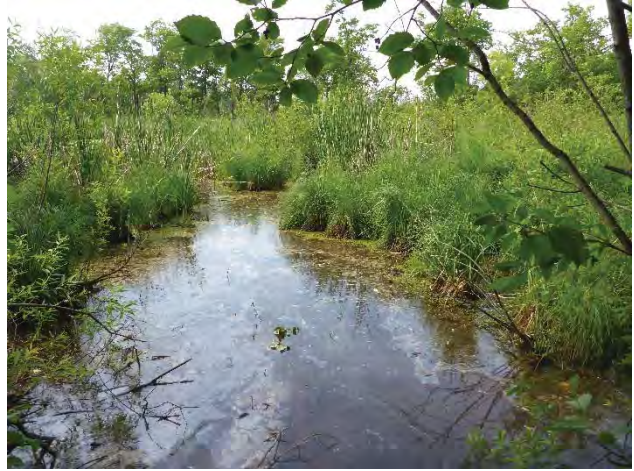
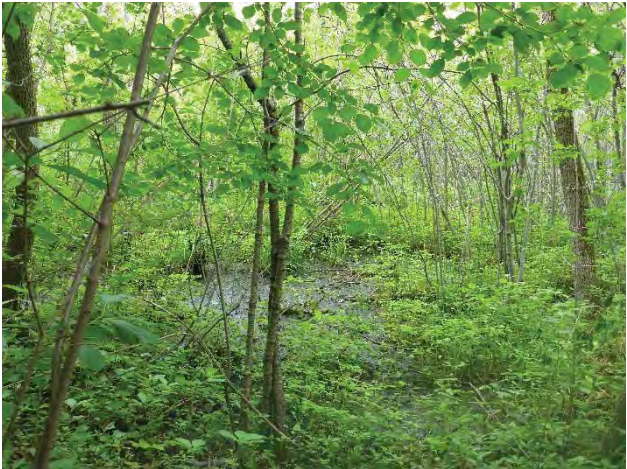
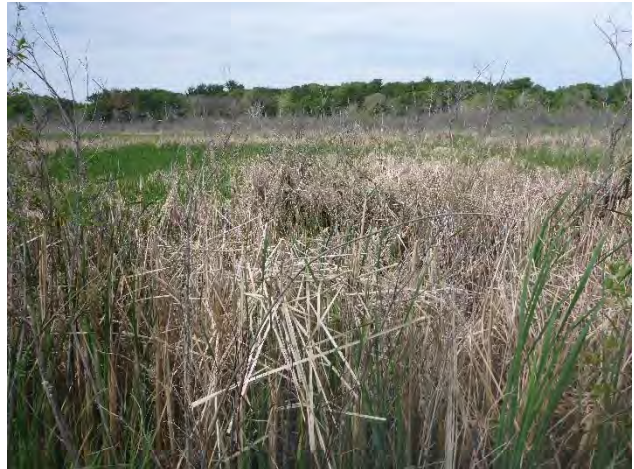
## Wetland 3

**Wetland Type:** Seasonally Flooded Basin/ Shallow Marsh/ Shrub-carr  
**Sample Point ID:** 3-1W, 3-2W, 3-3W, 3-4W

The shallow marsh habitat is variable, but typically a mix of native sedges and forbs with cat-tails (multiple species) was observed along the shore of Sucker Lake. Most often, the cat-tails were growing with native species and not as dense monocultures. Buckthorn (European and glossy) was often observed along the fringe of the habitat.

This community within wetland 3 is a small area on the southern extent of Sucker Lake. The area is dominated by native species, with red osier and sandbar willow dominate in the shrub stratum, and a variety of forbs with low aerial coverage in the herbaceous stratum. Non-native invasive species observed include garden birds'-foot-trefoil and European buckthorn, but in very low amounts.

The habitat identified as shrub carr 2 likely has the highest species richness and diversity within the basin. European buckthorn is common along the perimeter and glossy buckthorn is present throughout, however speckled alder is also dominant, with scattered willows. The herbaceous stratum is primarily native ferns, forbs, and sedges, with some sporadic cat-tails.

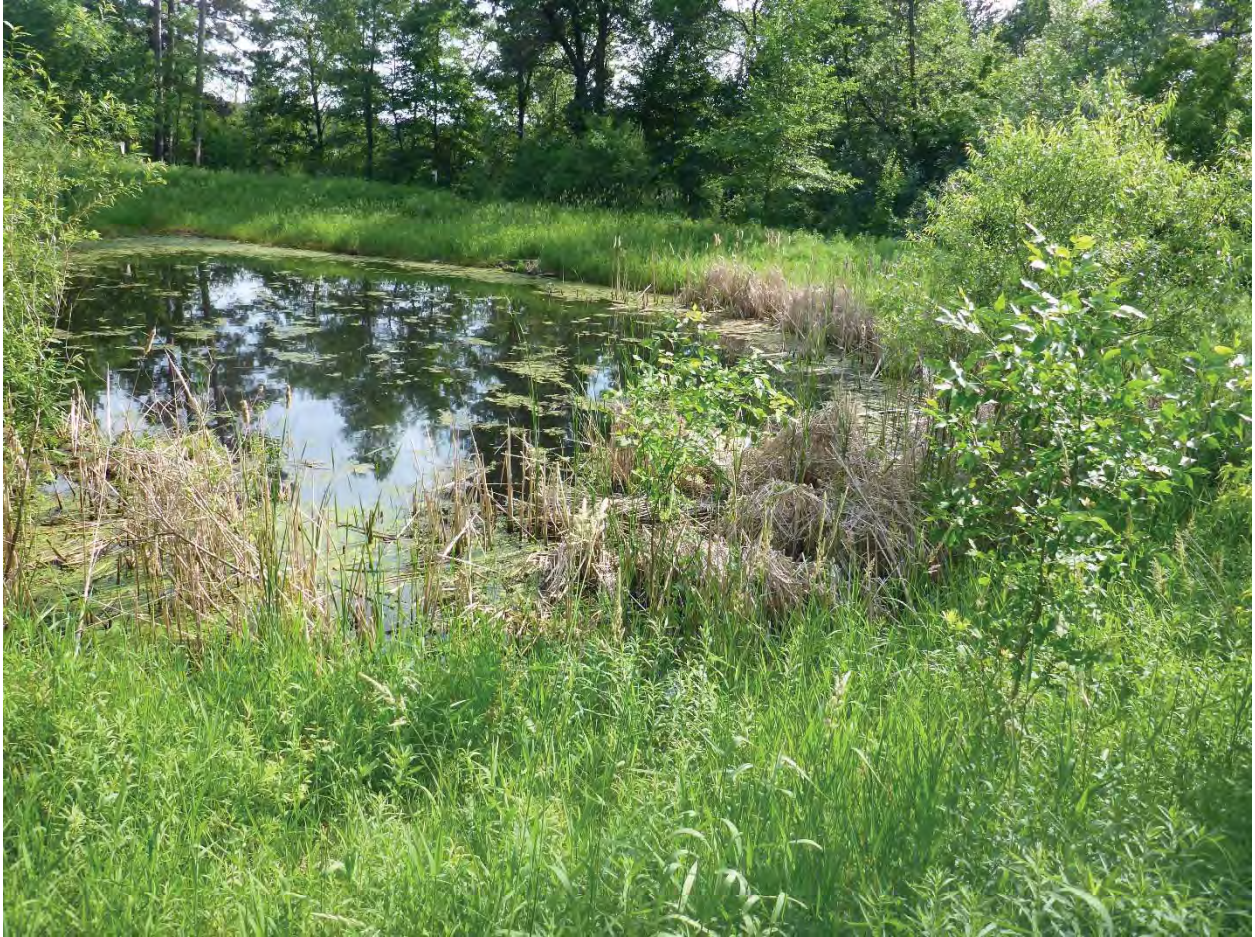
## Wetland 4

**Wetland Type:** Fresh (wet) Meadow/ Shallow Open Water  
**Sample Point ID:** 4-1W

The shallow open water is primarily un-vegetated, with duck weed in the deeper portions and narrow-leaf cat-tail along the edges. There are few species present within the habitat.

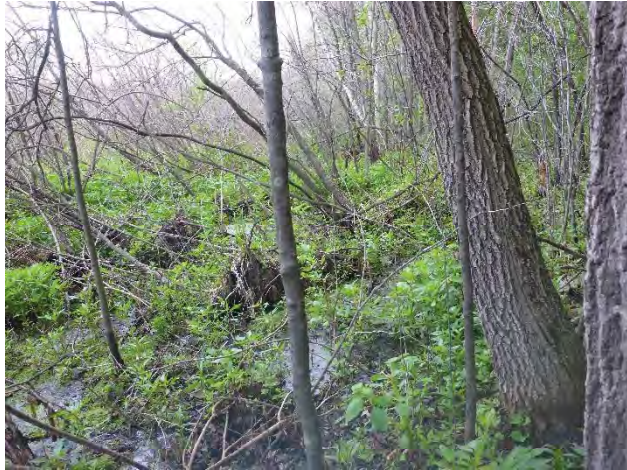
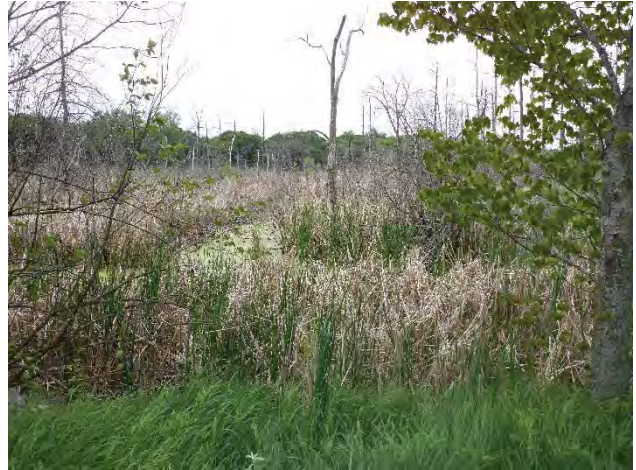
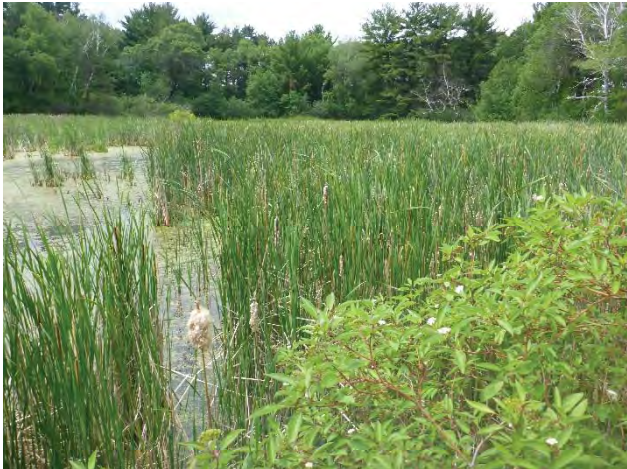
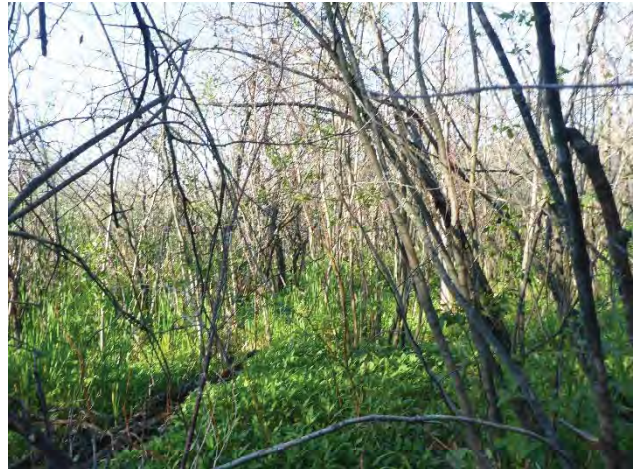
## Wetland 5

**Wetland Type:** Shallow Marsh/ Shrub-carr  
**Sample Point ID:** 5-1W, 5-2W, 5-3W

Most of the shallow marsh habitat of Wetland 5 is dominated by cat-tails, likely narrow-leaf and/or hybrid, in some areas forming a monoculture. Native plants are present, as scattered individual plants at low areal coverage, and appear impacted by the current dense cat-tail growth and remnant vegetation from prior years. The fringe of the habitat appears to have greater species richness and diversity, and the deeper portions of the basin less. Dead/drying trees and shrubs were observed throughout, mostly

present as snags (i.e., standing dead wood). There are inclusions of higher quality vegetation and greater species richness/diversity, but the habitat as a whole contains low quality vegetation, low species diversity, and low species richness. The far northern extent of the shallow marsh of Wetland 5 contains a small infestation of European Phragmites (*Phragmites australis* subsp. *australis*). The species was observed intermixed with other plants over an approximately 0.2 acre area. It is not the dominant species in the area currently. Glossy buckthorn is also common in the habitat, in some areas dead or dying, in some areas alive.

The habitat identified as shrub carr 2 likely has the highest species richness and diversity within the basin. Glossy buckthorn is the dominant shrub throughout the habitat, with scattered speckled alder and red osier dogwood. Dead/dying shrubs were observed, likely remnant speckled alder and/or European buckthorn. Tamarack trees are dispersed throughout, although do not have high areal coverage. The herbaceous stratum however, has numerous native graminoid and forbs species throughout. The habitat resembles the Northern Rich Alder Swamp Alder - (Maple - Loosetrife) Swamp (FPn73a) Native Plant Community, although typical dominate shrubs like speckled alder, appear to have been replaced by glossy buckthorn. The shade tolerant herbaceous species have persisted, as glossy buckthorn provides a similar canopy to speckled alder. Other NON-NATIVE INVASIVE species observed are sporadic but include reed canary grass, narrow-leaf cat-tails, and giant chickweed.

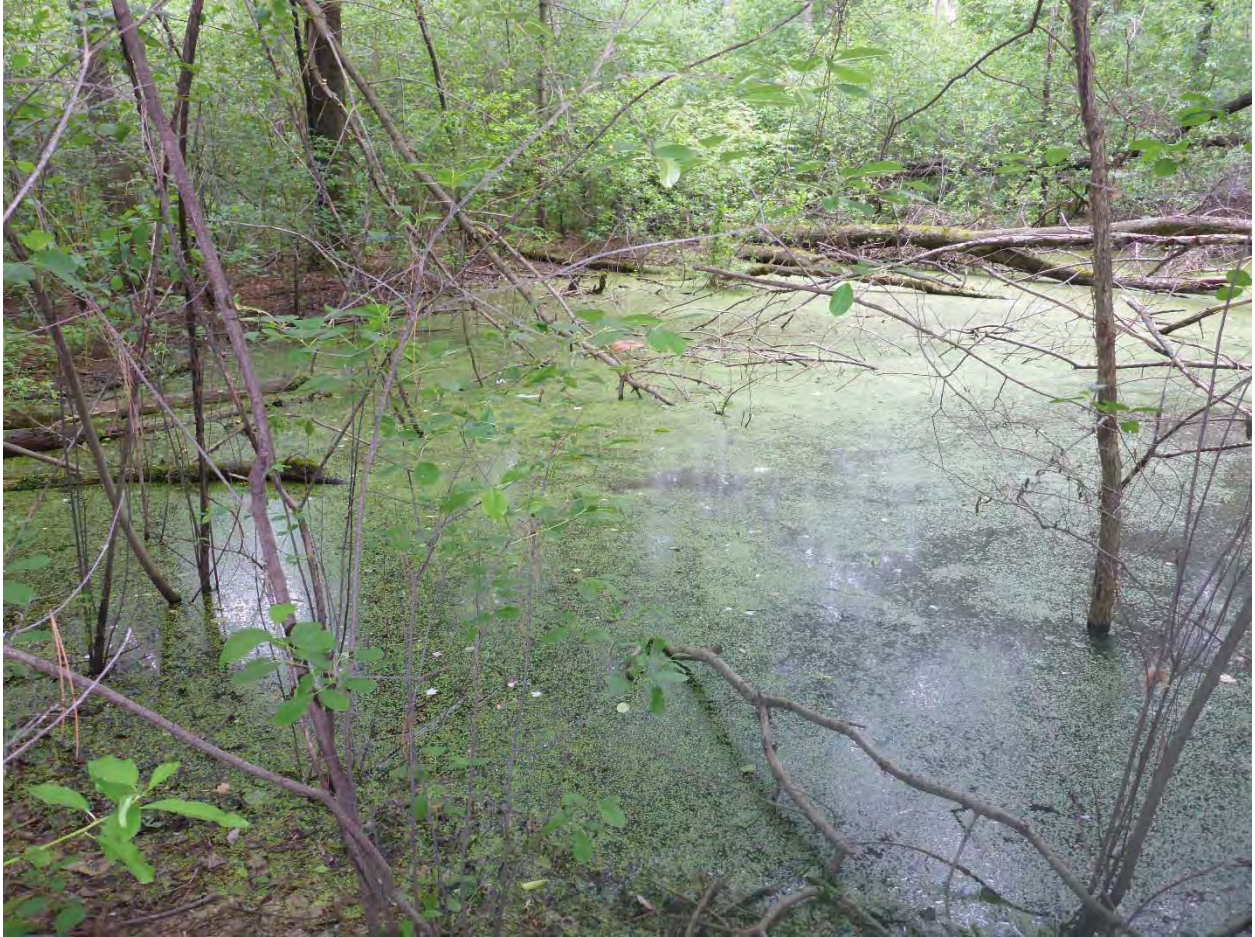
## Wetland 6

**Wetland Type:** Shallow Open Water  
**Sample Point ID:** 6-1W

The fringe of Wetland 6 is densely covered by European buckthorn, reducing the prevalence of native herbaceous and shrub species. Herbaceous plants are still present but at lesser areal coverage. Within the open water, duck weed is the primary component.

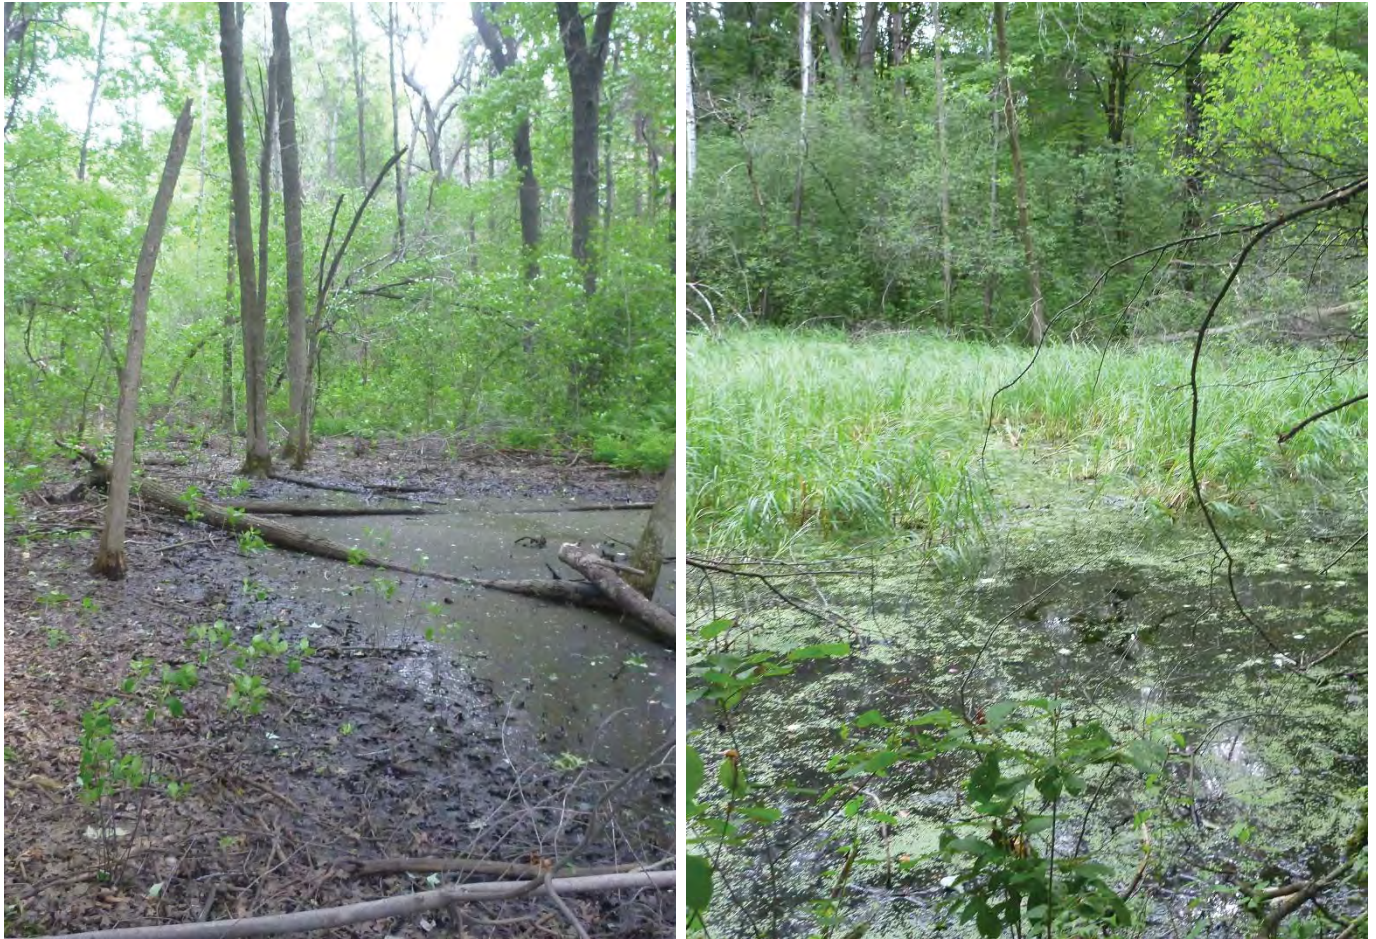
## Wetland 7

**Wetland Type:** Seasonally Flooded Basin/ Shallow Marsh  
**Sample Point ID:** 7-1W

Primarily un-vegetated within the open water and surrounding floodplain. Buckthorn (European and glossy) is common along the perimeter, reduces herbaceous growth.

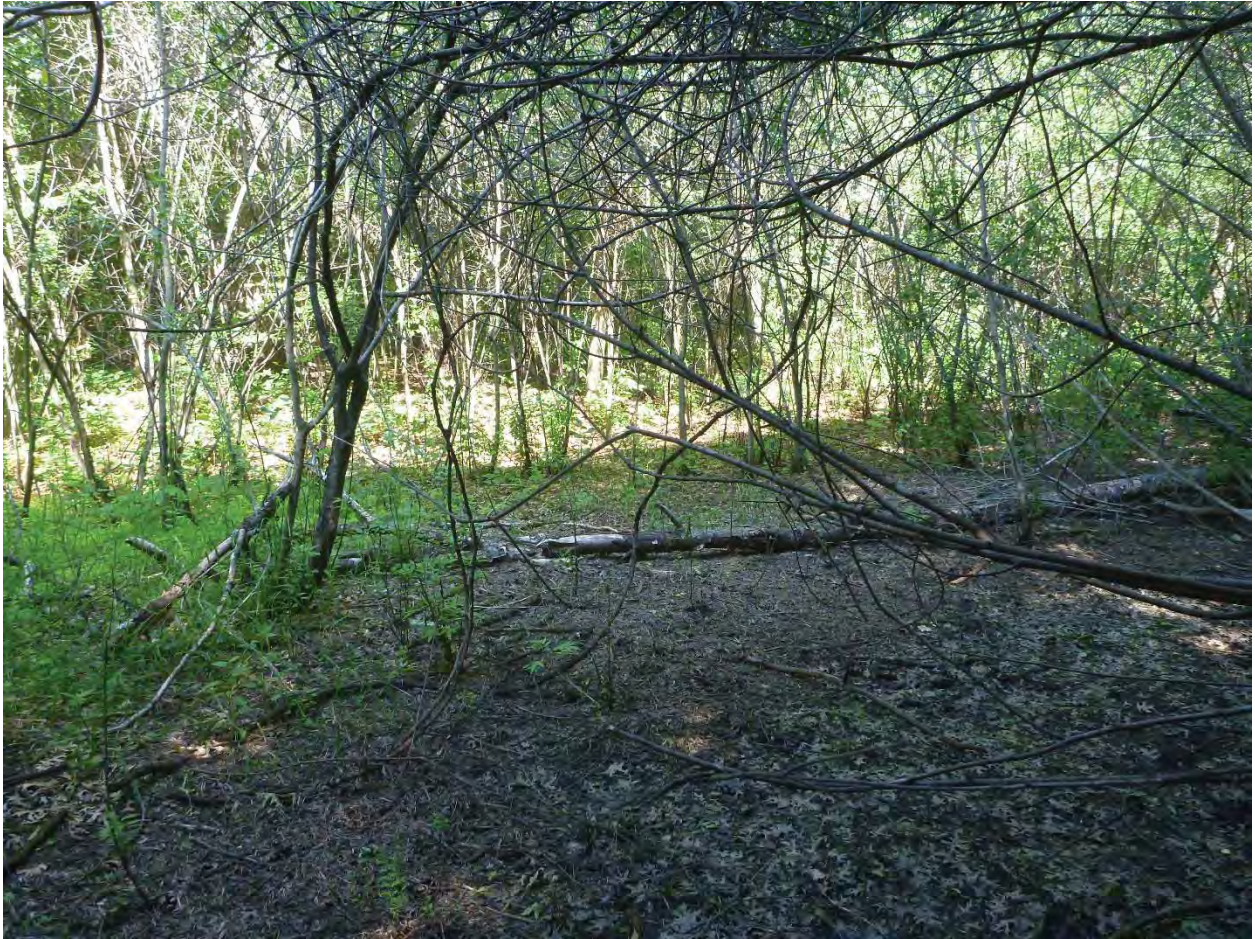
## Wetland 8

**Wetland Type:** Seasonally Flooded Basin

The most prevalent species within Wetland 8 was buckthorn. The shrub canopy appears to shade much of the ground, likely inhibiting overall growth and occurrence of herbaceous species. Other non-native invasives observed within the basins included reed canary grass and Canada thistle.

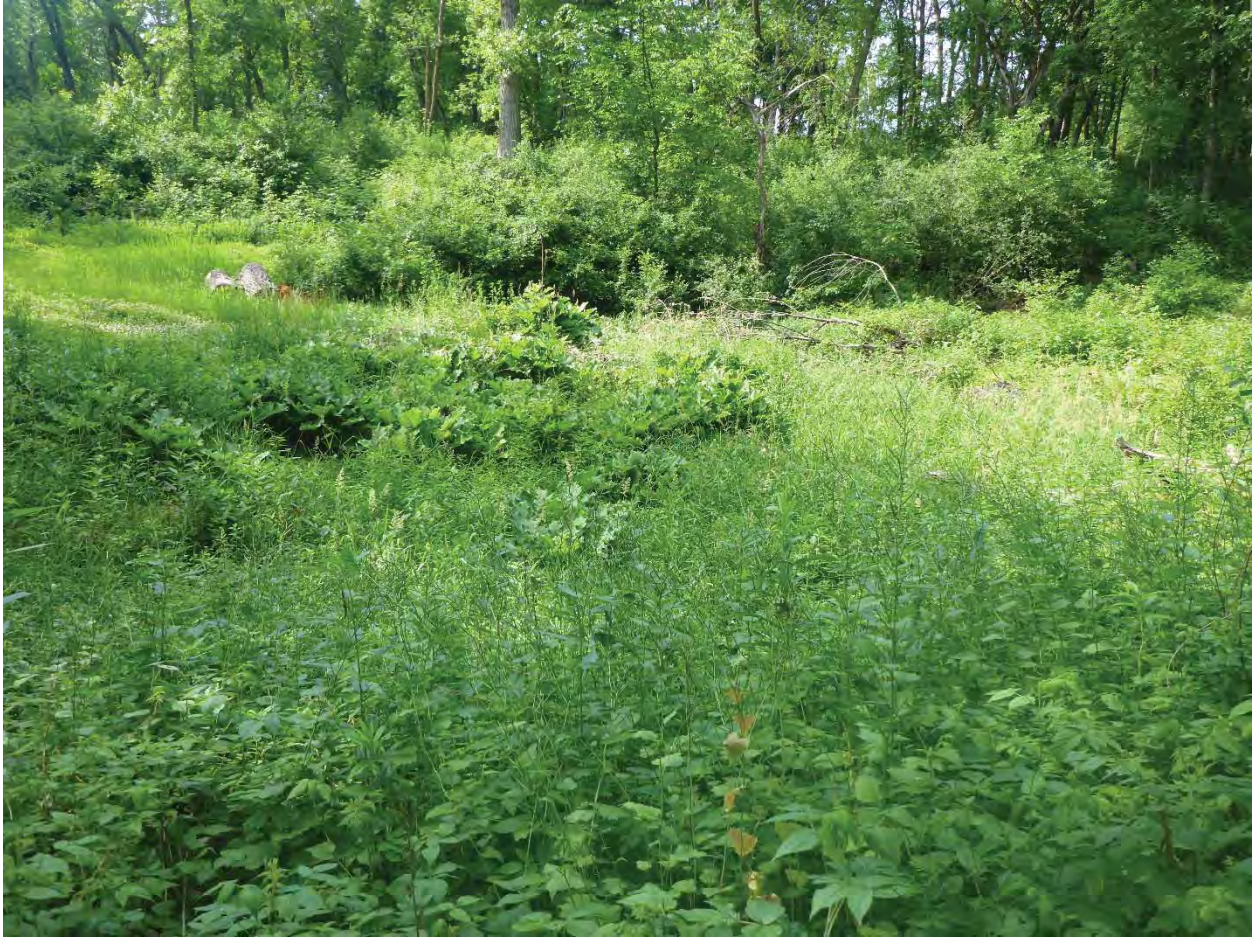
## Wetland 9

**Wetland Type:** Fresh (wet) Meadow  
**Sample Point ID:** 9-1W

Vegetation within this basin primarily includes disturbance adapted and/or non-native invasive species, such as reed canary grass, stinging nettle, and lesser burdock. It appears to be within an area subjected to past disturbance, resulting in the low quality vegetation.

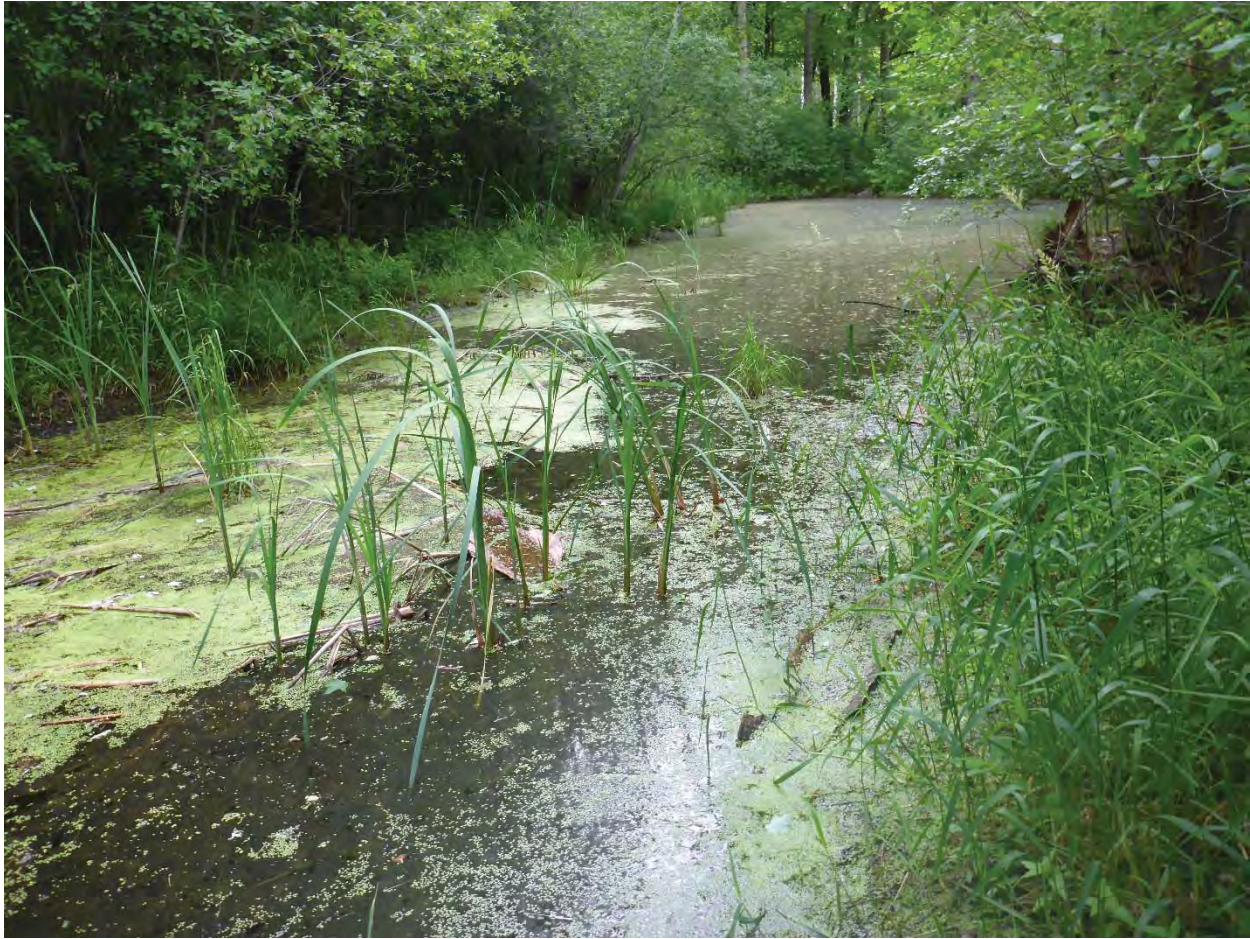
## Wetland 10

**Wetland Type:** Shallow Open Water/ Shallow Marsh  
**Sample Point ID:** 10-1W

The shallow marsh habitat contained a mix of species, with primary coverage of lakebank sedge and cattails. Non-native invasive species included cattails reed canary grass in the herbaceous stratum, although both species are intermixed with other plants, and two species of buckthorn in the shrub stratum. Buckthorn (European and glossy) forms a dense canopy along the perimeter of the wetland.

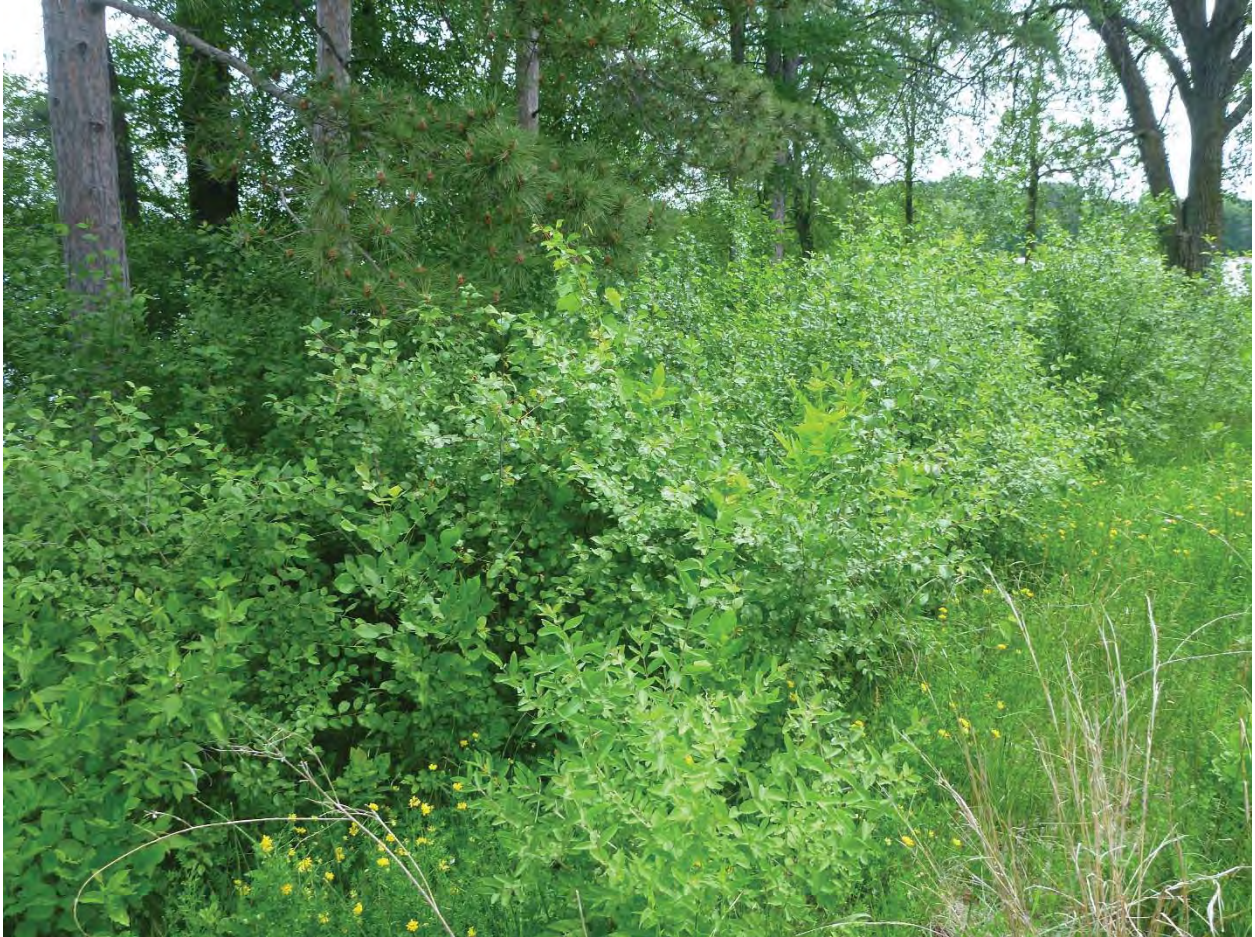
## Wetland 11

**Wetland Type:** Seasonally Flooded Basin

Wetland 11 is a linear wet ditch with buckthorn as the primary species in both the shrub and herbaceous strata. There are other herbaceous species present, but are shaded by a dense shrub canopy.

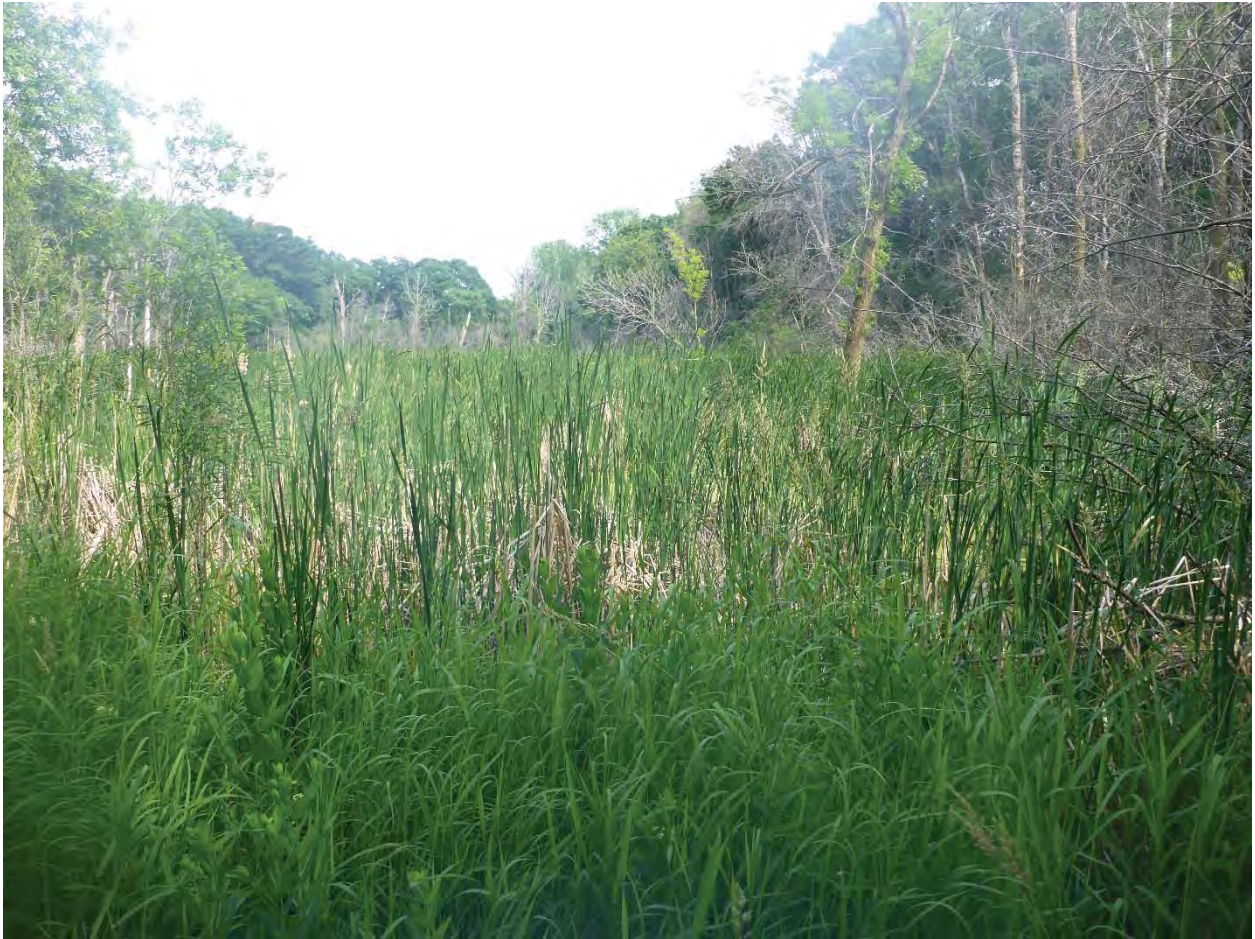
## Wetland 12

**Wetland Type:** Seasonally Flooded Basin/ Shallow Marsh

The shallow marsh is primarily a cattail monoculture with few pockets of shallow open water, and sporadic green ash trees and willow shrubs. The pockets typically included duck weed with, with few other species present in the habitat.

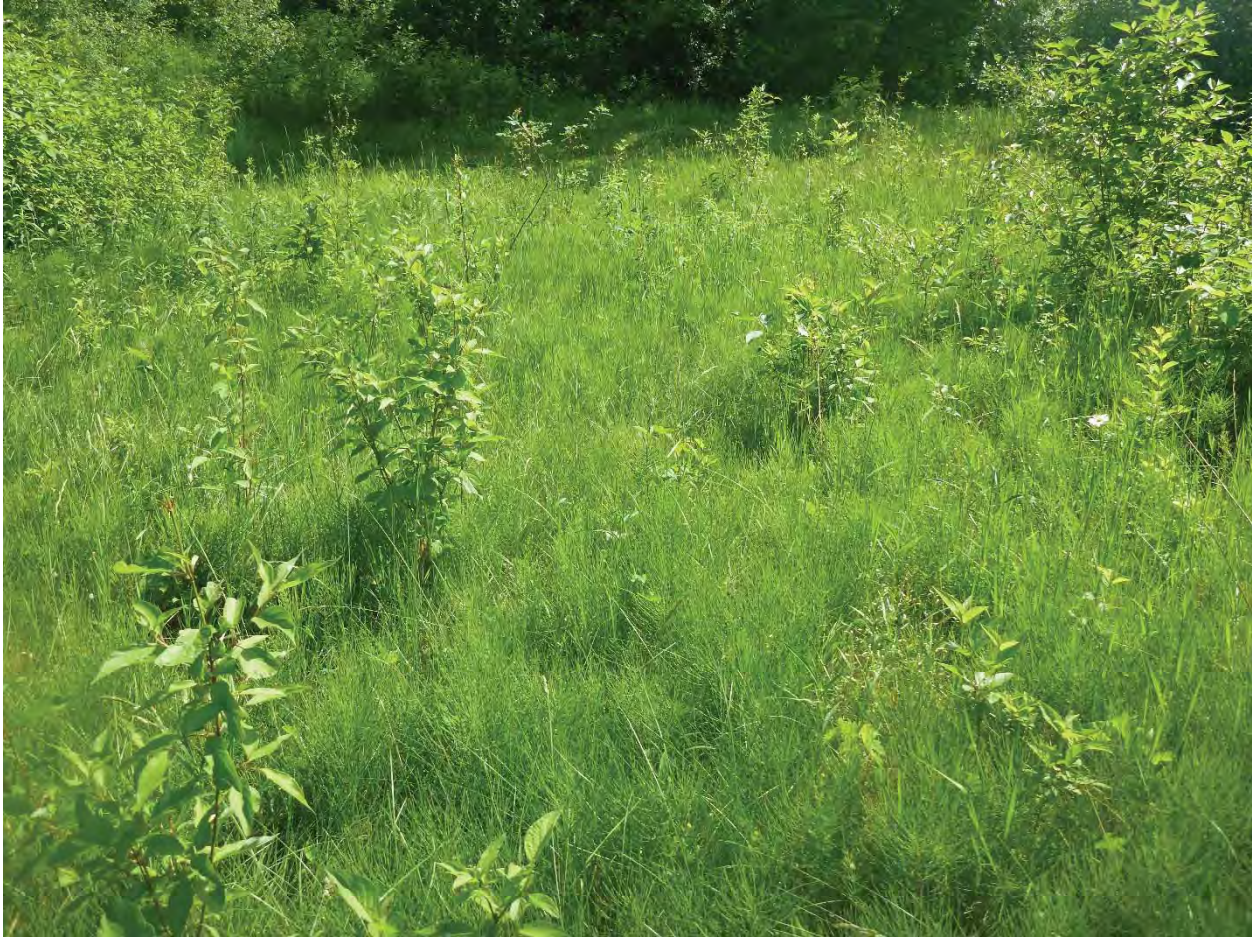
## Wetland 13

**Wetland Type:** Fresh (wet) Meadow

The critical function that caused this wetland rank was “Maintenance of Hydrologic Regime and Vegetative Diversity”.

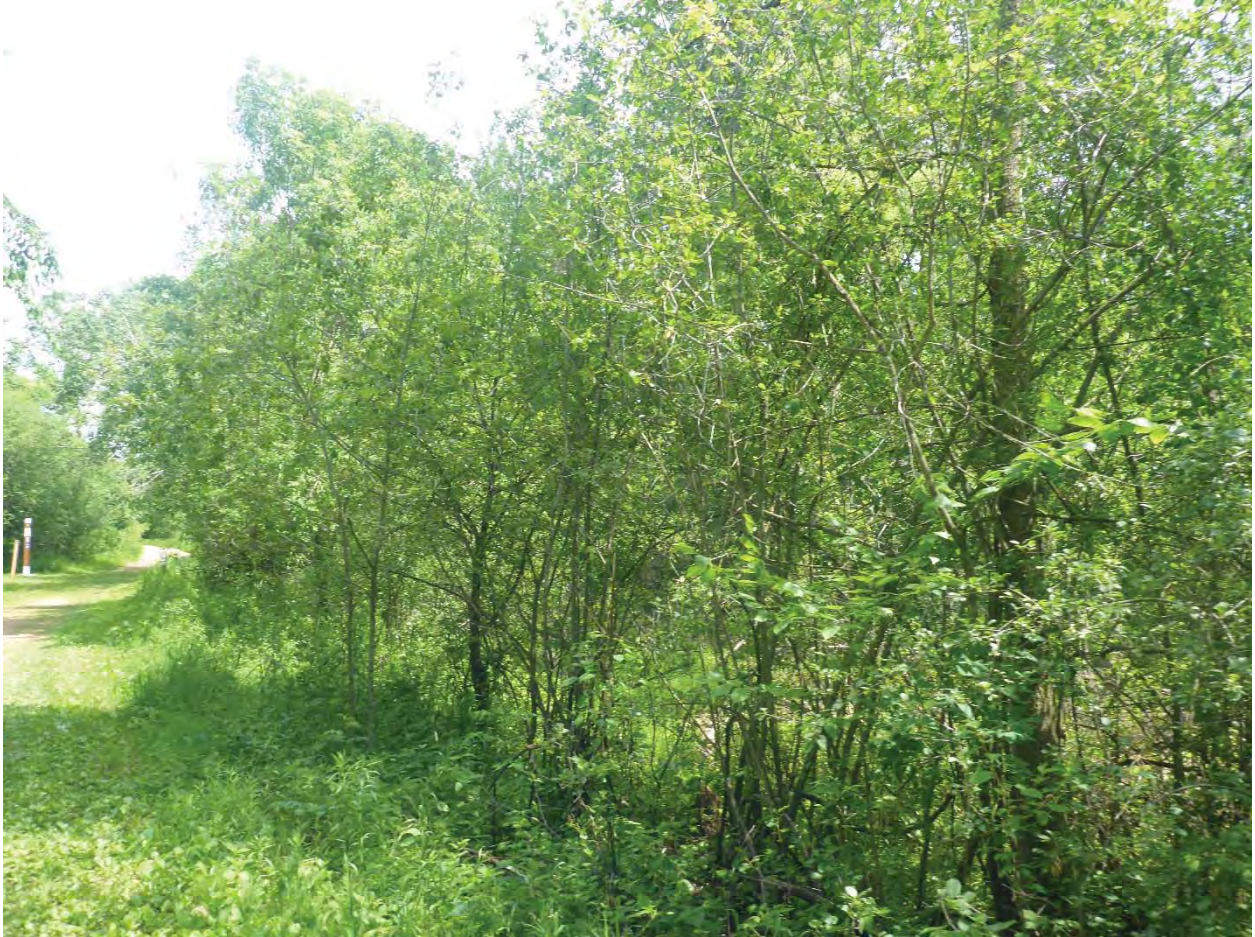
## Wetland 14

**Wetland Type:** Seasonally Flooded Basin

Wetland 14 is a linear wet ditch with buckthorn as the primary species in both the shrub and herbaceous strata.

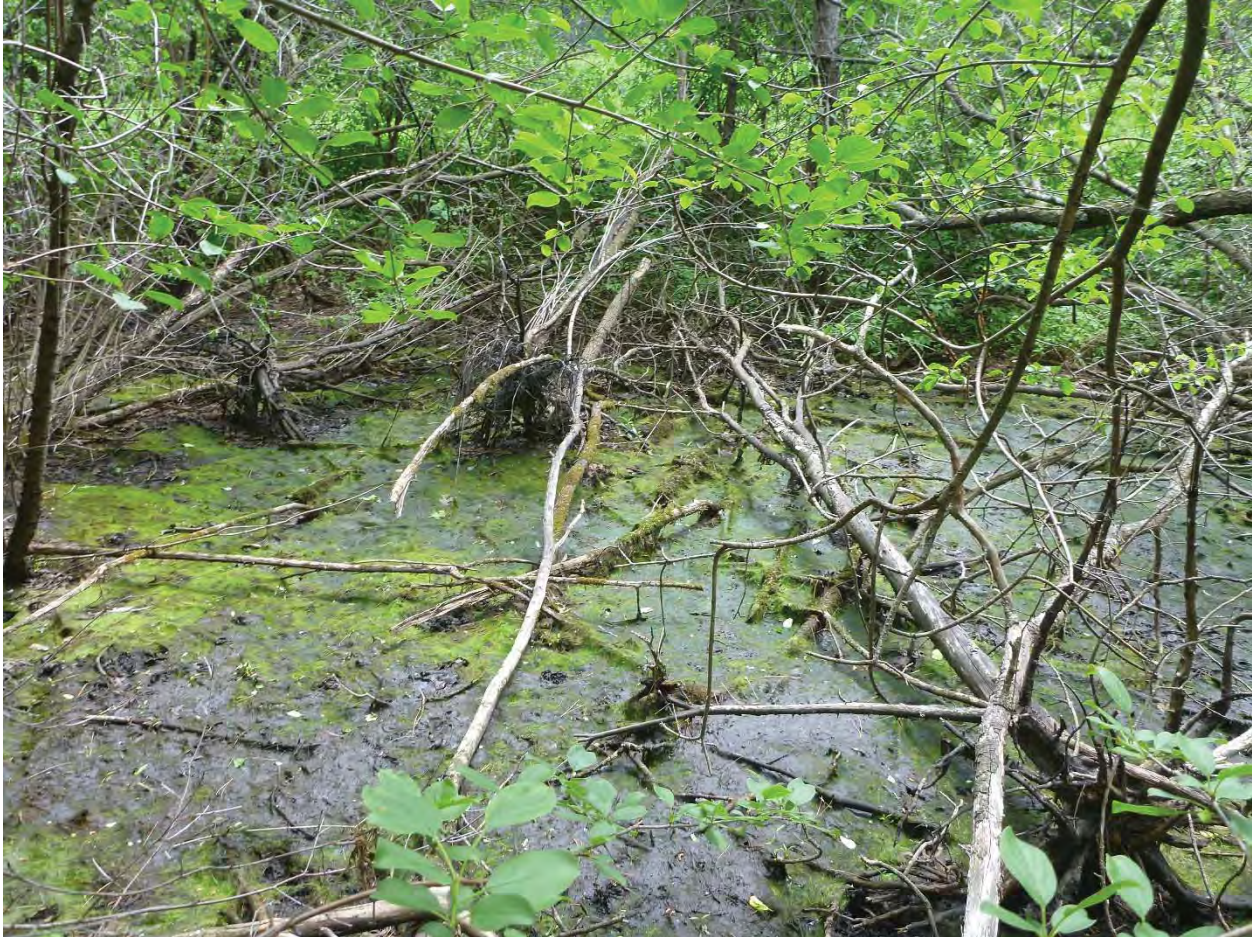
## Wetland 15

**Wetland Type:** Seasonally Flooded Basin

The shrub stratum is primarily European buckthorn, but the herbaceous layer contains a mix of native species throughout the basin, with royal fern, jewelweed, and water horsetail commonly observed.
