## MEMORANDUM

RE: Vadnais/Sucker Park Wetland Assessment

SEH No. VADLA 154641 14.00

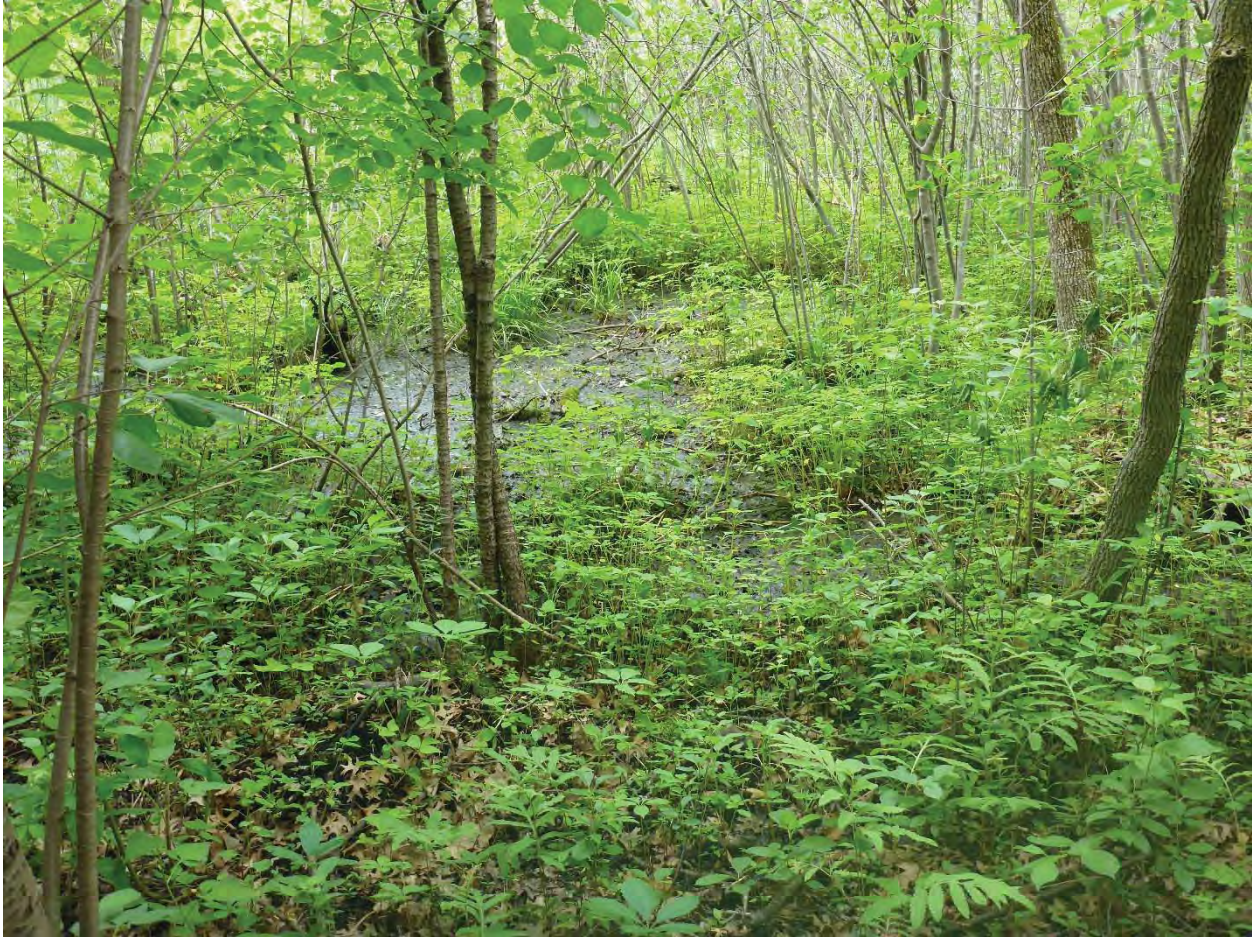
## Wetland 16

**Wetland Type:** Seasonally Flooded Basin

The critical function that caused this wetland rank was "Maintenance of Characteristic Wildlife Habitat Structure".

The herbaceous layer is sporadic and primarily European buckthorn, with few native species mixed. The shrub stratum contains mixed green ash and buckthorn. There are few other species present other than green ash as trees.

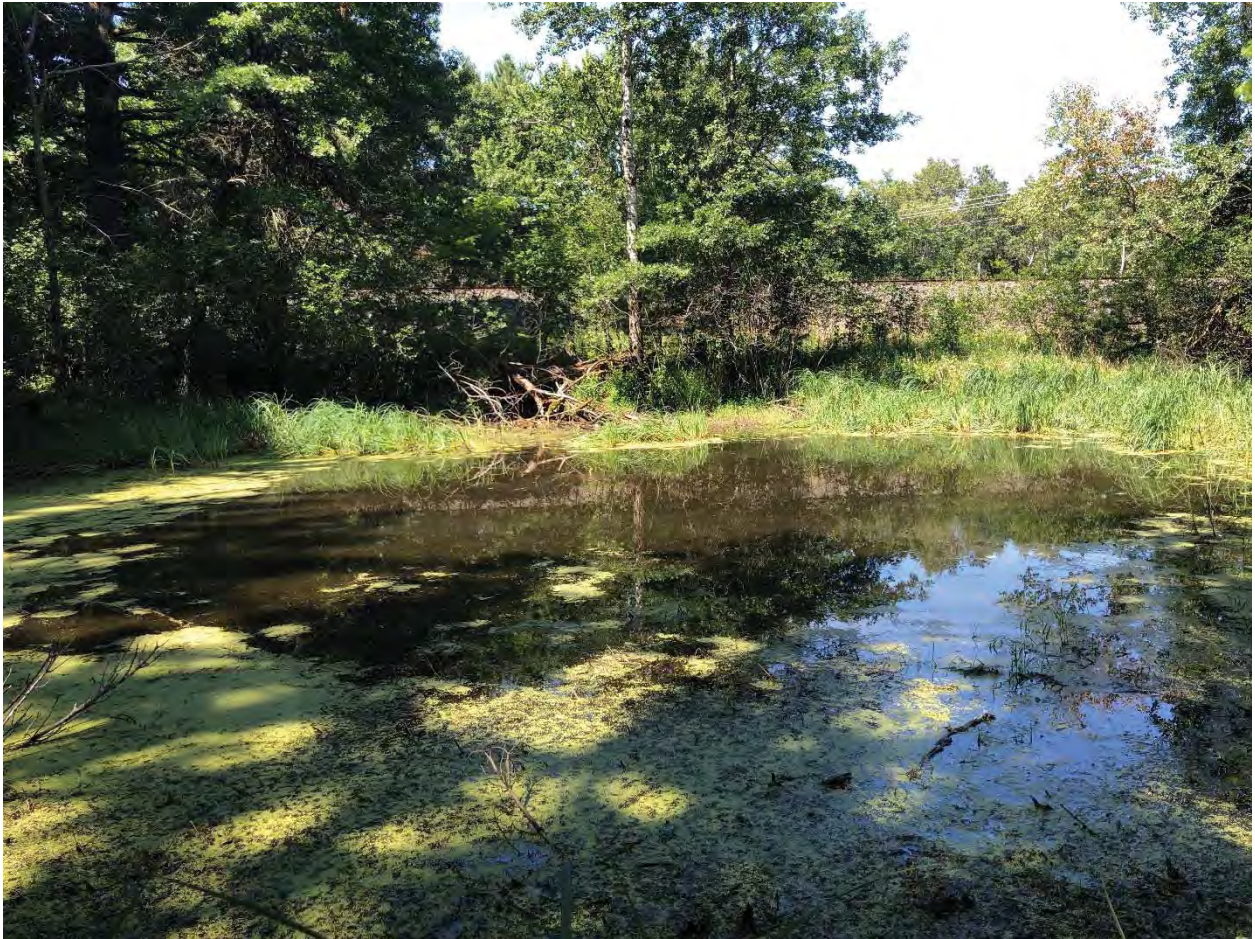
## Wetland 17

**Wetland Type:** Seasonally Flooded Basin

The critical function that caused this wetland rank was “Wetland Sensitivity to Stormwater and Urban Development and Vegetative Diversity”.

Primarily reed canary grass but mixed in with native species, including lakebank sedge, arrowleaf tearthumb, and northern water plantain.

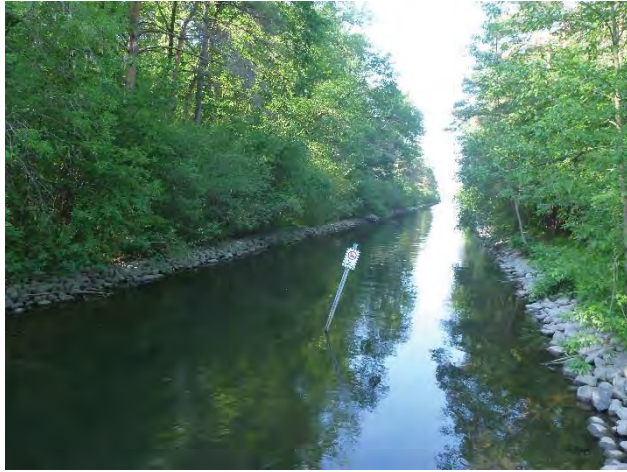
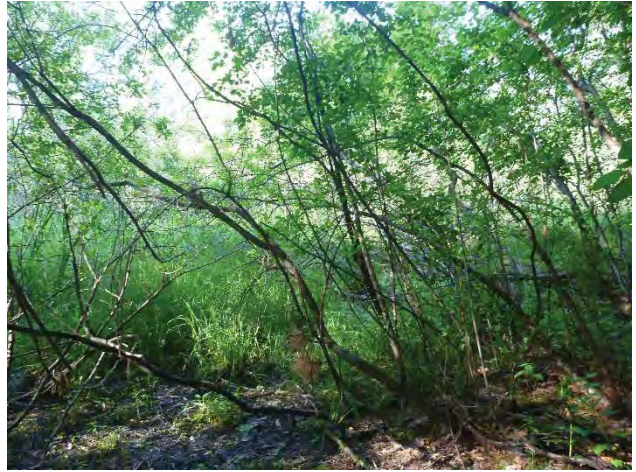
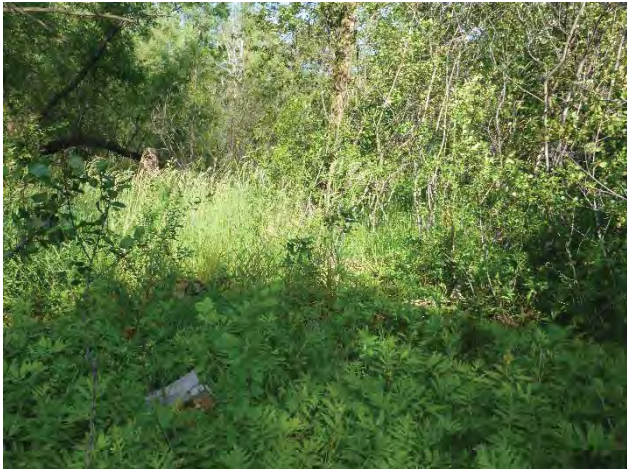
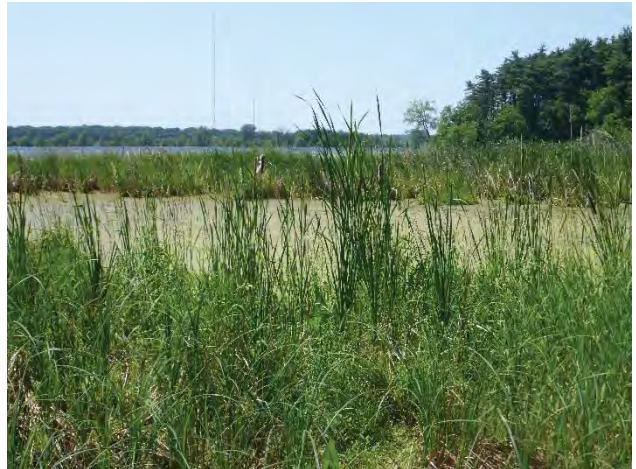
## Wetland 18

**Wetland Type:** Seasonally Flooded Basin/ Shallow Marsh/ Shrub-carr  
**Sample Point ID:** 18-1W, 18-2W, 18-3W

This is a large wetland complex associated with East Vadnais Lake, located throughout the southern half of the project limits. Because this wetland complex is so large, it was broken into community types for a total of 3 MnRAM assessments.

The shrub carr habitat is variable, with dense areas of reed canary grass and areas with primarily native herbaceous species. Buckthorn (glossy and European) are common throughout the habitat, but do not produce a canopy so dense that native species are completely absent.

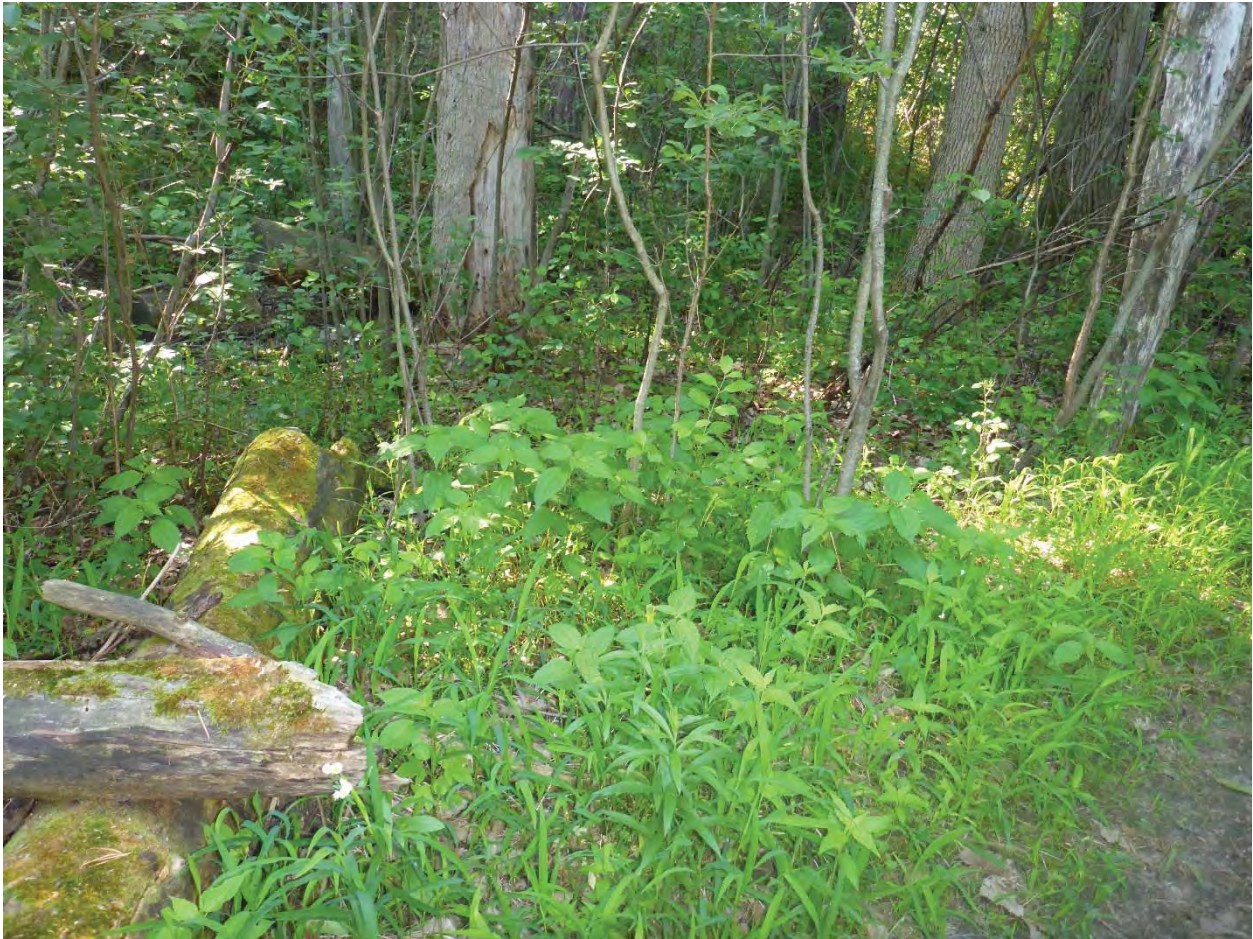
## Wetland 19

**Wetland Type:** Seasonally Flooded Basin

The critical function that caused this wetland rank was “Maintenance of Characteristic Wildlife Habitat Structure”.

The herbaceous stratum is primarily native species, with white grass and Canadian wood-nettle common throughout the habitat. Non-native invasive species include European buckthorn in the sapling and herbaceous strata. Buckthorn is common throughout the habitat, however although other species are still prevalent.

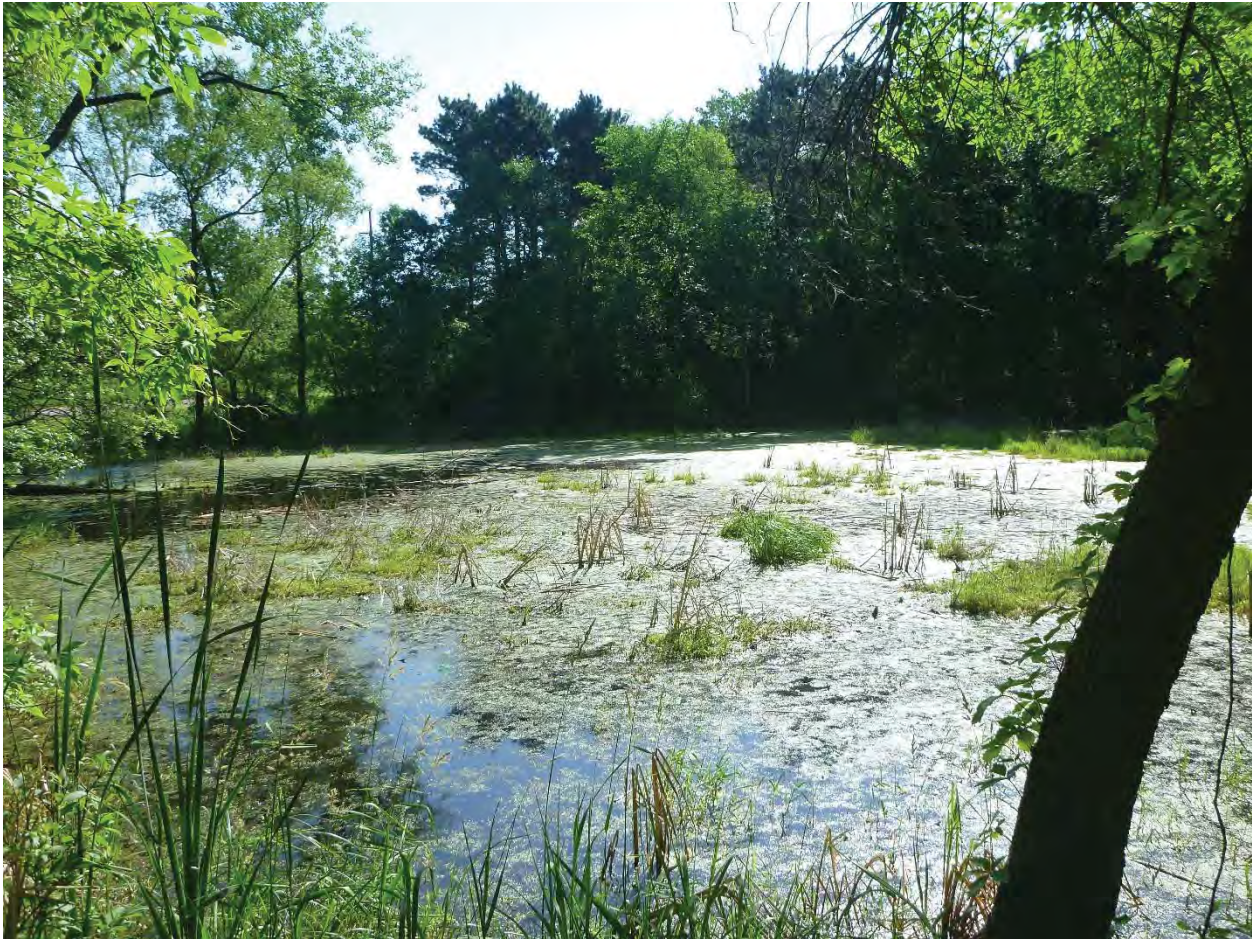
## Wetland 20

**Wetland Type:** Shallow Marsh

The critical function that caused this wetland rank was "Maintenance of Characteristic Amphibian Habitat".

The basin is dominated by duck weed with sporadic areas of emergent vegetation, primarily sedges, cattails, and reed canary grass. The wetland is fringed by native tree and shrub species, including green ash, black willow, and Missouri willow.

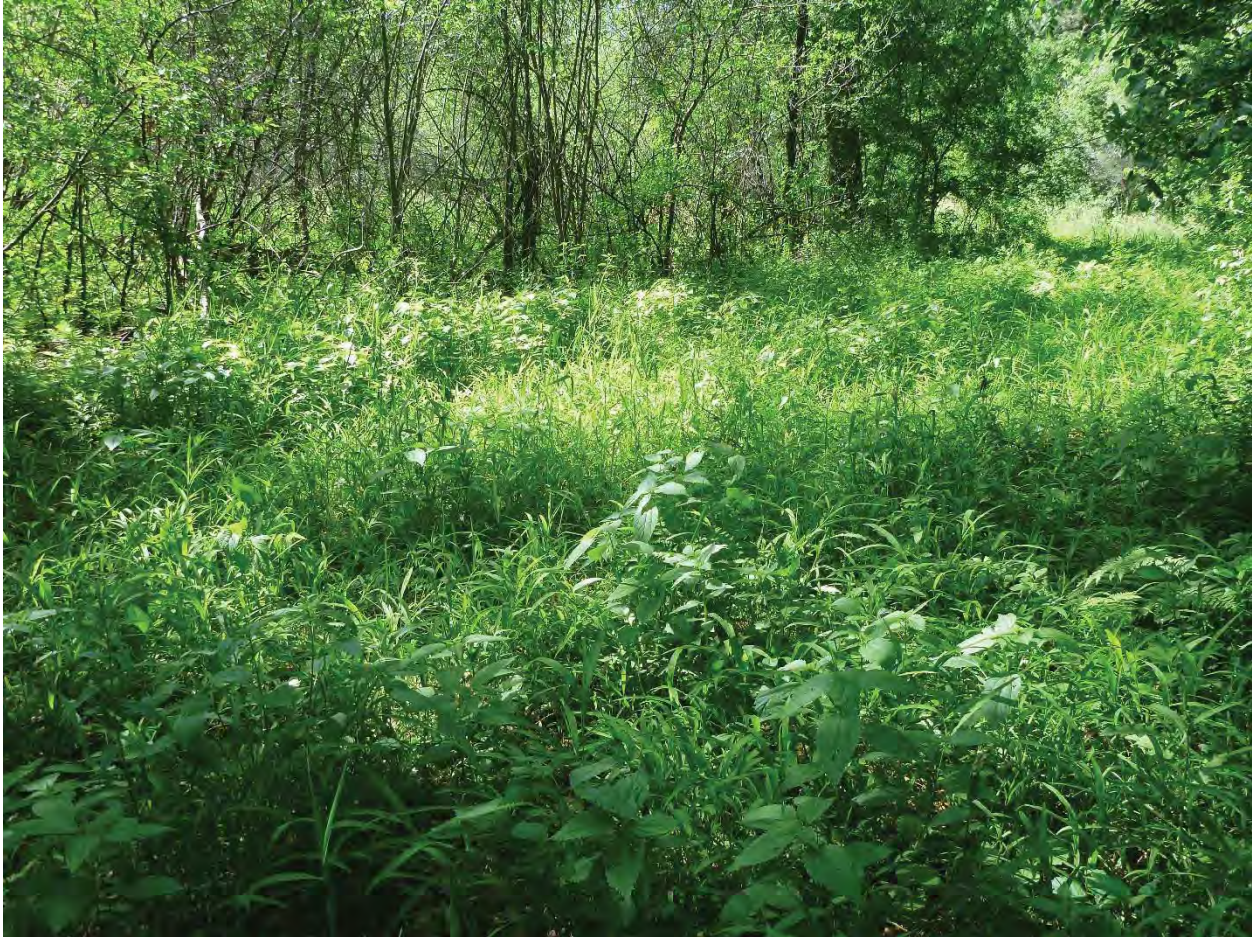
## Wetland 21

**Wetland Type:** Seasonally Flooded Basin/ Fresh (wet) Meadow  
**Sample Point ID:** 21-1W

The critical function that caused this wetland rank was “Maintenance of Water Quality and Vegetative Diversity”.

The habitat is dominated by reed canary grass, with European buckthorn dominant in the shrub stratum.

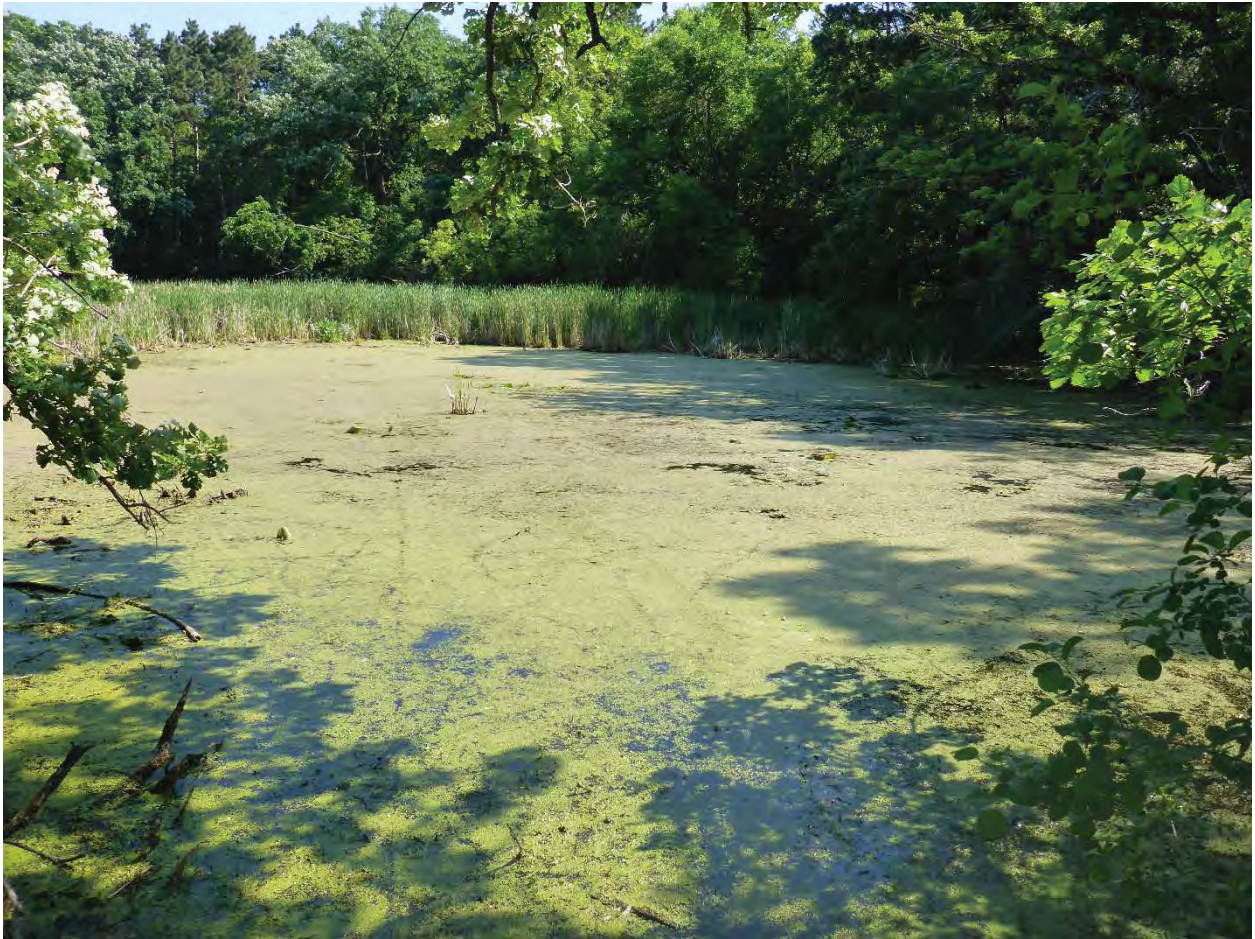
## Wetland 22

**Wetland Type:** Shallow Marsh/ Seasonally Flooded Basin  
**Sample Point ID:** 22-1W

The critical function that caused this wetland rank was “Maintenance of Characteristic Amphibian Habitat”.

The shallow marsh is comprised of a cattail monoculture and duck weed in the deeper portions of the habitat, with a fringe of European buckthorn.

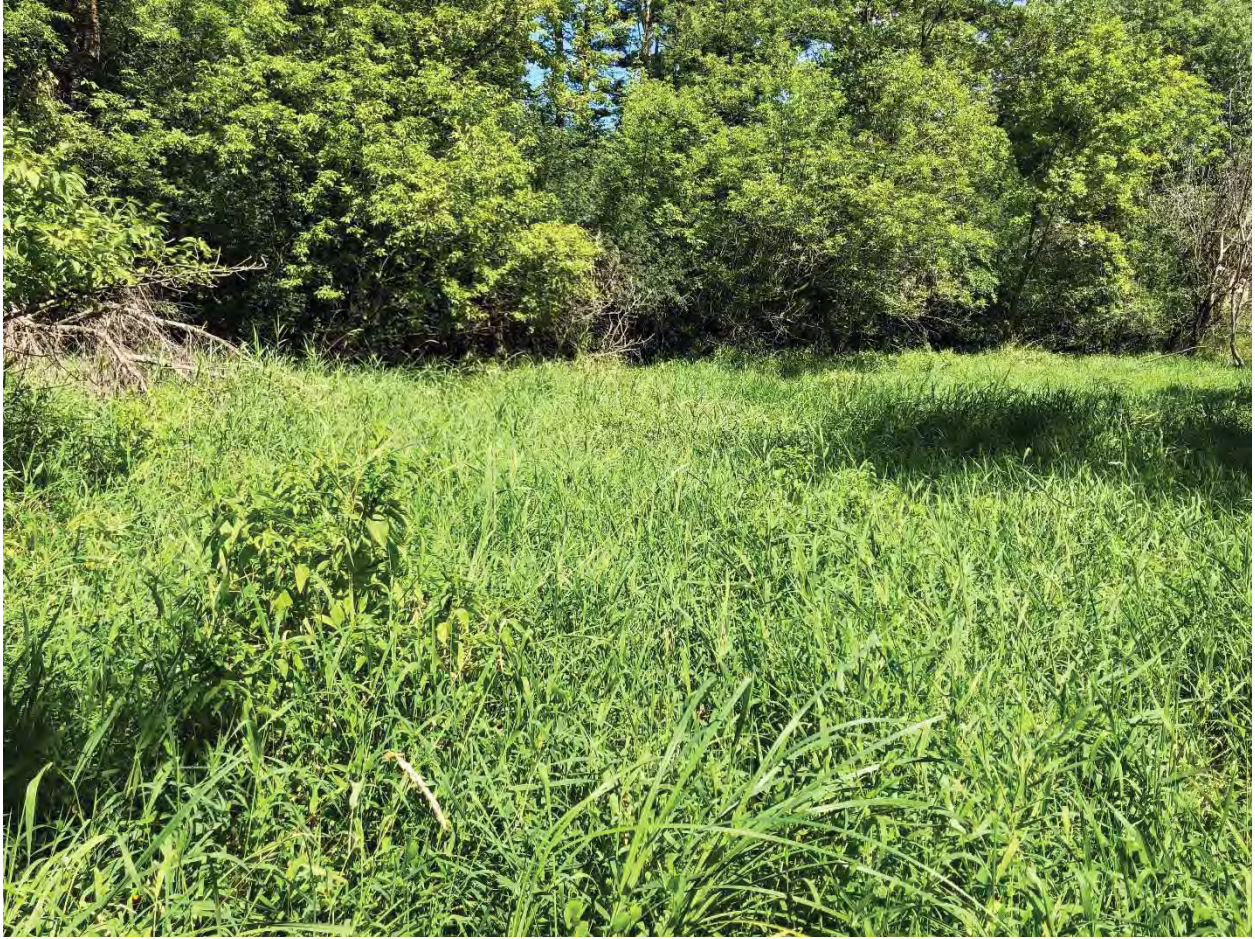
## Wetland 23

**Wetland Type:** Fresh (wet) Meadow

The critical function that caused this wetland rank was “Maintenance of Characteristic Wildlife Habitat Structure”.

The habitat is dominated by reed canary grass, with European buckthorn dominant in the shrub stratum.

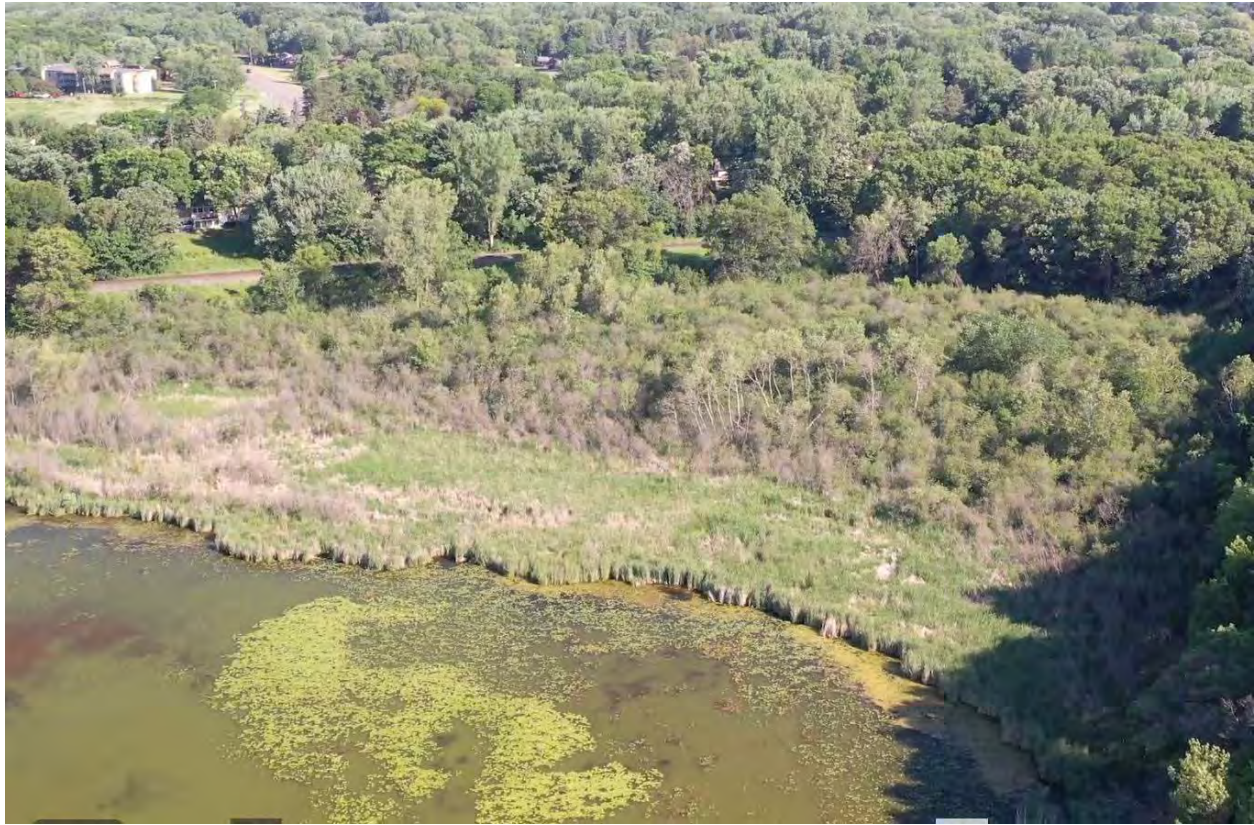
## Wetland 24

**Wetland Type:** Shallow Marsh/ Shrub-carr  
**Sample Point ID:** 24-1W, 24-2W

This is a large wetland complex associated with West Vadnais Lake, located throughout the southern half of the project limits. Because this wetland complex is so large, it was broken into community types for a total of 2 MnRAM assessments.

The shrub carr habitat has a dense canopy with little light penetration. The primary shrubs include glossy and European buckthorn, green ash, willows, and red osier dogwood. Cattails (narrow-leaf and/or hybrid) and reed canary grass are predominate near the transition to shallow marsh, with shade tolerant sedges and grasses present within the shrub canopy.

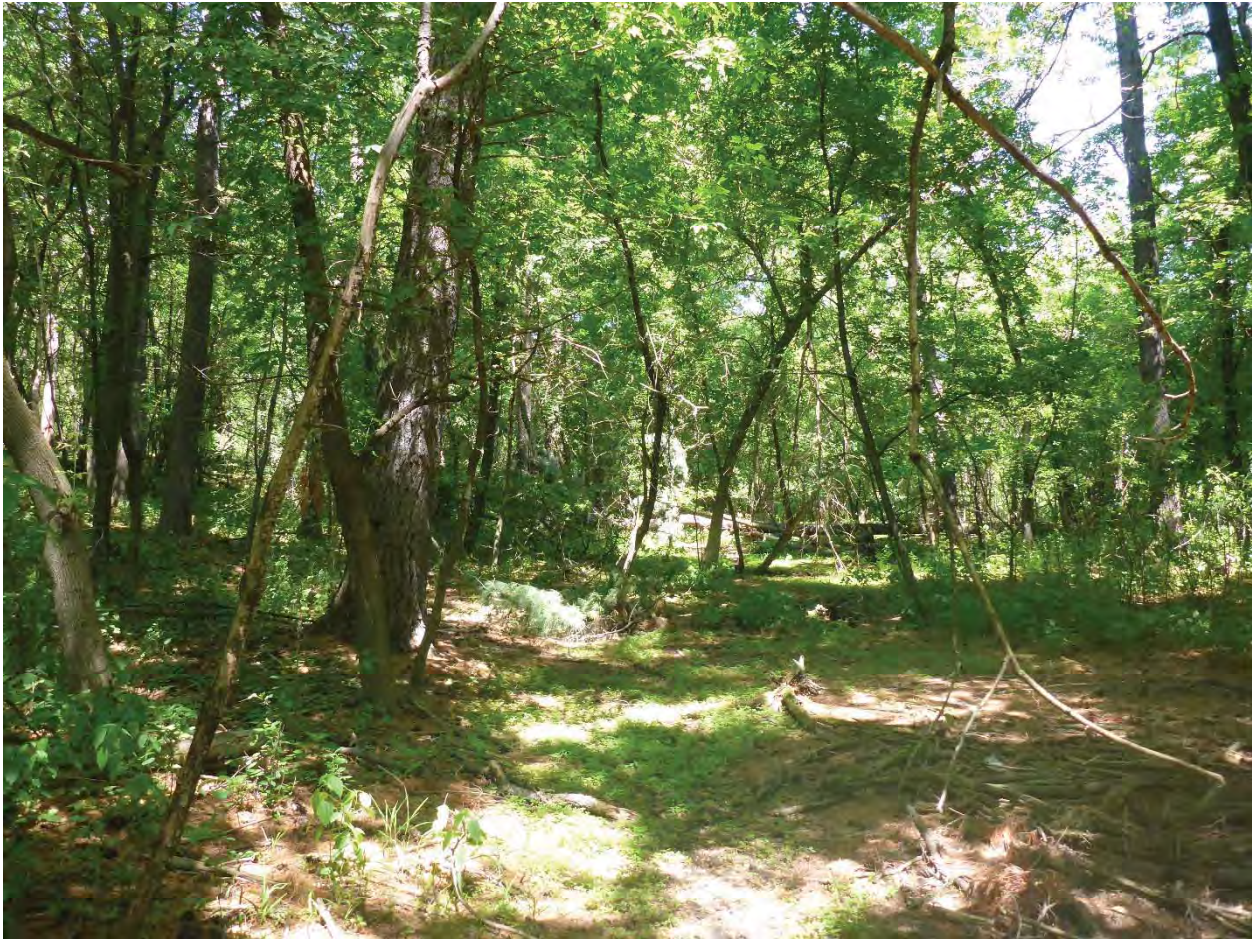
## Wetland 25

**Wetland Type:** Seasonally Flooded Basin

The critical function that caused this wetland rank was “Maintenance of Characteristic Wildlife Habitat Structure”.

Non-native invasive species are intermixed with native plants throughout the basin. European buckthorn seedlings and shrubs are prevalent, however the herbaceous stratum is present and contains primarily native species. Canadian wood-nettle, multiple species of sedges, and European buckthorn are the most common herbaceous species.

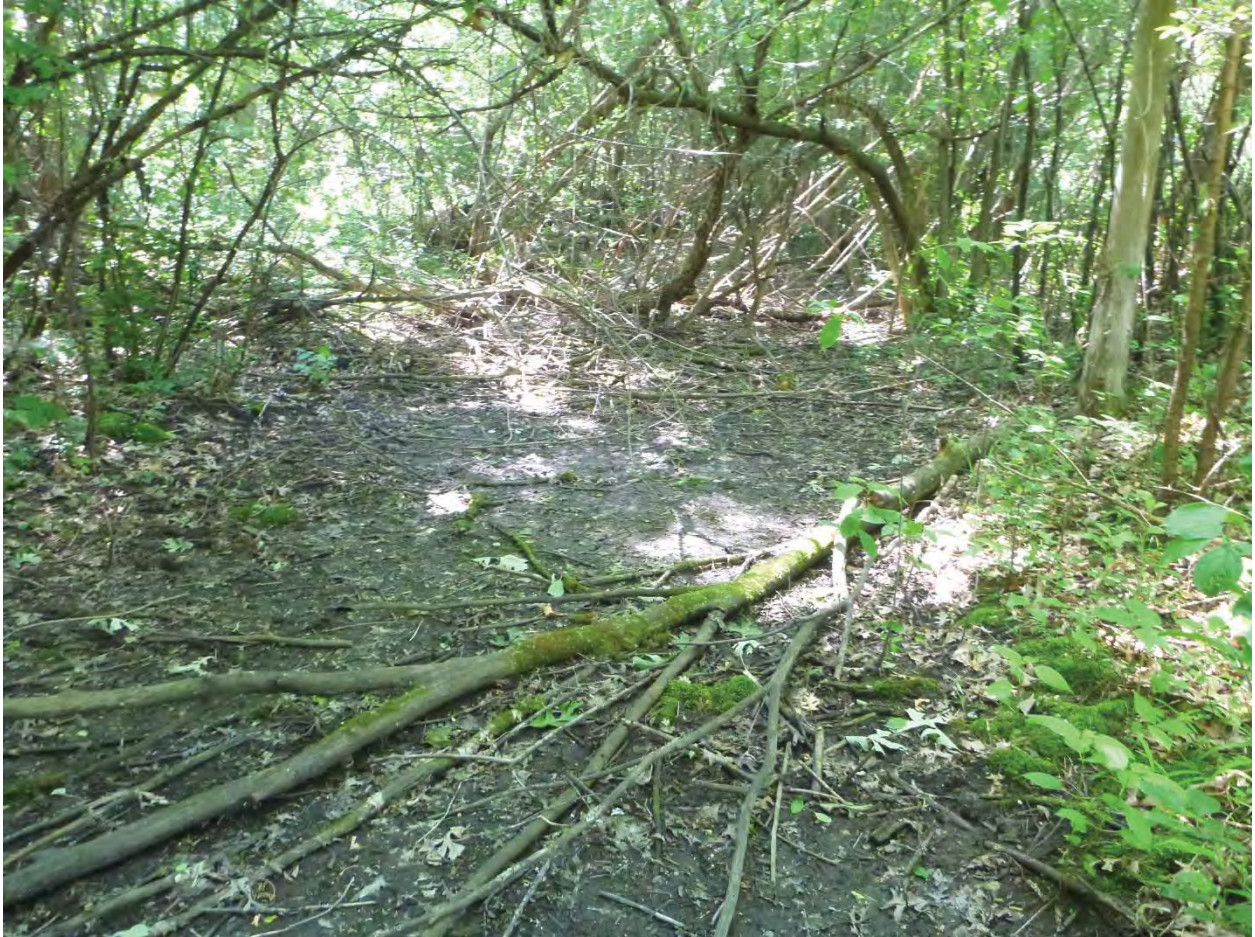
## Wetland 26

**Wetland Type:** Seasonally Flooded Basin

The critical function that caused this wetland rank was “Wetland Sensitivity to Stormwater and Urban Development and Vegetative Diversity”.

Wetland 26 is a linear wet ditch with flood tolerant species. The herbaceous stratum is dominant by natives, with few European buckthorn seedlings. Buckthorn is present in the shrub stratum as well, but mixed with an equal amount of green ash.

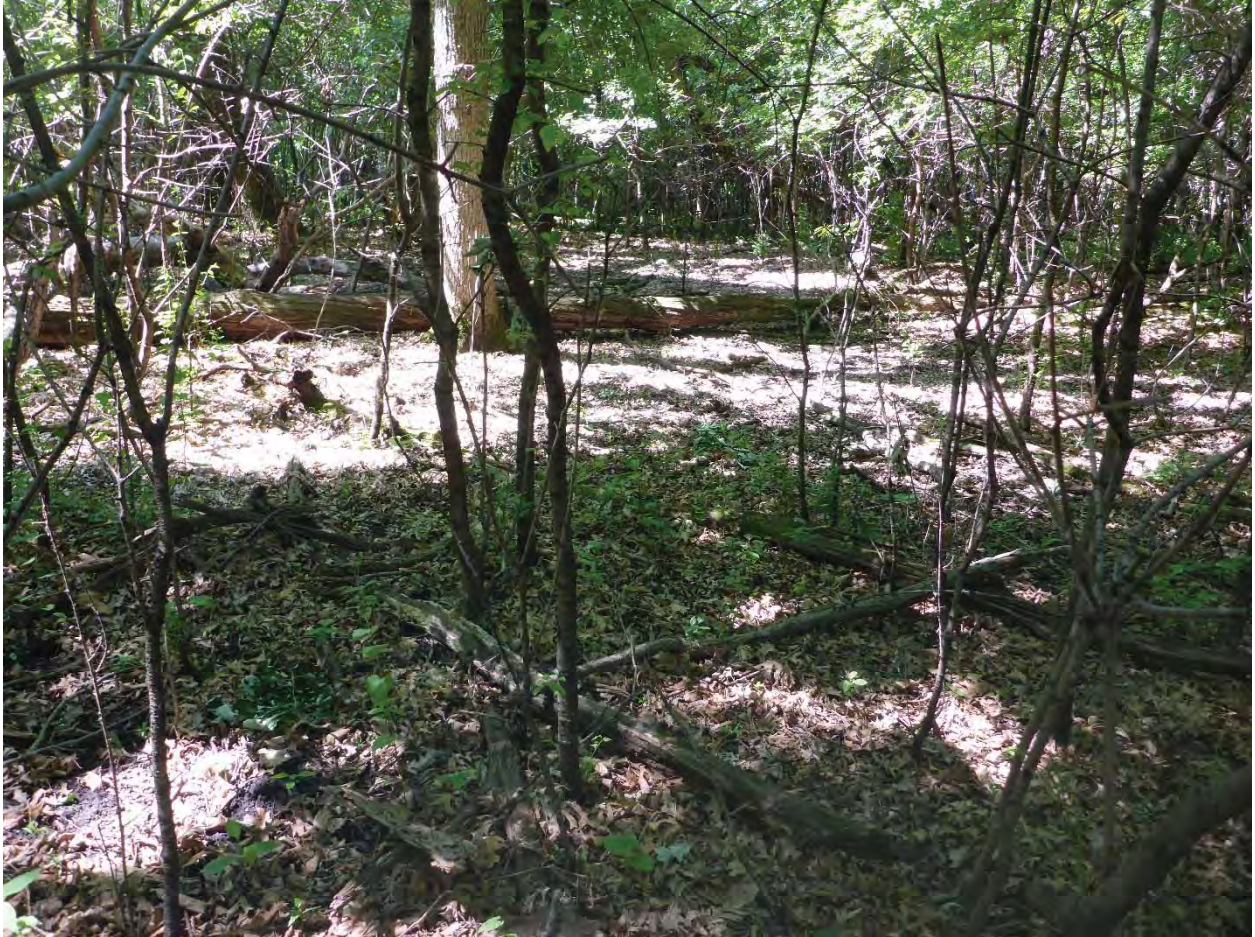
## Wetland 27

**Wetland Type:** Seasonally Flooded Basin

The critical function that caused this wetland rank was “Maintenance of Characteristic Wildlife Habitat Structure”.

European buckthorn most common species, present as seedlings and shrubs. Few other plants in the herbaceous stratum with low areal coverage. Buckthorn shrub canopy likely reduces herbaceous growth.

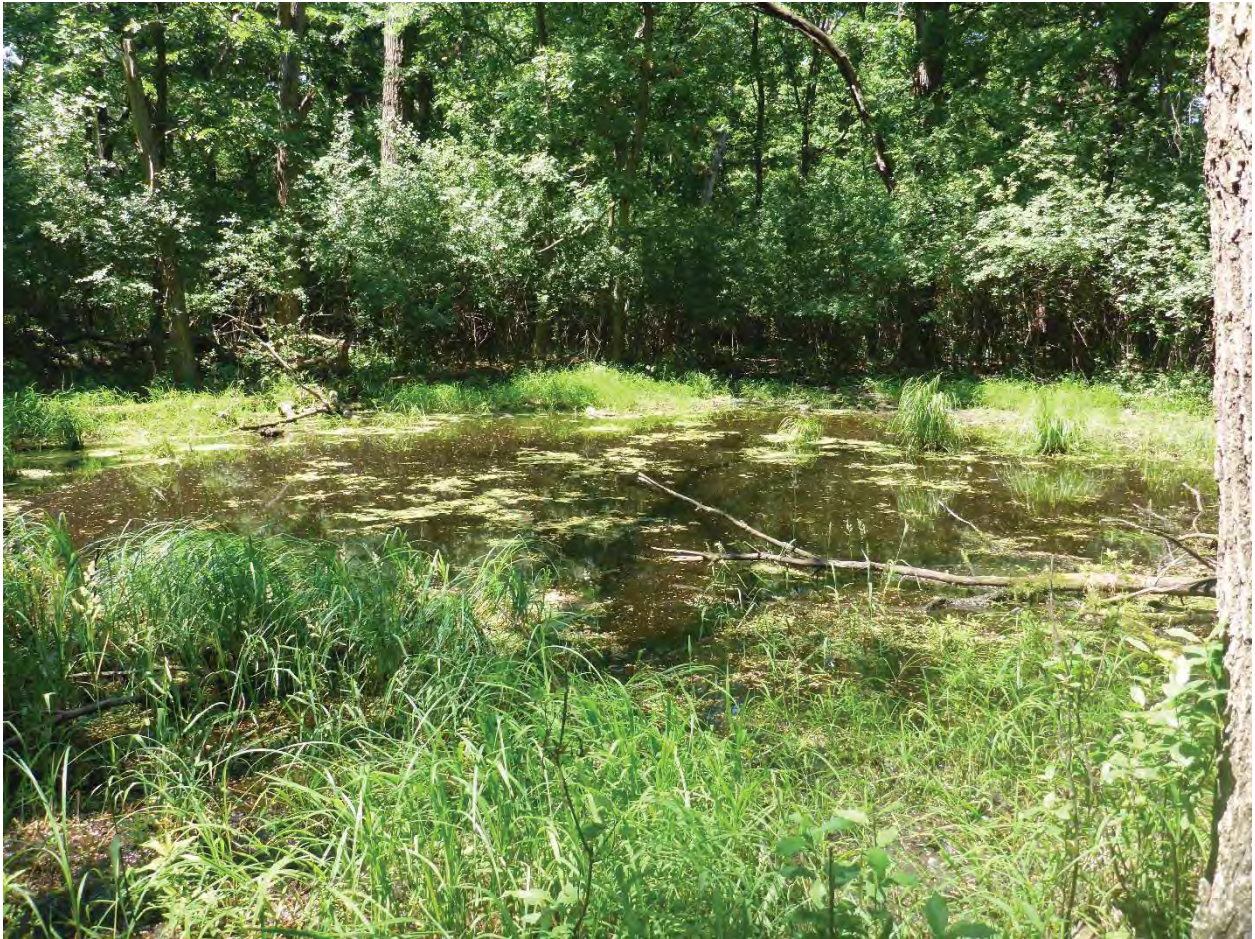
## Wetland 28

**Wetland Type:** Seasonally Flooded Basin/ Shallow Marsh  
**Sample Point ID:** 28-1W

This wetland is a small basin located in the southern half of the project limits, east of Vadnais Lake.

The critical function that caused this wetland rank was “Maintenance of Characteristic Amphibian Habitat”.

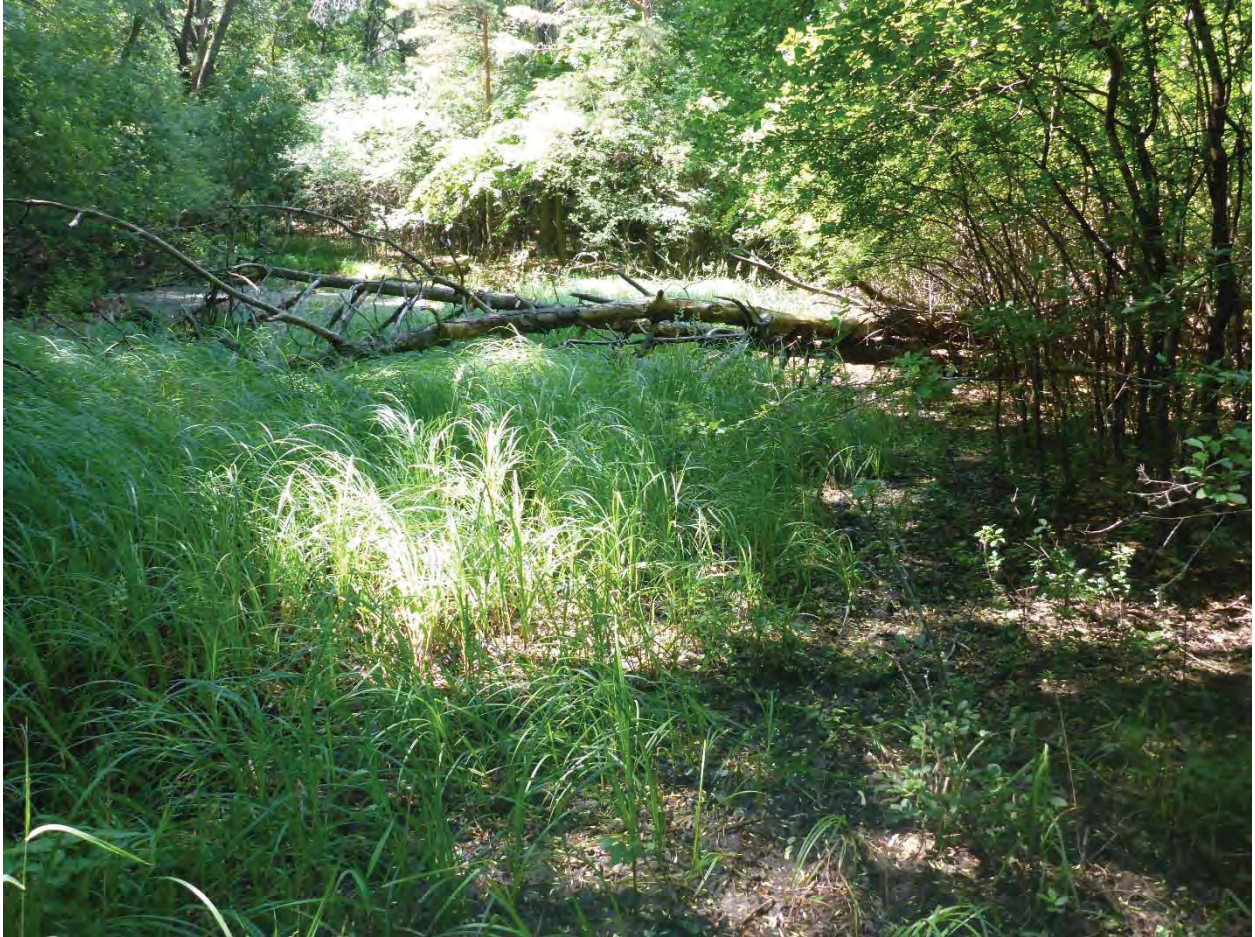
## Wetland 29

**Wetland Type:** Shallow Open Water

There is a small pool of shallow open water with primarily northern water plantain and duck weed. No Non-native invasive species were observed within this habitat.

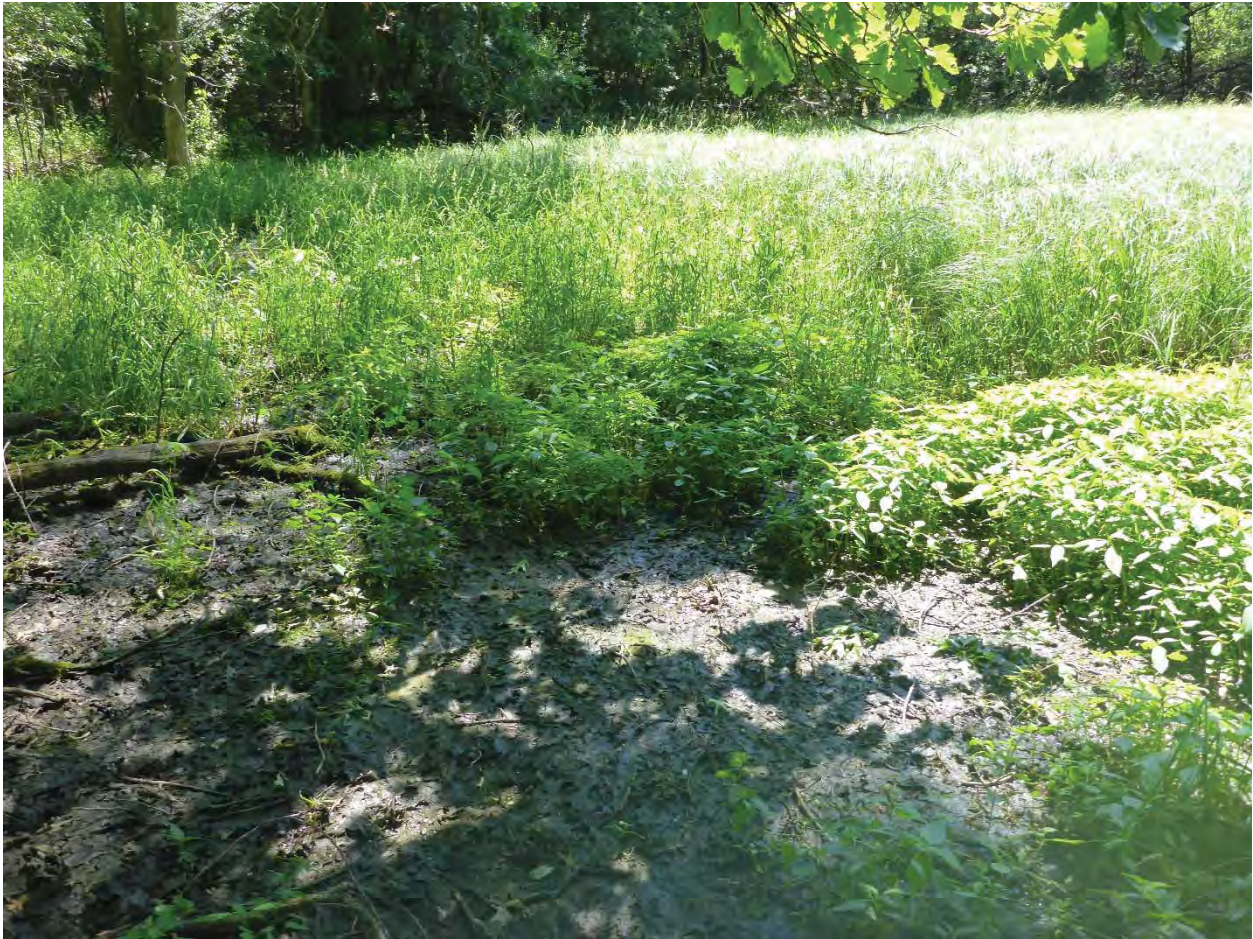
## Wetland 30

**Wetland Type:** Sedge Meadow

Wetland 30 is dominated by native graminoids and forbs. Upright, woolly-fruit, and lakebank sedge are the most prevalent species, with an array of native forbs intermixed. Reed canary grass was the only non-native invasive species observed within the wetland, but occurred as scattered clusters or individual plants growing within the native species.

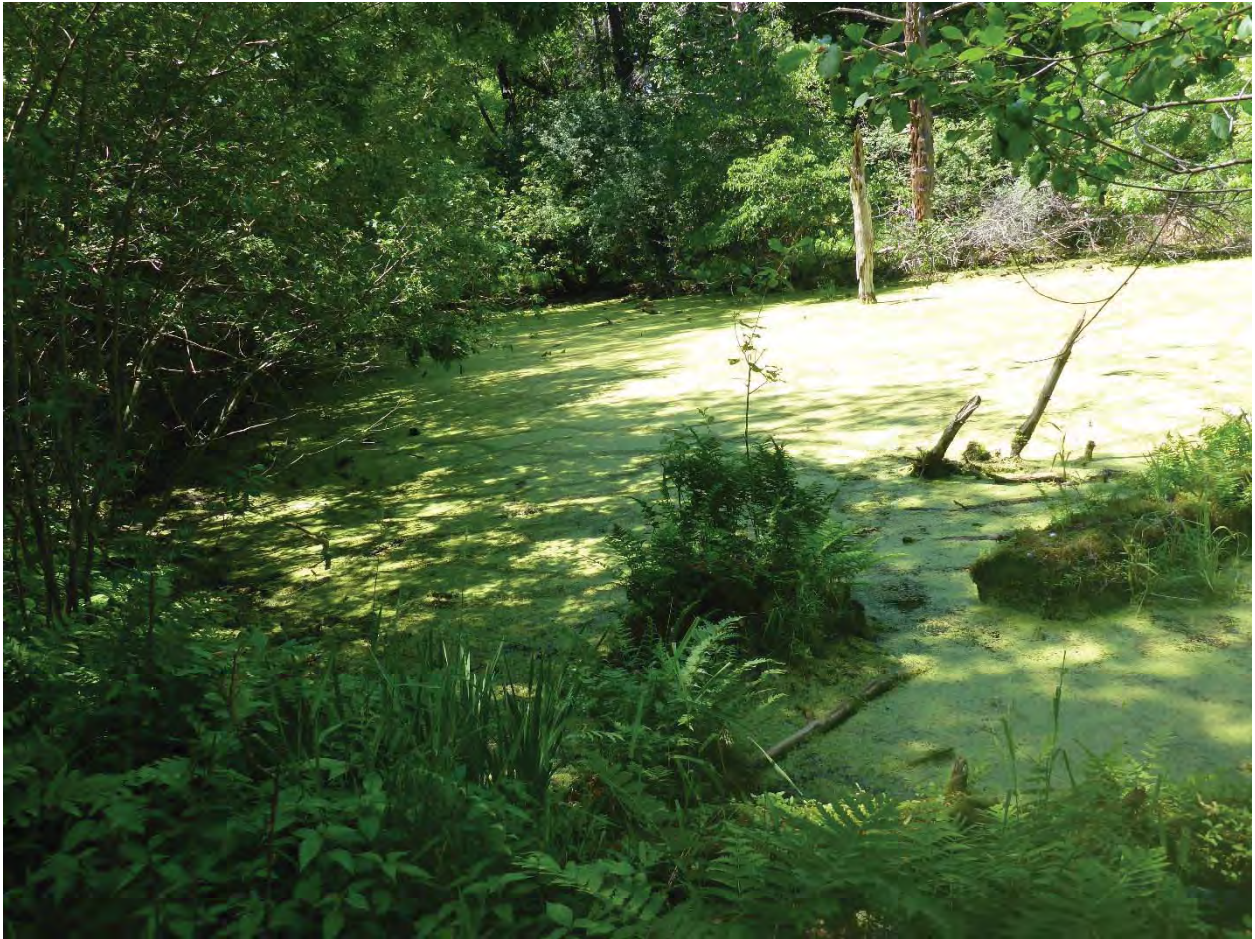
## Wetland 31

**Wetland Type:** Shallow Open Water  
**Sample Point ID:** 31-1W

Clusters of reed canary grass occur along the shallow areas of the habitat, with some forming small dense monocultures. European buckthorn shrubs were observed along the perimeter, but not dense enough to shade or inhibit growth of native forbs. Flood tolerant species, such as cinnamon fern and Canadian wood-nettle, are common along the wetland to upland transition. Duck weed was the most prevalent species in the open water.

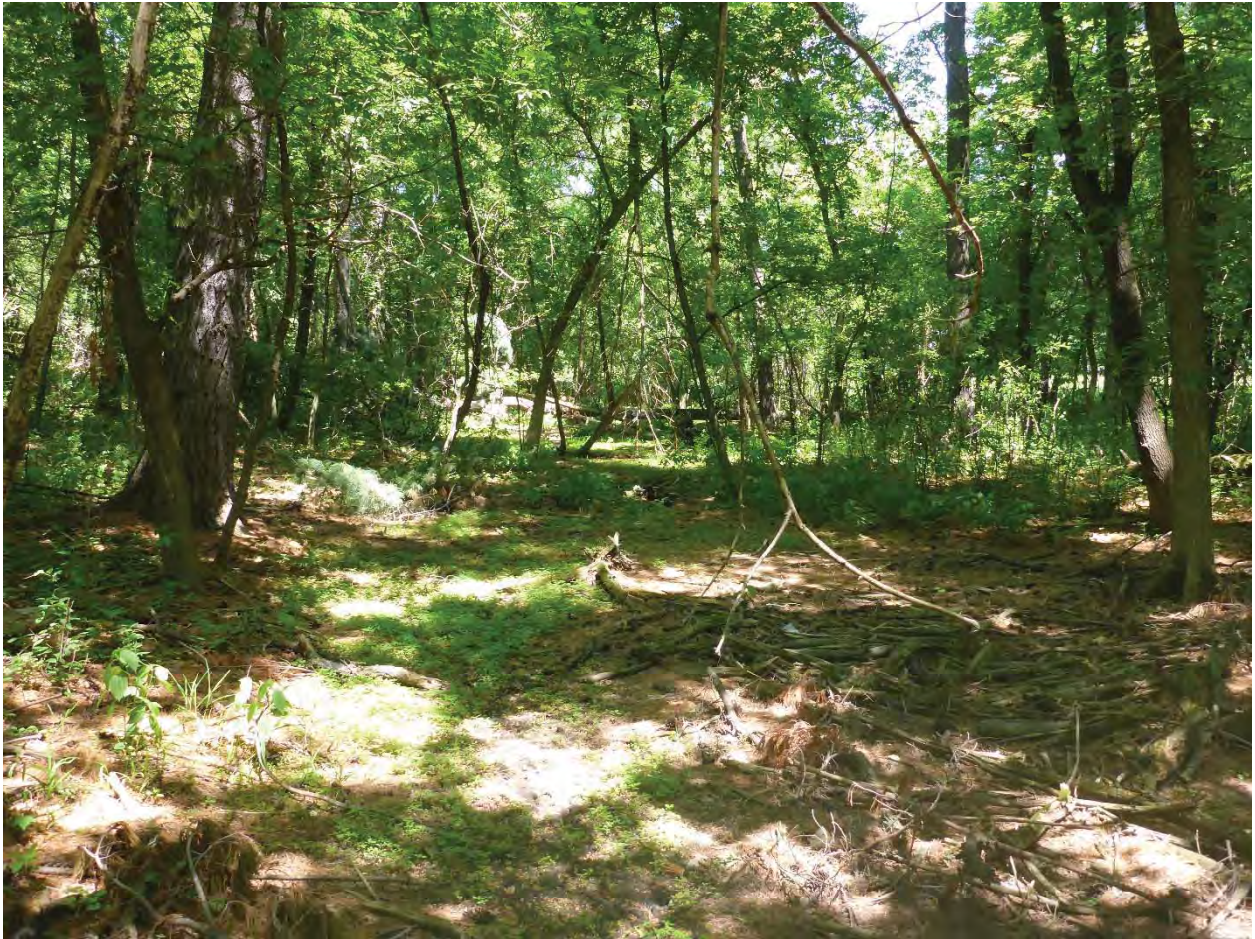
## Wetland 32

**Wetland Type:** Fresh (wet) Meadow  
**Sample Point ID:** 32-1W

Graminoids species are most common in this wetland, with reed canary grass and sedges the most abundant. Reed canary grass is relatively common, although it is growing mixed with other species. European buckthorn encompasses the perimeter with scattered shrubs throughout the basin. Seasonal ponding producing mud flats was observed in the habitat.

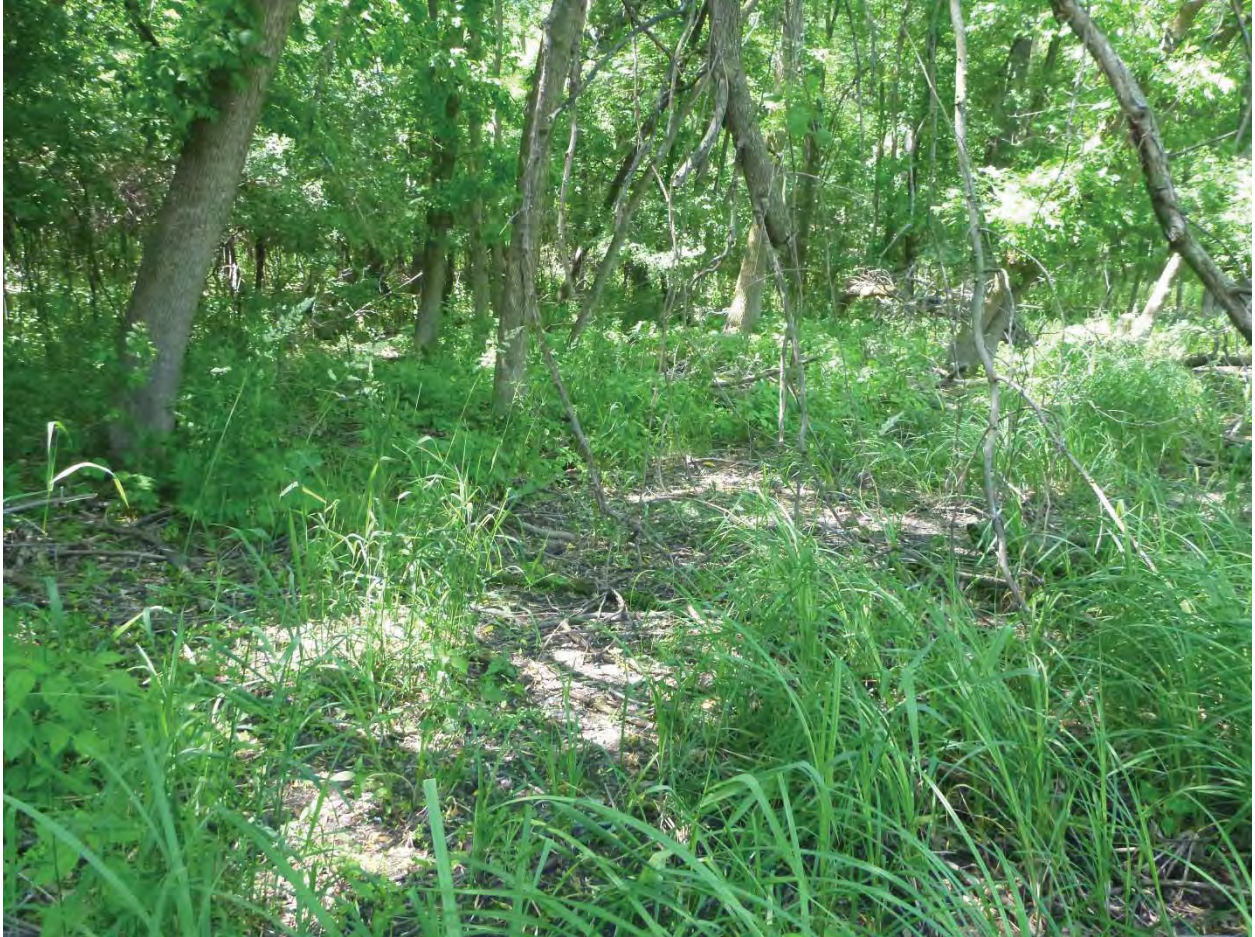
## Wetland 33

**Wetland Type:** Fresh (wet) Meadow  
**Sample Point ID:** 33-1W

The critical function that caused this wetland rank was “Maintenance of Characteristic Wildlife Habitat Structure”.

A majority of the wetlands dominated by native species, lakebank sedge and Canadian wood-nettle, with native forbs occurring throughout. Non-native invasive species encompass the perimeter, including Canada thistle, garlic mustard, and European buckthorn seedlings and shrubs. The garlic mustard and thistle are present as scattered individual plants.
