## MEMORANDUM

RE: Vadnais/Sucker Park Wetland Assessment

SEH No. VADLA 154641 14.00

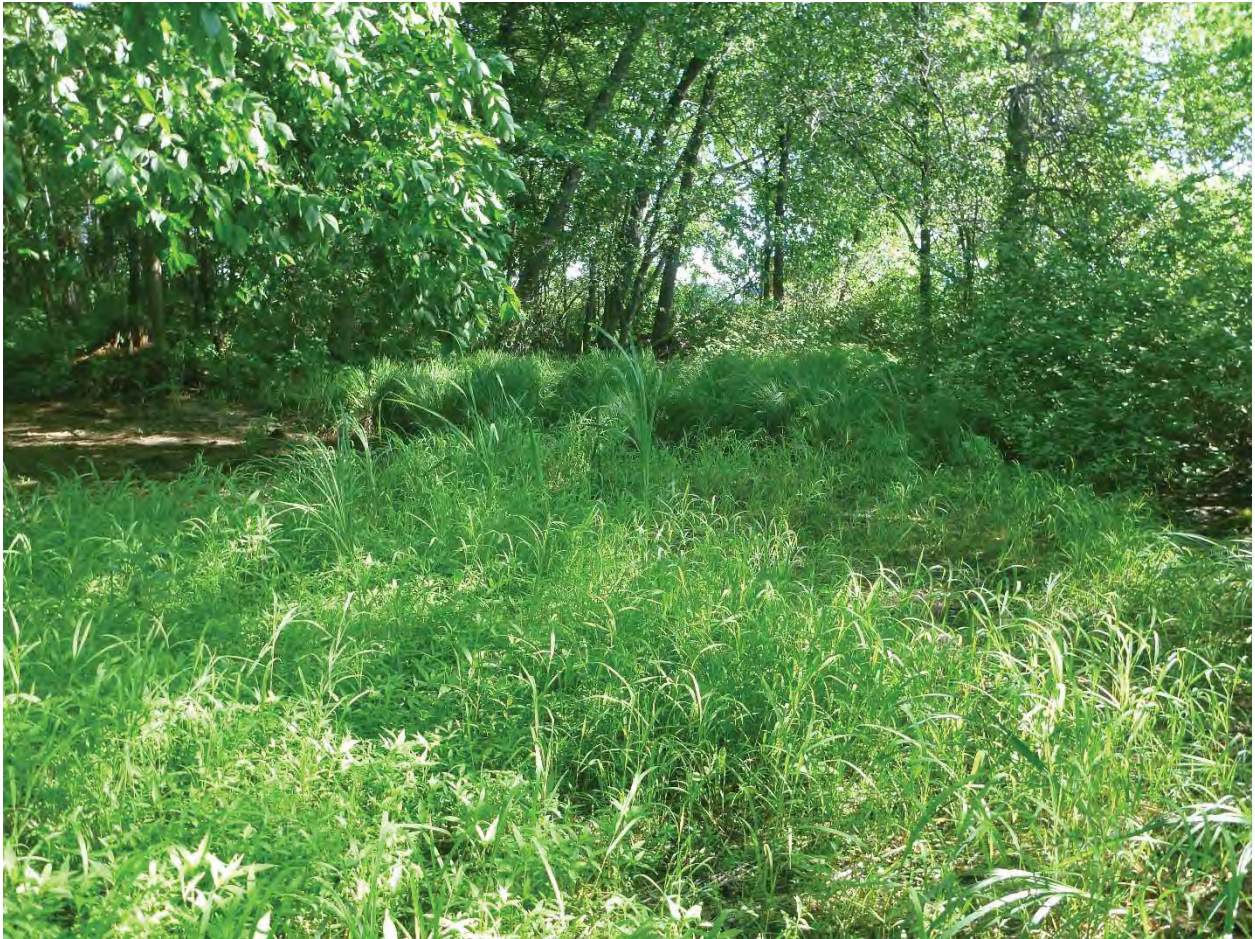
## Wetland 34

**Wetland Type:** Fresh (wet) Meadow

The critical function that caused this wetland rank was “Maintenance of Characteristic Wildlife Habitat Structure”.

A majority of the wetlands dominated by native species, lakebank sedge and Canadian wood-nettle, with native forbs occurring throughout. Non-native invasive species encompass the perimeter, including Canada thistle, garlic mustard, and European buckthorn seedlings and shrubs. The garlic mustard and thistle are present as scattered individual plants.

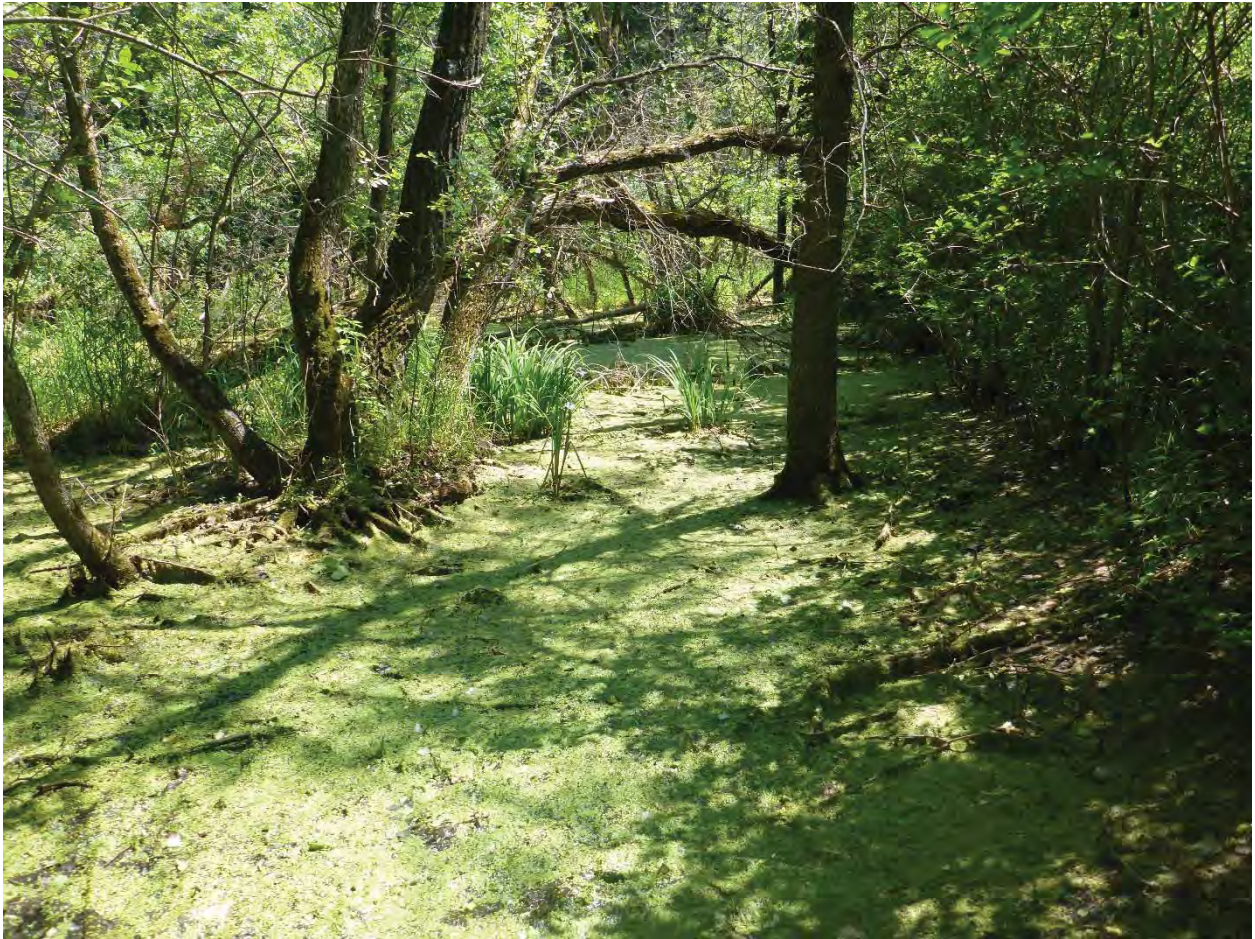
## Wetland 35

**Wetland Type:** Seasonally Flooded Basin

The critical function that caused this wetland rank was “Maintenance of Characteristic Amphibian Habitat”.

The habitat is dominated by flood tolerant species, such as green ash, harlequin blueflag (iris), and sedges. Reed canary grass is prevalent throughout the basin but typically is mixed with other species. Mud flats due to seasonal ponding were observed with reed canary and European buckthorn clustered along the fringe.

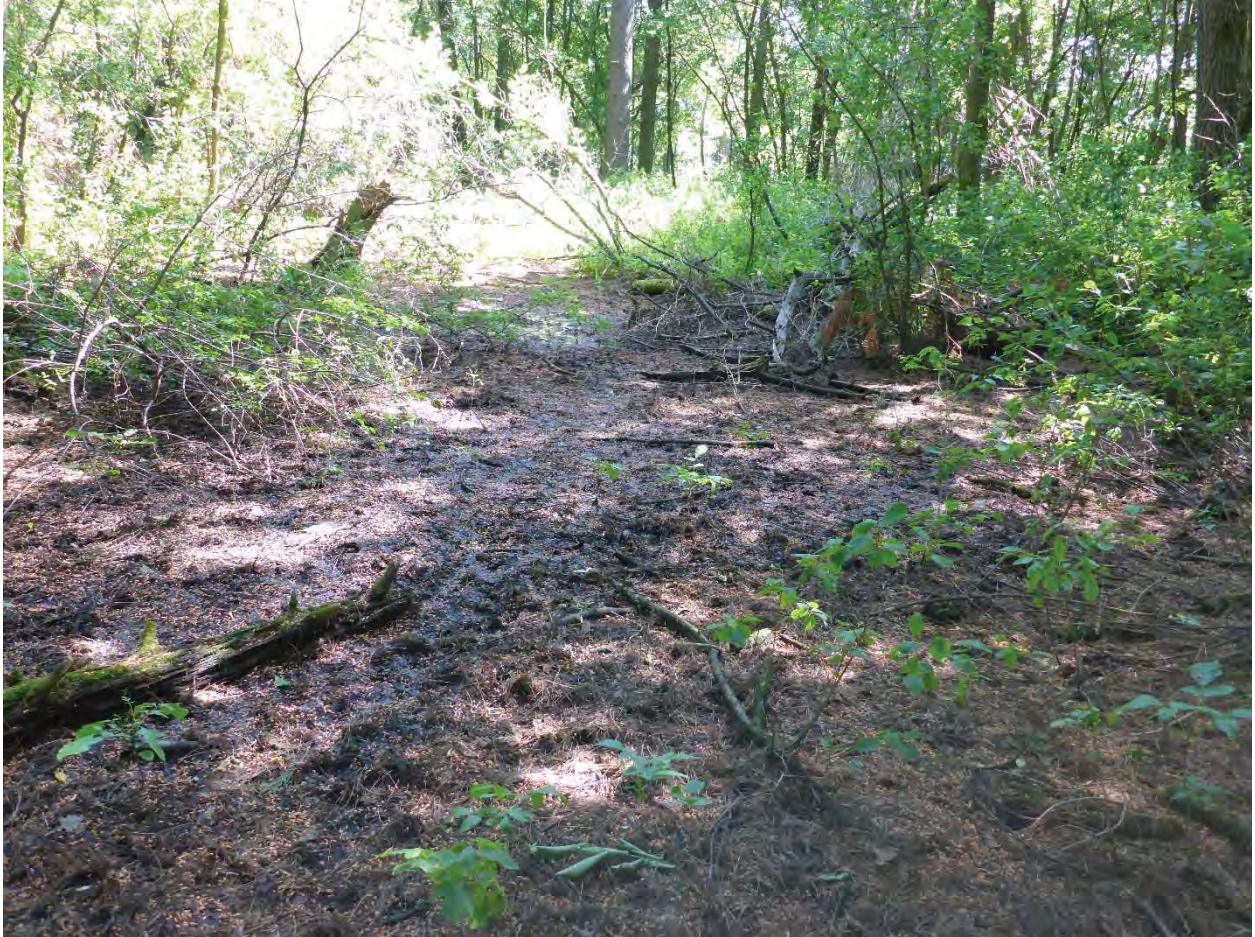
## Wetland 36

**Wetland Type:** Seasonally Flooded Basin

The critical function that caused this wetland rank was “Wetland Sensitivity to Stormwater and Urban Development and Vegetative Diversity”.

There are few species present within this habitat, primarily European buckthorn in the herbaceous and shrub strata, and ash-leaf maple in the tree stratum.

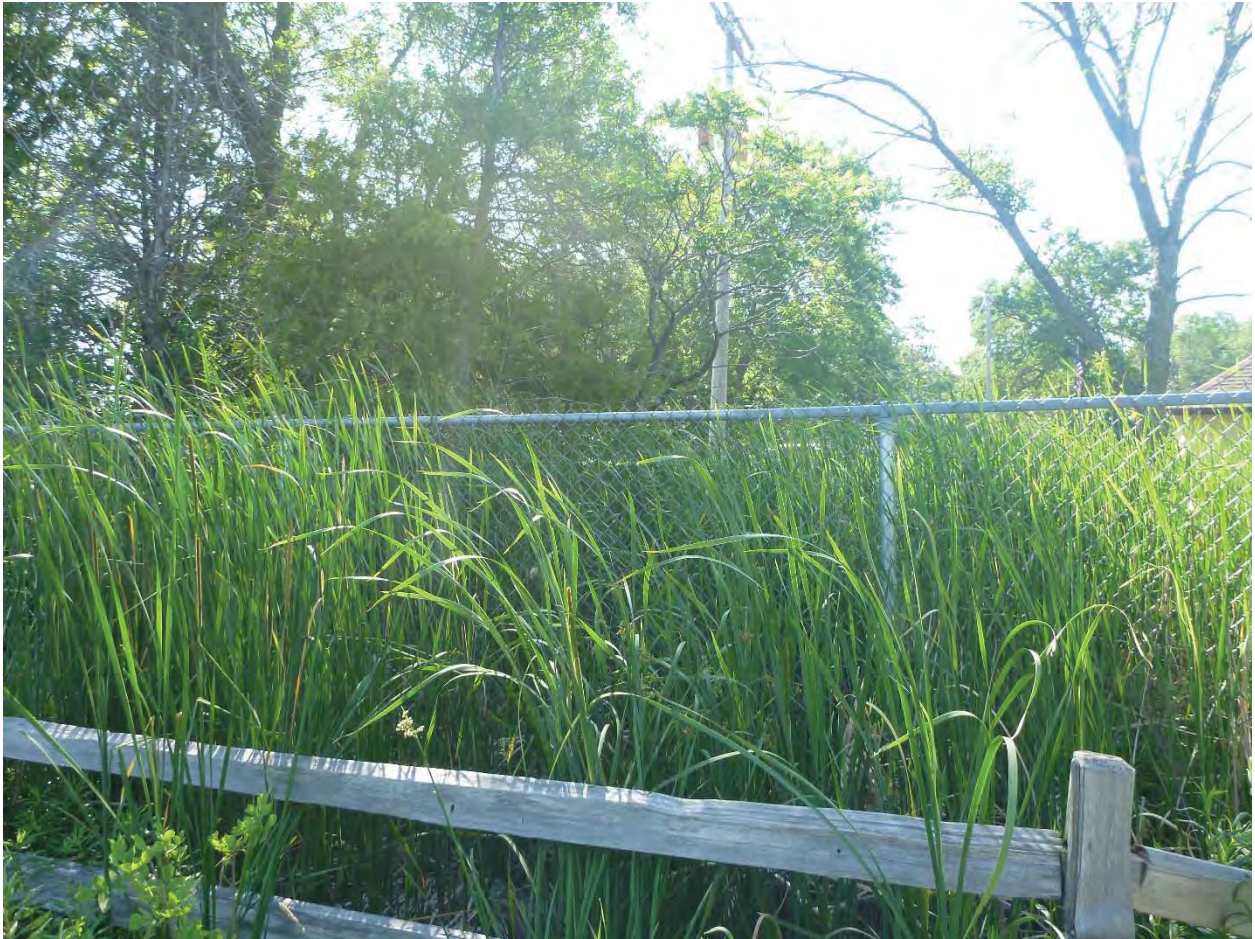
## Wetland 37

**Wetland Type:** Shallow Marsh

The critical function that caused this wetland rank was “Maintenance of Characteristic Amphibian Habitat”.

Wetland 37 is a linear wet ditch. Narrow-leaf cat-tail as the predominant species.

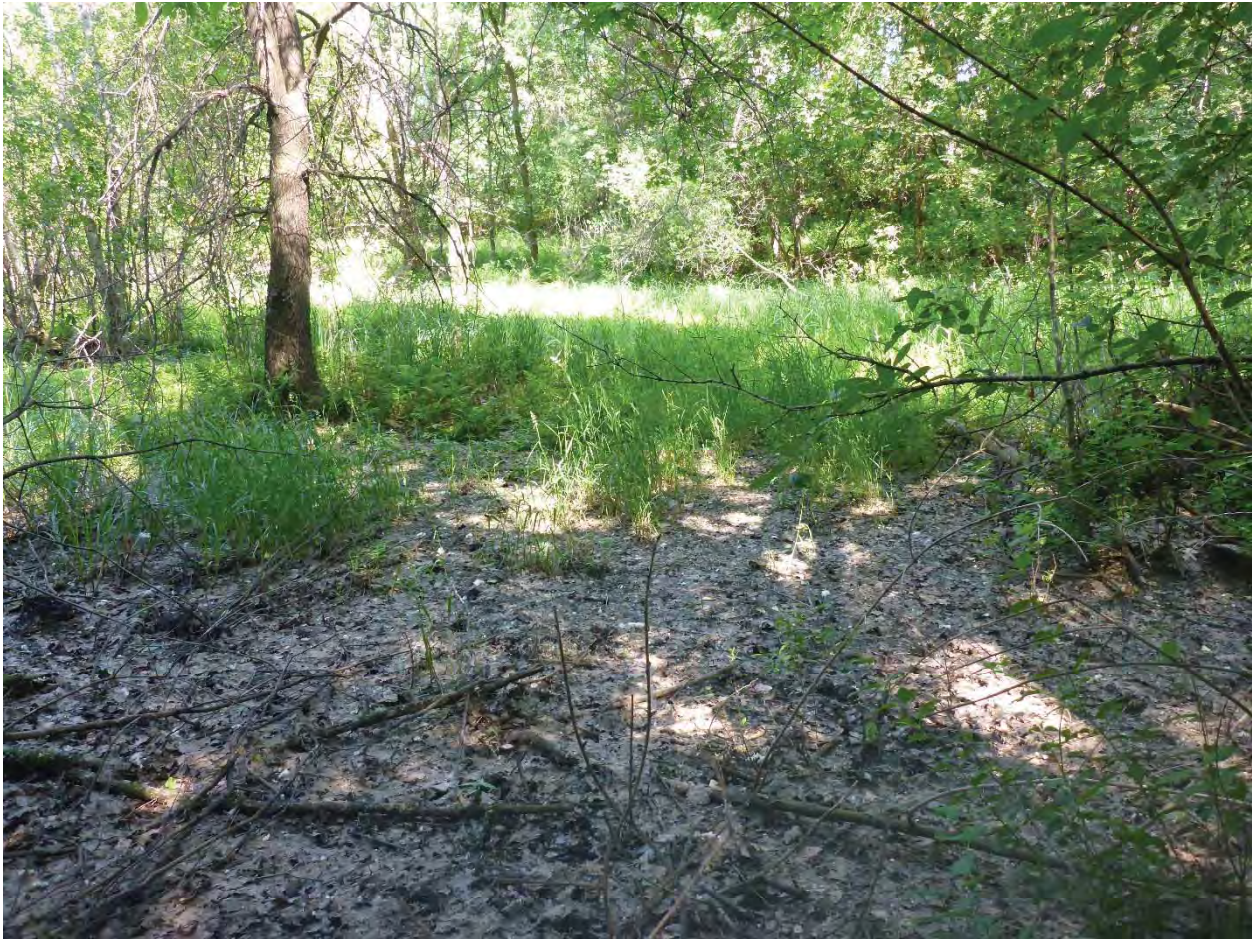
## Wetland 38

**Wetland Type:** Fresh (wet) Meadow

The critical function that caused this wetland rank was “Maintenance of Characteristic Wildlife Habitat Structure”.

Reed canary grass is a prevalent species within the basin, however native species are intermixed. Lakebank sedge and ferns are common within the shadier areas of the wetland. Other non-native invasive observed include giant chickweed.

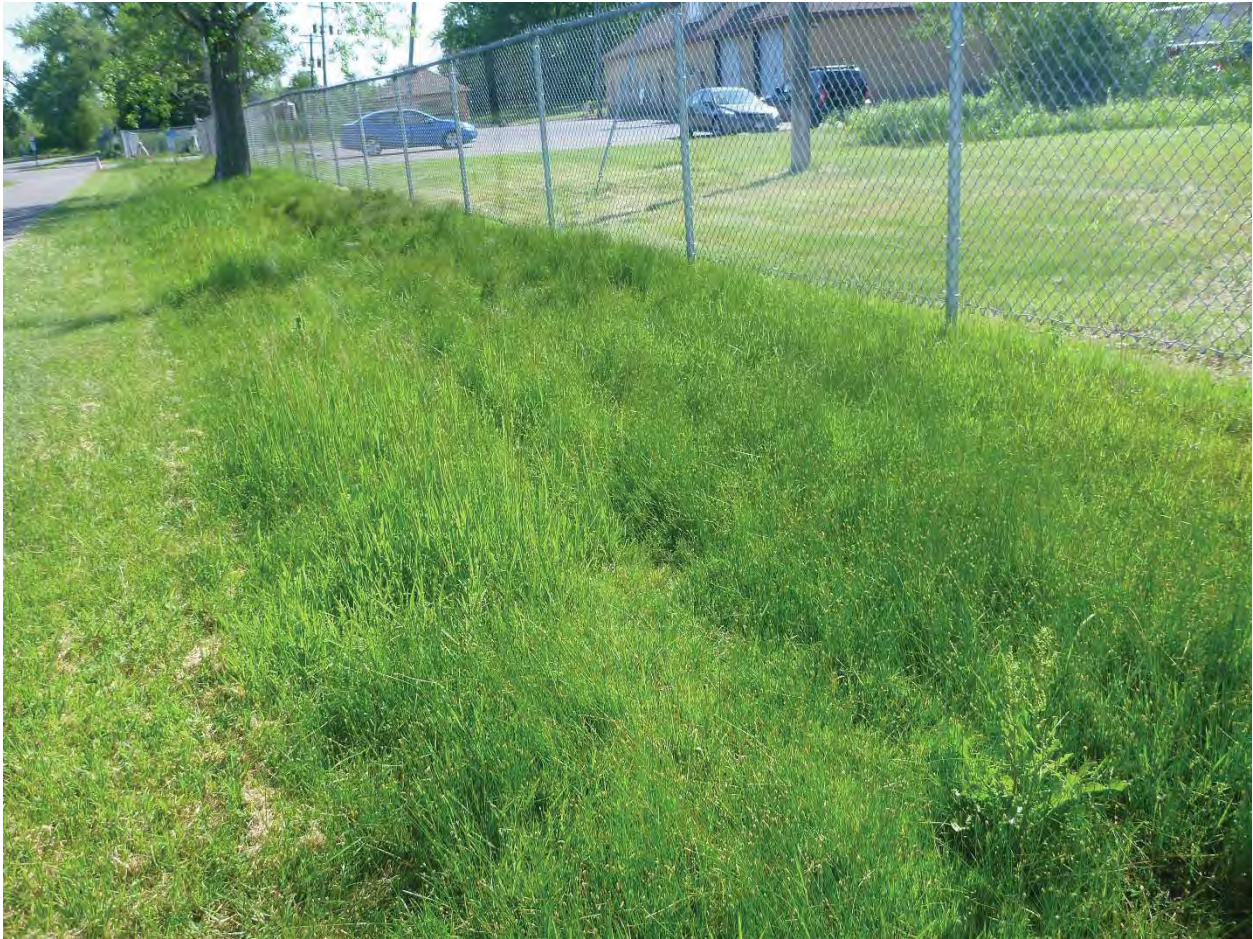
## Wetland 39

**Wetland Type:** Fresh (wet) Meadow

The critical function that caused this wetland rank was “Maintenance of Characteristic Wildlife Habitat Structure”.
