VADNAIS LAKE AREA WATER MANAGEMENT ORGANIZATION
Sucker and East Vadnais Lake Review,
Ramsey County, MN

1.1 INTRODUCTION

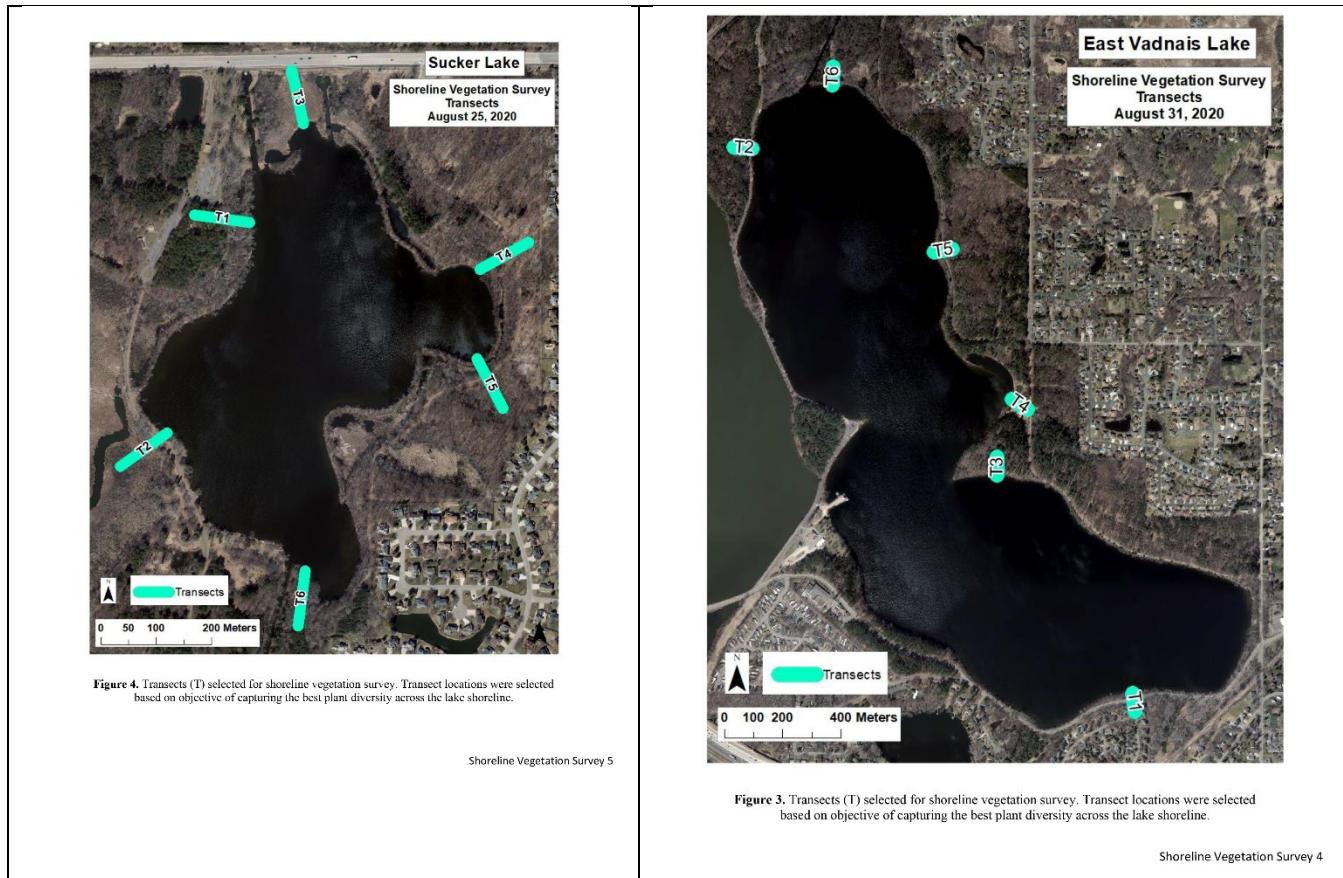
Figure 17: Sucker and East Vadnais Lakes Transect Locations
