**VADNAIS LAKE AREA WATER MANAGEMENT ORGANIZATION
East and West Goose Lake Review,
Ramsey County, MN**

2024

TABLE OF CONTENTS

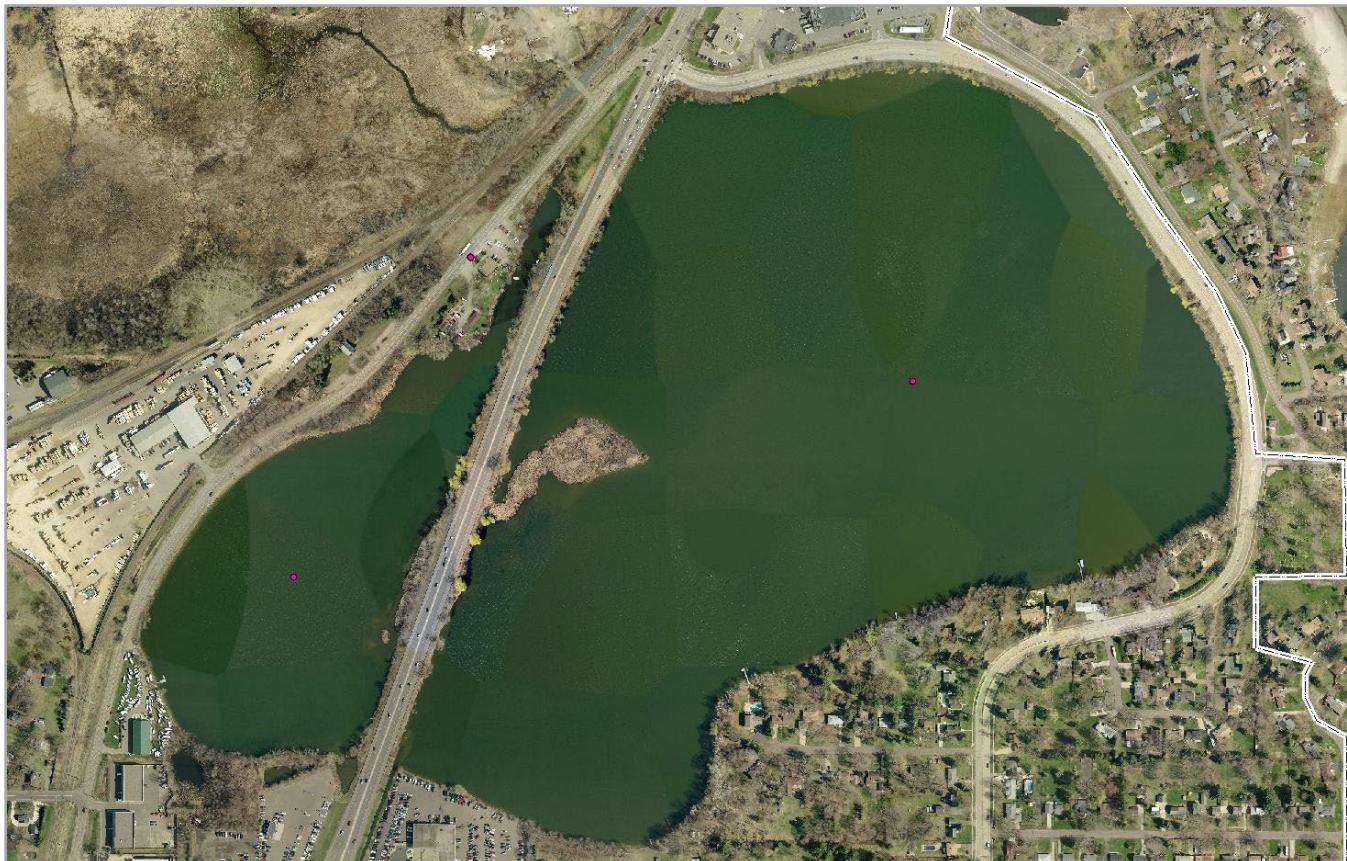
Figure 2: Aerial view of East and West Goose Lakes. Both lakes are impaired for nutrients. Annual phytoplankton surveys show above-CDC recommended levels for potentially harmful blue-green algae (2021-2023).

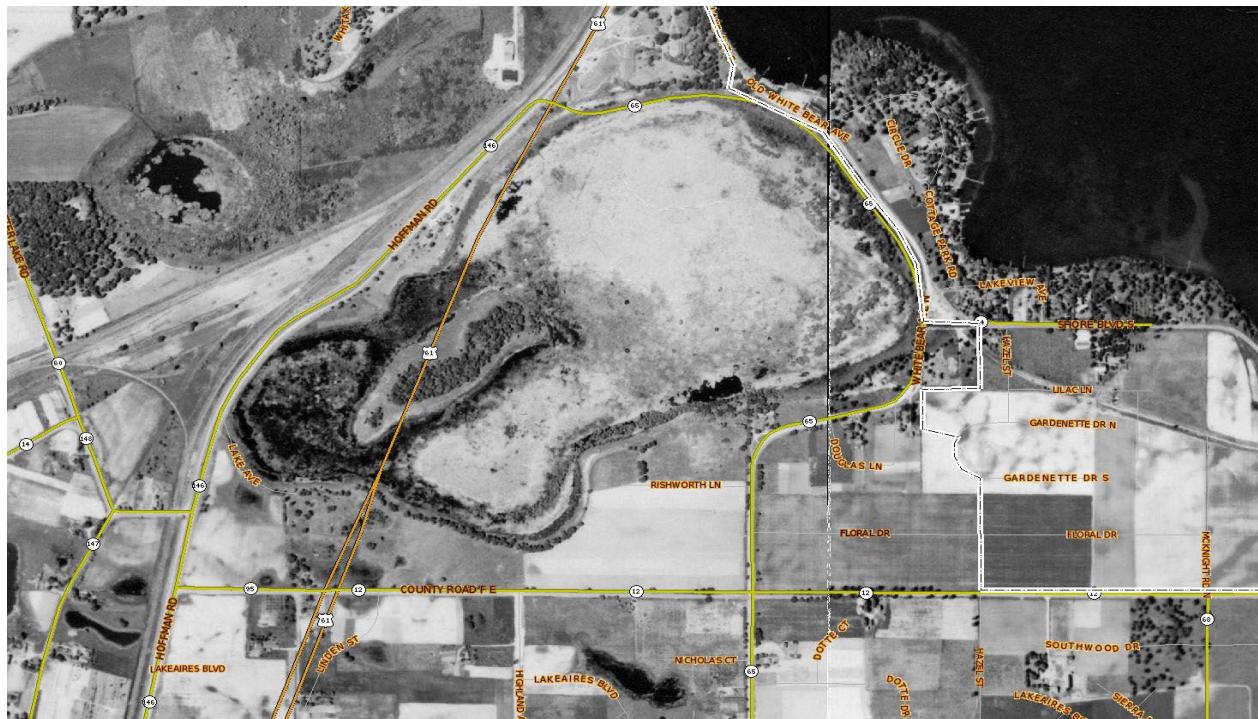
Figure 3: Aerial photo of Goose Lake from 1940. There is little standing water in the photo, the lake area appears to be more of a wetland/bog than an open-water lake.

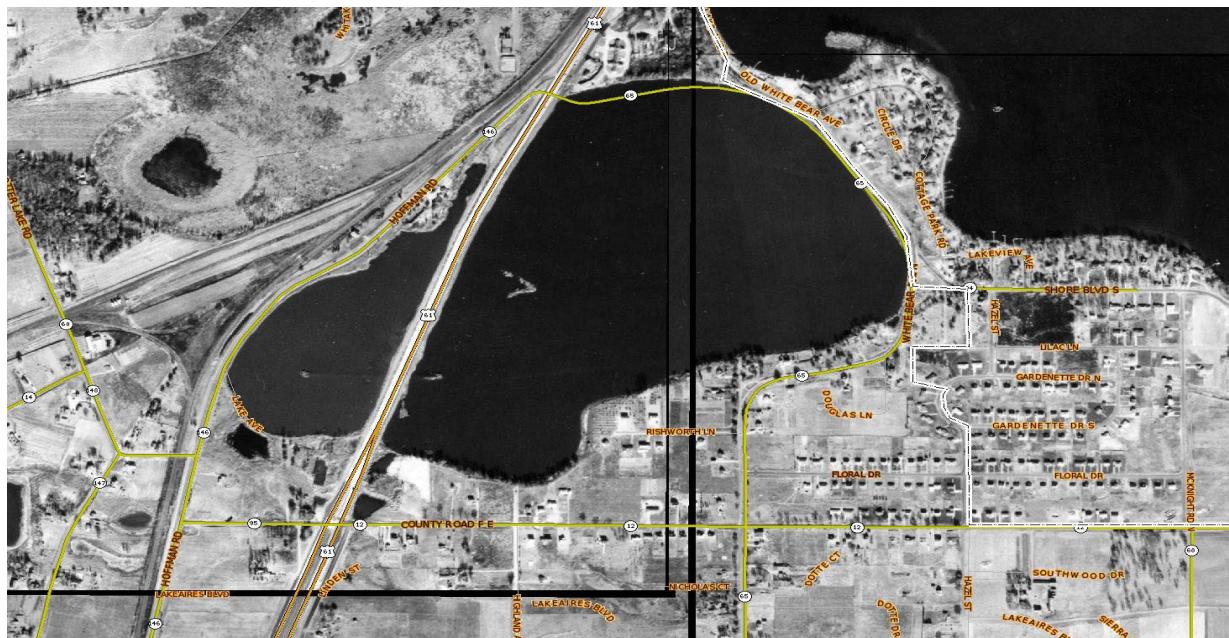
Figure 5: 1953 aerial photo: Goose was dredged some time during the 1940s/early 1950s. Highway 61 was also built in the early 1950s, which separated Goose Lake into East and West Goose Lakes.

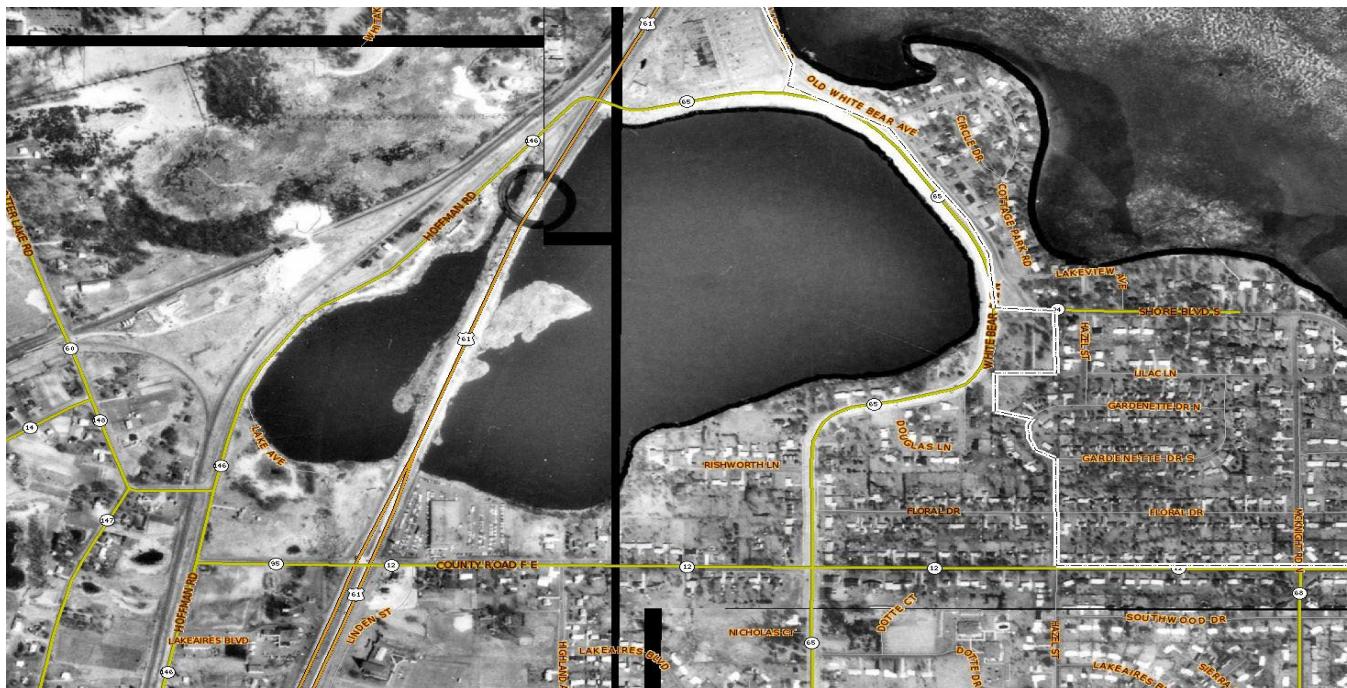
Figure 6: By 1974, more development is occurring around Goose Lake. White Bear Lake Sewage Plant discharged into the north end of the East basin.

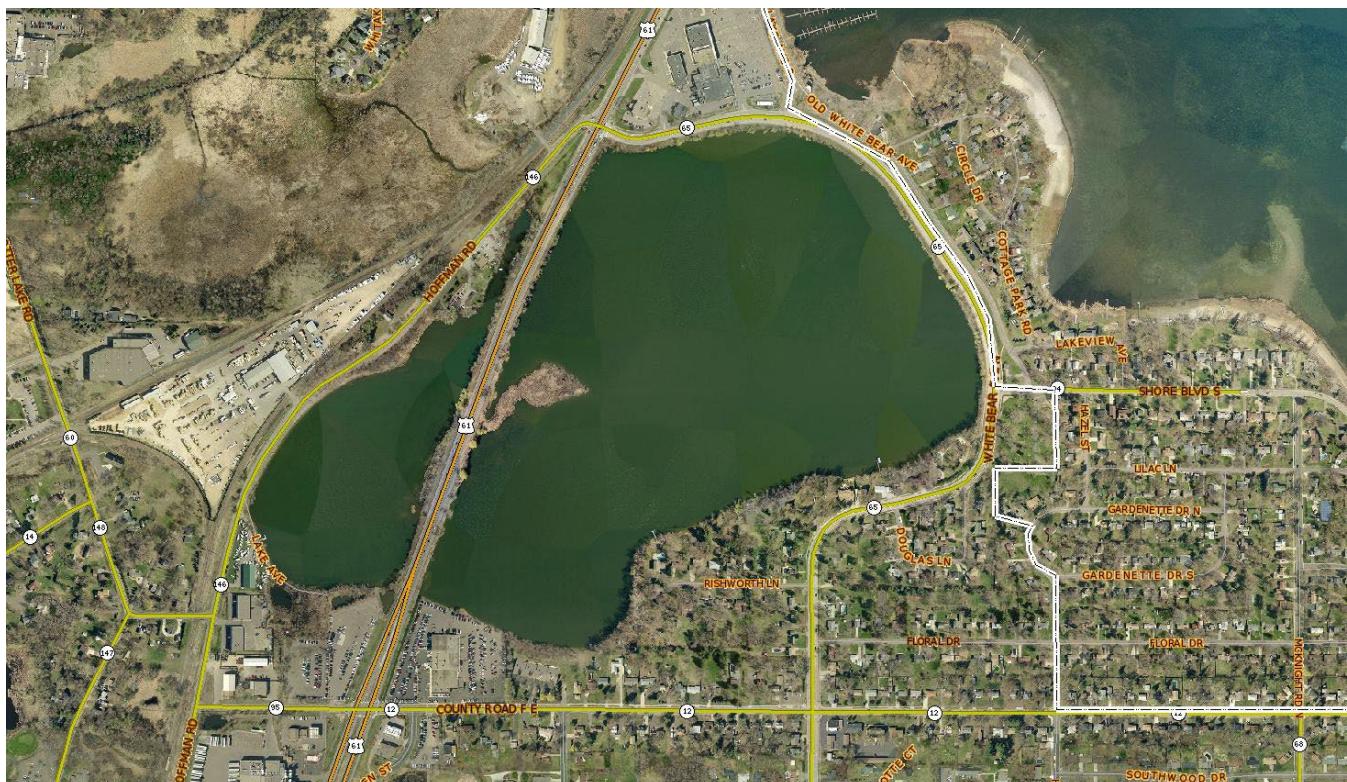
Figure 9: By 2012, high chlorophyll levels remain apparent, as indicated by the green water color compared to that of White Bear Lake to the northeast.

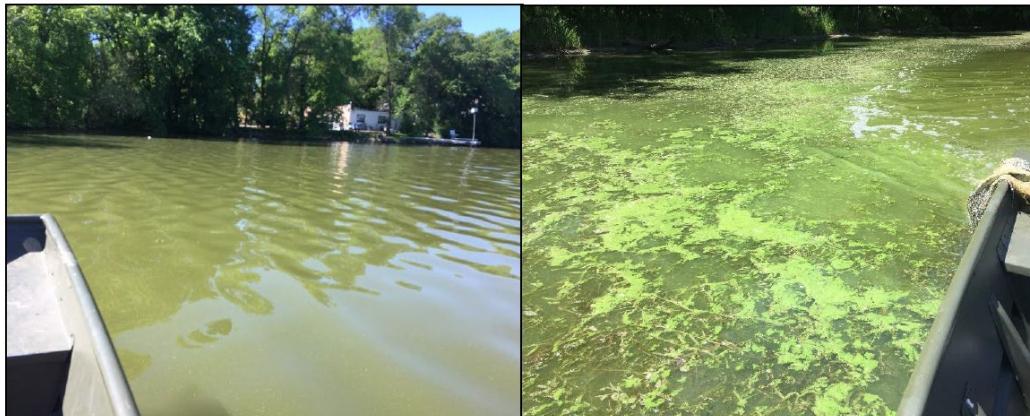
Figure 17: Macrophyte sampling with RCSWCD and VLAWMO staff.

Figure 2. Left: Green color of lake water on East Goose Lake – secchi disk visibility was 1 ft. No macrophytes were present at the 94 surveyed points.

Right: Blue-green algae and curly-leaf pondweed along the southern border of West Goose Lake. Secchi disk visibility was 1.5 ft, and macrophytes were found at 10 out of 22 surveyed points.

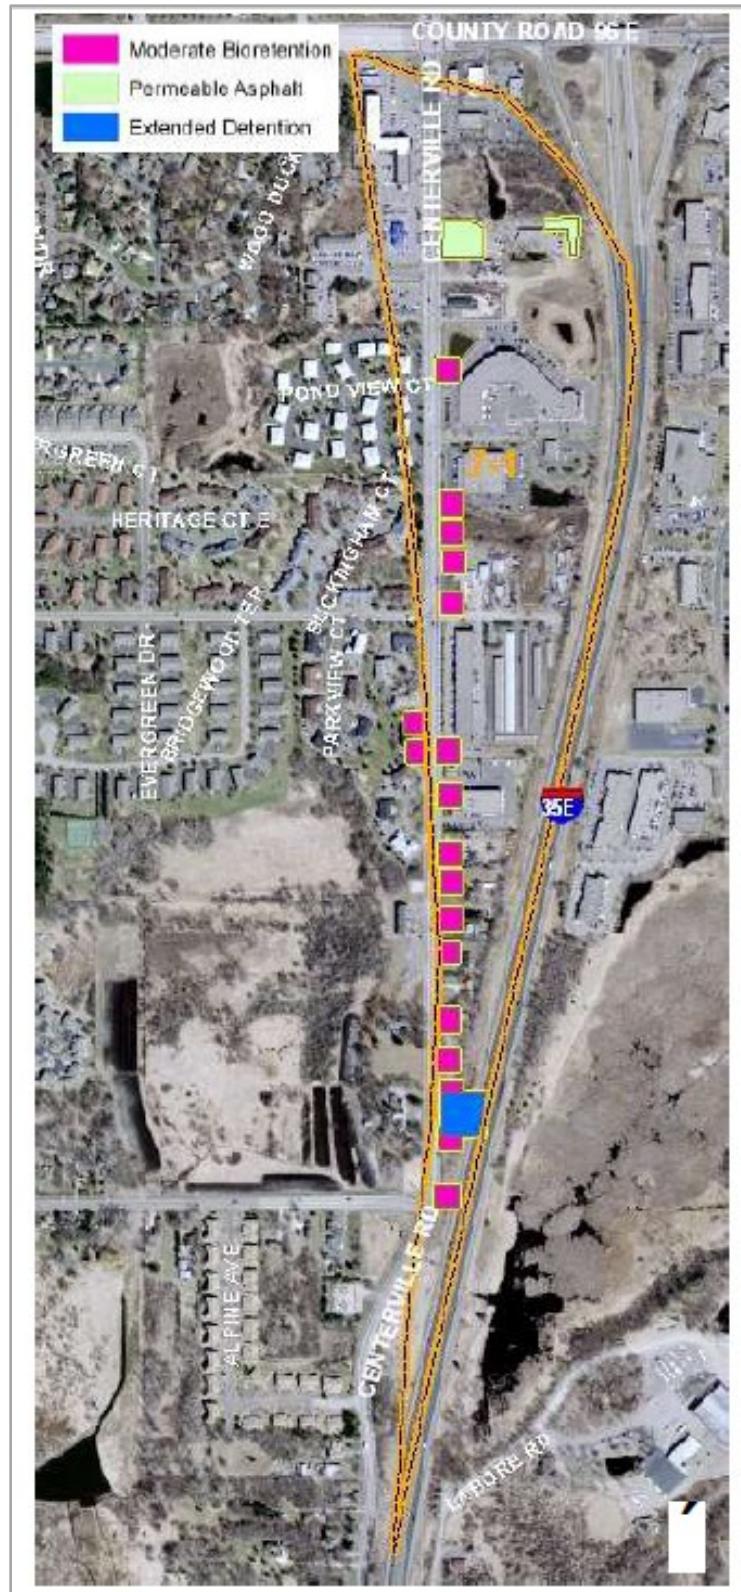
Figure 25: Goose Lake Subwatershed: 3 subcatchments focused upon for recommended retrofits

This catchment is comprised of primarily commercial and industrial land use and contributes an average of 1.03 Total Phosphorus (lb) per Acre per Year (TP/Acre/Yr). Analysis shows that this catchment contributes the most TP/Acre/Yr second to catchment 9-2 which empties into Goose Lake before entering Lambert Creek. This catchment drains through a series of storm sewer pipes that carry storm water south discharging into Lambert Creek near Centerville road and County road F.

Due to favorable soil types on site, a combination of bio-infiltration types is recommended for this catchment. Where soils are found to be less than favorable additional soil amendments or bio-retention cells should be utilized. The majority of these bio-infiltration cells will rely on newly poured curb cut inlets and sediment forebays for conveyance of street runoff to the treatment cell. Where elevations of the road and/or land behind the curb line are more than gradual, retaining walls will be necessary. The boulevards in this area are wide and ideal for adequately sized bio-infiltration cells, however, where space is limited, such as in boulevards where sidewalk and curb lines define the useable space, we recommend poured concrete wall retainment to form “box planters” along the streetscape.

Alternate best management practices that could be placed within the catchment include porous asphalt strips and a detention basin. South within the catchment is municipal owned land where an extended detention basin could be constructed. Pond construction would be complex and include day lighting a portion of the storm sewer system to flow into this basin. The design criteria for a storm water pond, according to The Minnesota Stormwater Manual, states that the permanent pool volume for a stormwater pond should be sized 1800 cubic feet per acre draining to the pond and have the appropriately-sized live storage capacity which in conjunction could have the potential to remove 50% of the TP. Given the approximate watershed size flowing to this point estimated at 25 acres the permanent pool of the pond could be sized at 1666 cubic yards with a live storage area of approximately half of the permanent pool size estimated at 833 cubic yards.
