VADNAIS LAKE AREA WATER MANAGEMENT ORGANIZATION
Black Lake Review,
Ramsey County, MN

2024

Vadnais Lake Area Water Management Organization
800 County Road E East
Vadnais Heights, MN 55127
651-204-6070
www.vlawmo.org

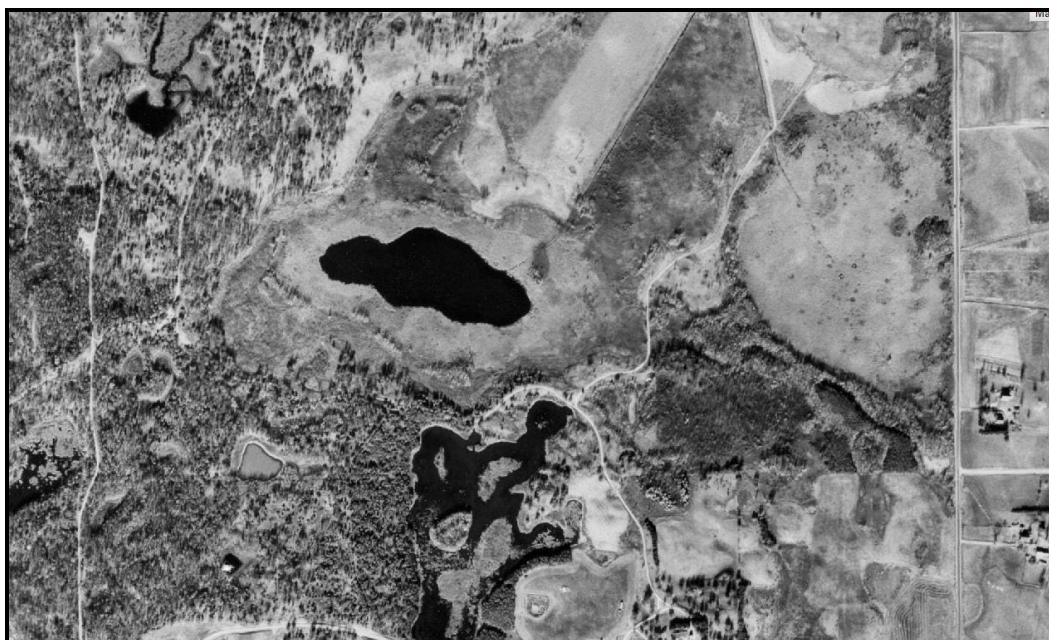
Figure 3: In 1953, the land just south of Black Lake appears to have been excavated to create open water. This area is now considered a wetland.

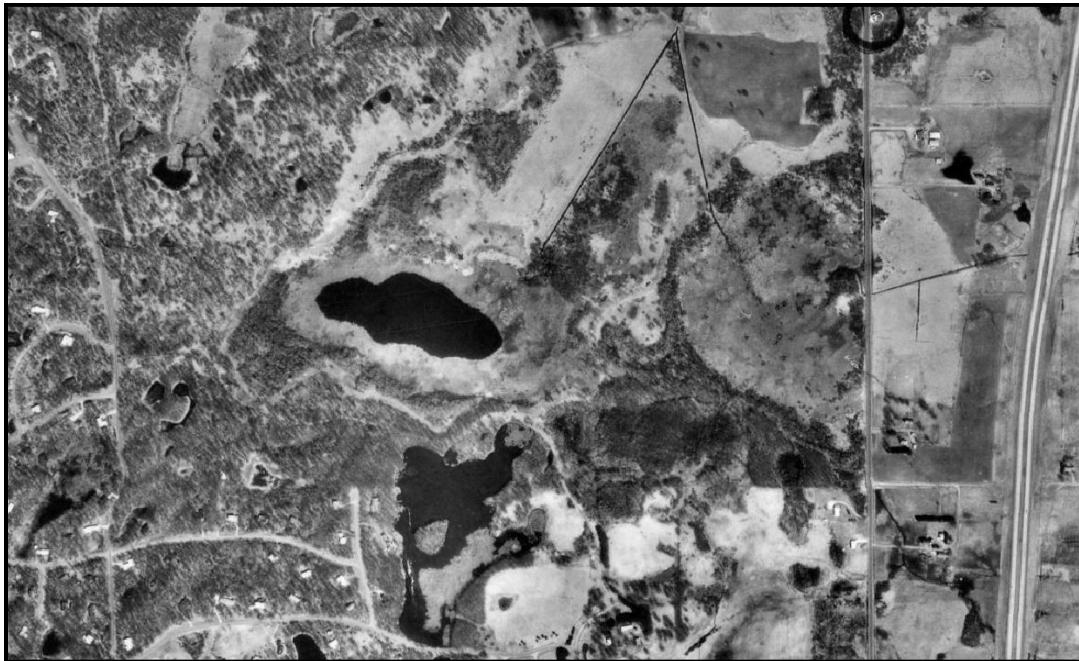
Figure 4: By 1974, residential development is prevalent and I-35E has been constructed east of the lake. Additionally, drainage conduits have been dug which allow water to flow more freely from Black Lake north towards Wilkinson Lake.

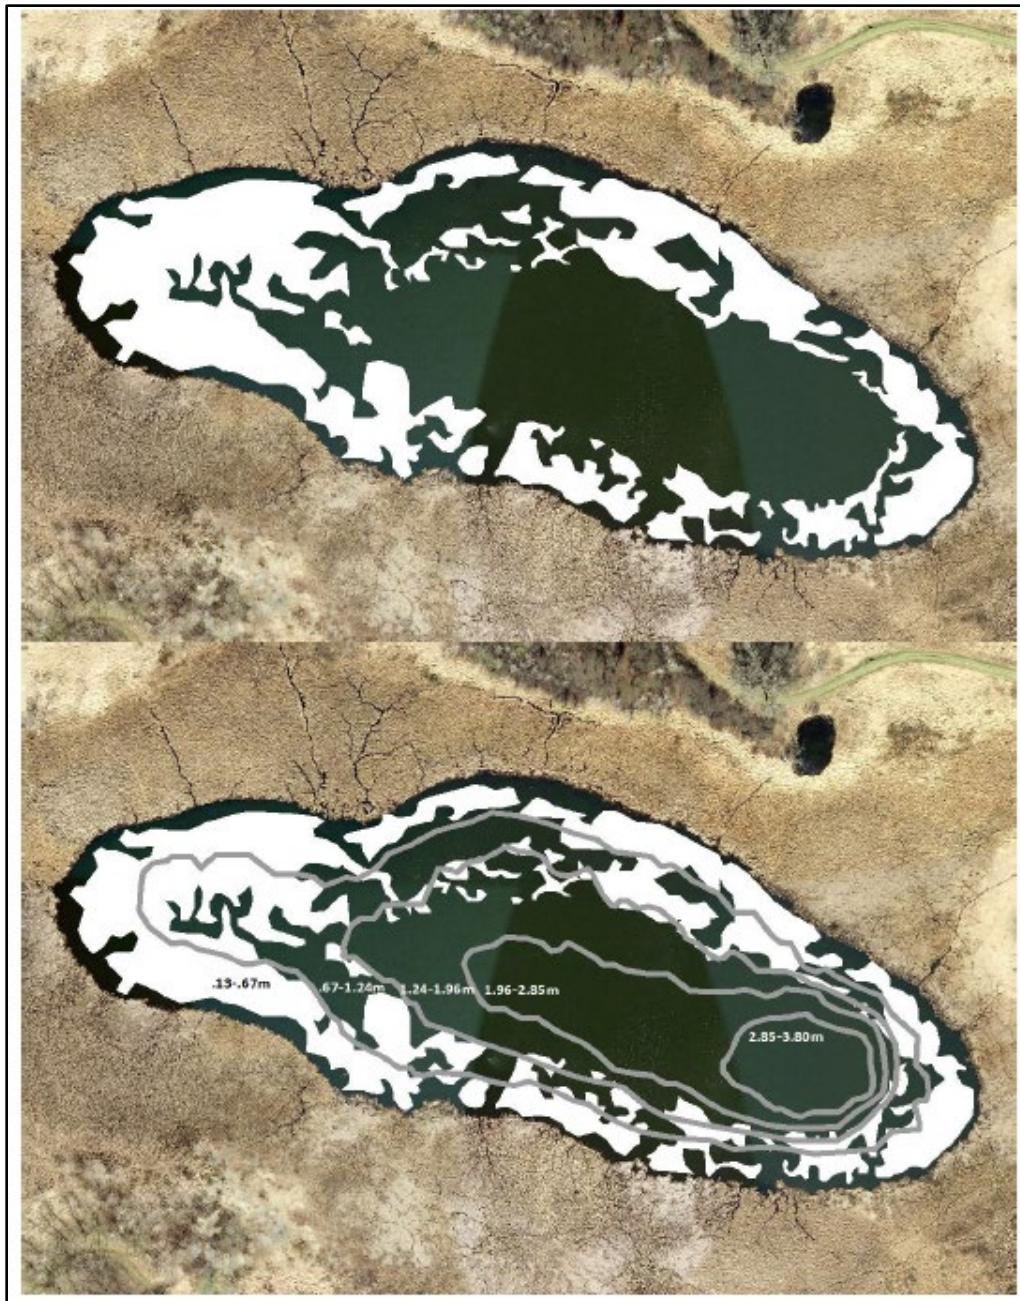
Figure 15: Black Lake wild rice emergent areas displayed with April 29, 2015 contours.

Satellite imagery was utilized to estimate areas of wild rice emergence using Google Earth Technology, which was ground-truthed to field observations. The area of wild rice growth was found to be approximately 16,725 square meters or 40% of the lake surface. Wild rice emergence occurred no deeper than an approximate water depth of 1.25m (4ft) based on contours sampled on May 29, 2015.

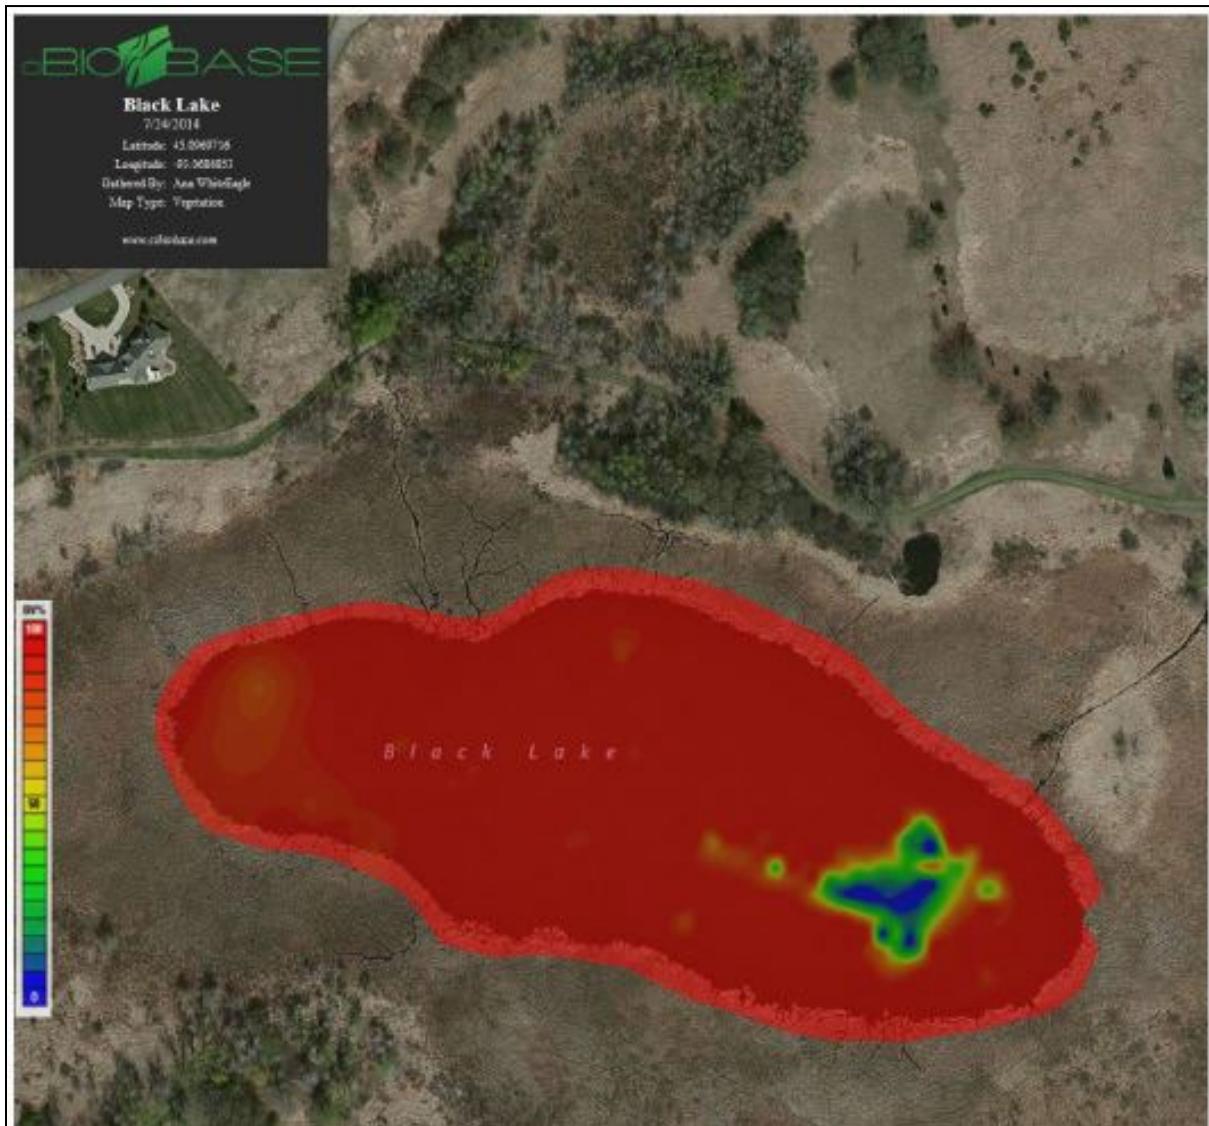
Figure 16: Black Lake Biovolume – Summer Conditions – collected 7/24/2014

Figures 14 and 15 demonstrate the difference in biovolume (abundance of in lake vegetation) from spring and summer conditions. In the summer, the lake is almost entirely filled with vegetation. The spectrum of blue – red indicated the amount of vegetation with blue being little to no vegetation and red being 100% vegetation.
