**VADNAIS LAKE AREA WATER MANAGEMENT ORGANIZATION**

**Charley Lake Review,**

**Ramsey County, MN**

**2024**

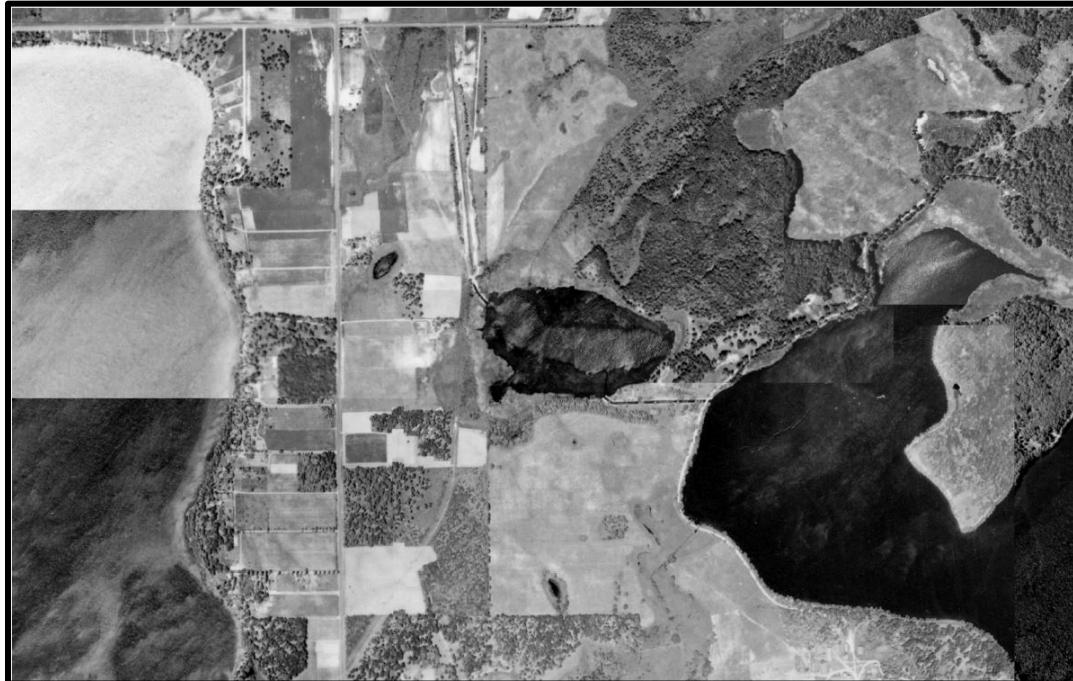
Figure 2: 1940 aerial photo of Charley Lake

In 1940, there are agricultural clearings and lake homes on Turtle Lake. The channel on the NW side of the lake appears to connect to Baldwin Lake. County Rd I and Hodgson Rd are present.

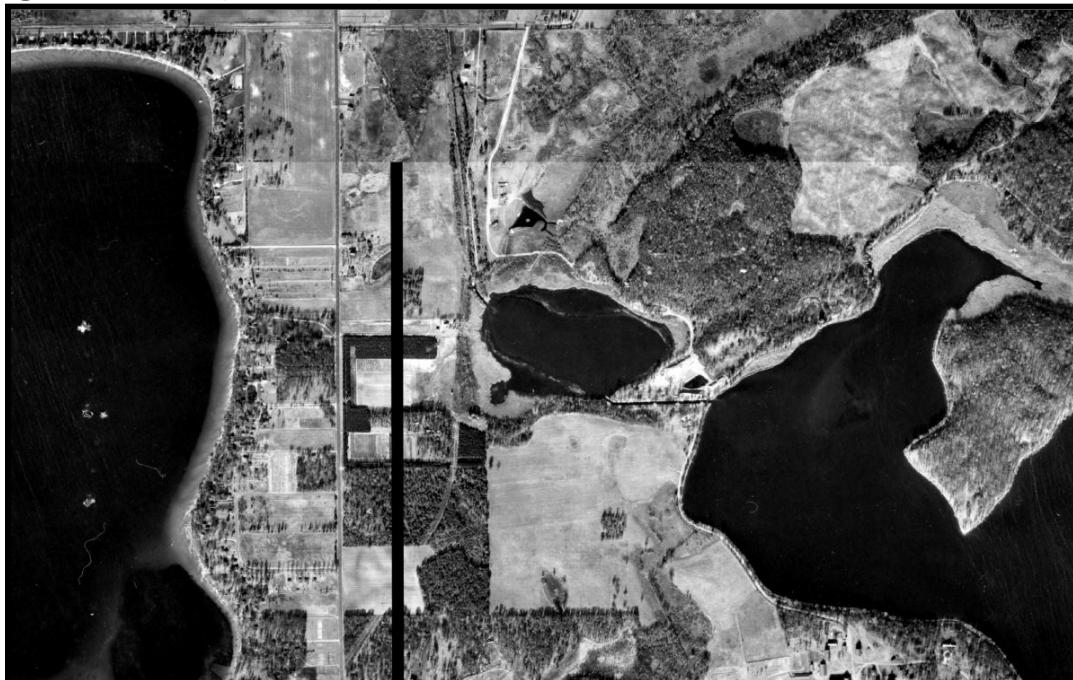
Figure 3: 1953 aerial photo of Charley Lake

In 1953, a road and a few buildings on the north side of the lake have been built.

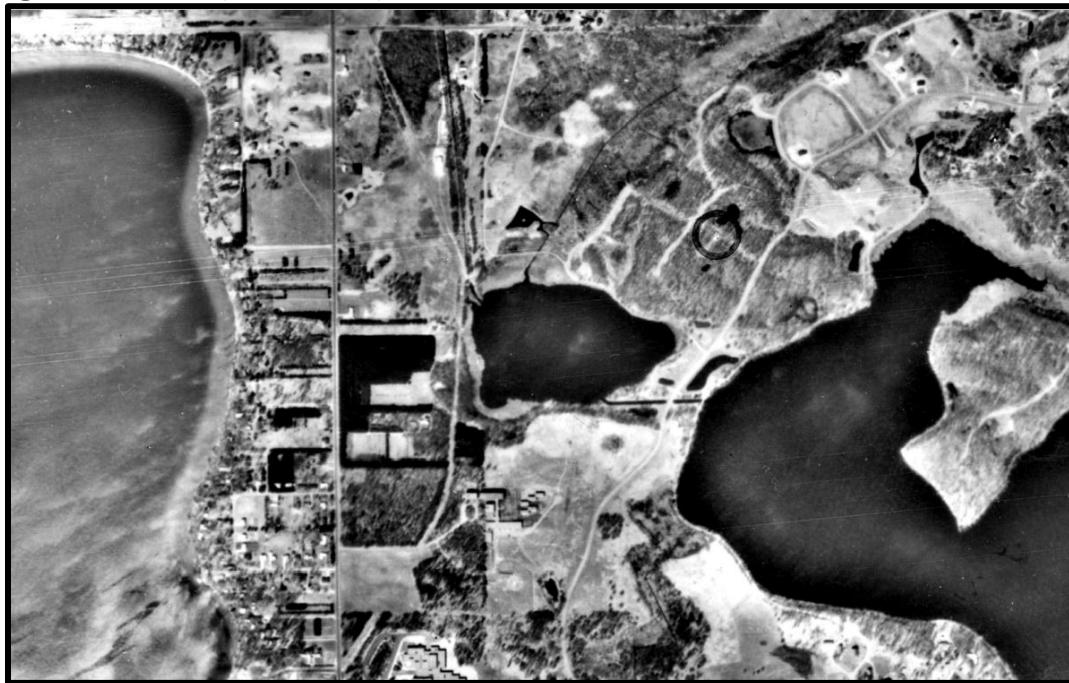
Figure 4: 1974 aerial photo of Charley Lake

By 1974, the residential development of North Oaks has begun, the convent south of Charley has been built, and the aqueduct pumping water from the Mississippi connects to the North Oaks chain of lakes by entering through Charley.

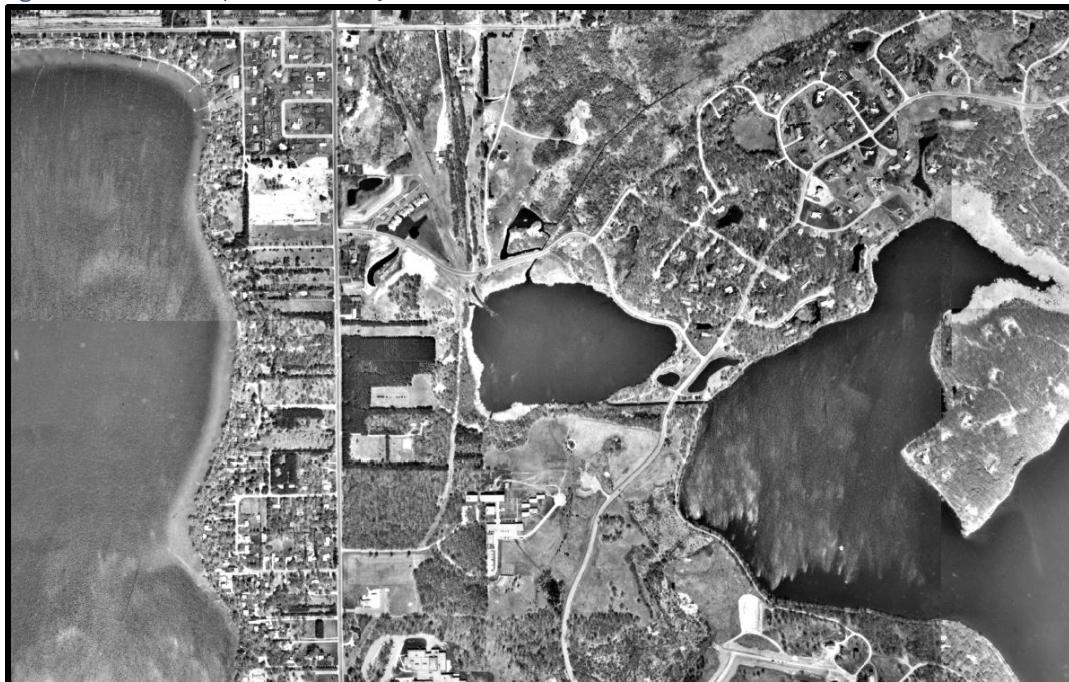
Figure 5: 1985 aerial photo of Charley Lake

In 1985, early residential development north of Charley is in place, some homes have been added off Hodgson Road, and residential development out of frame to the north has begun.

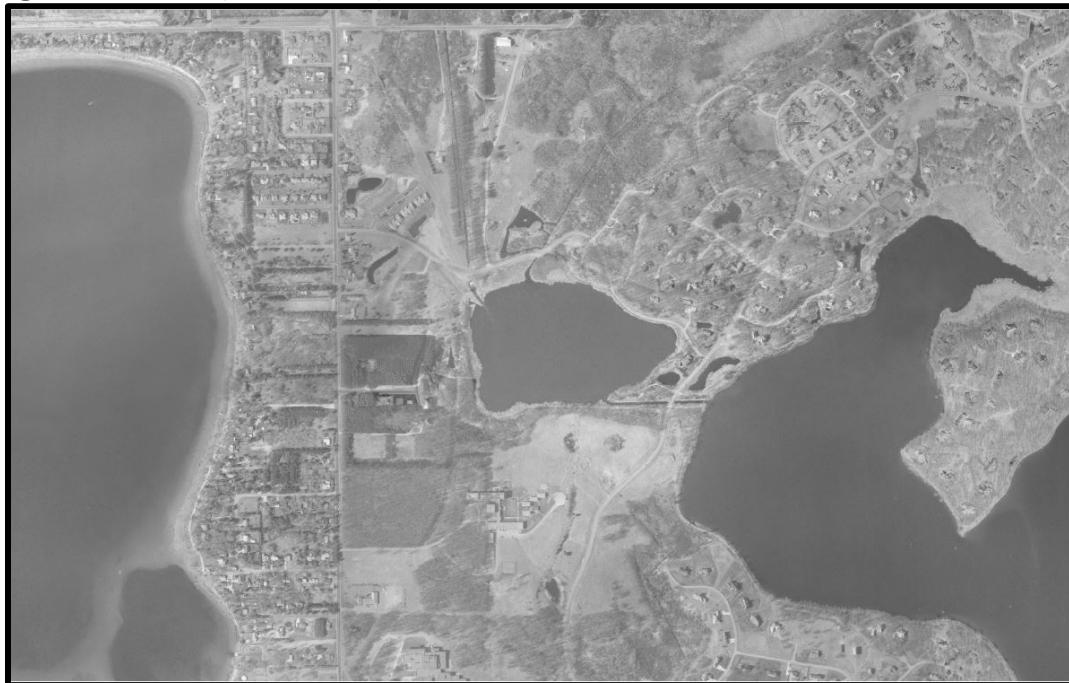
Figure 6: 1991 aerial photo of Charley Lake

In 1991, the first-phase development within the Charley subwatershed catchment has been completed.

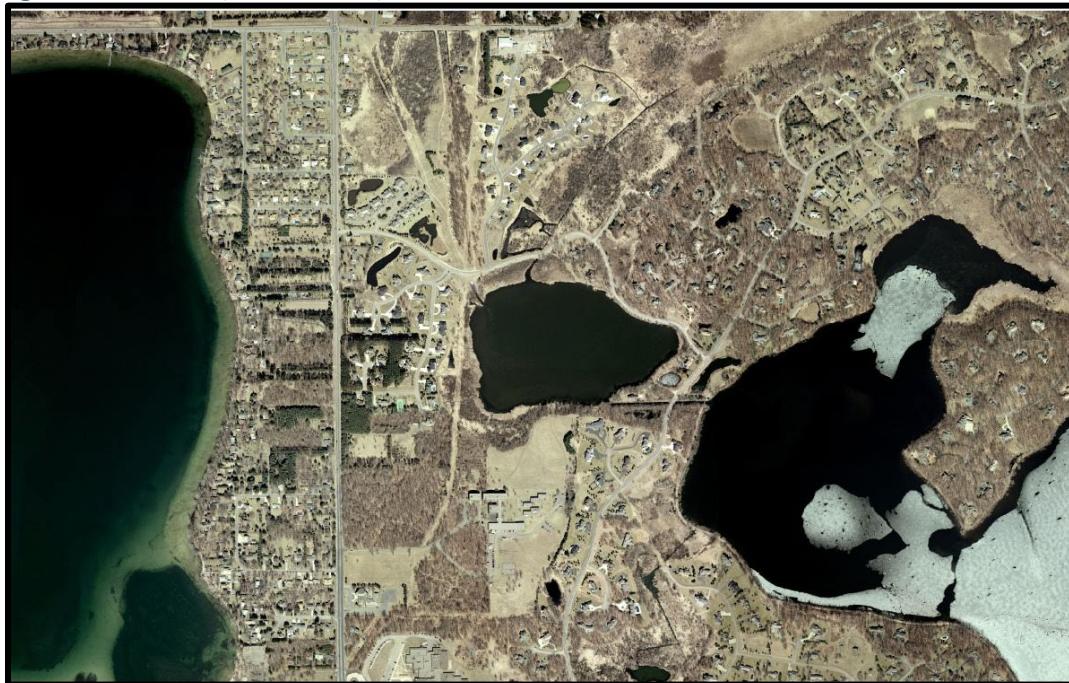
Figure 7: 2003 aerial photo of Charley Lake

In 2003, more development has been added to the north and west of Charley, and development is underway to the south of Charley Channel.

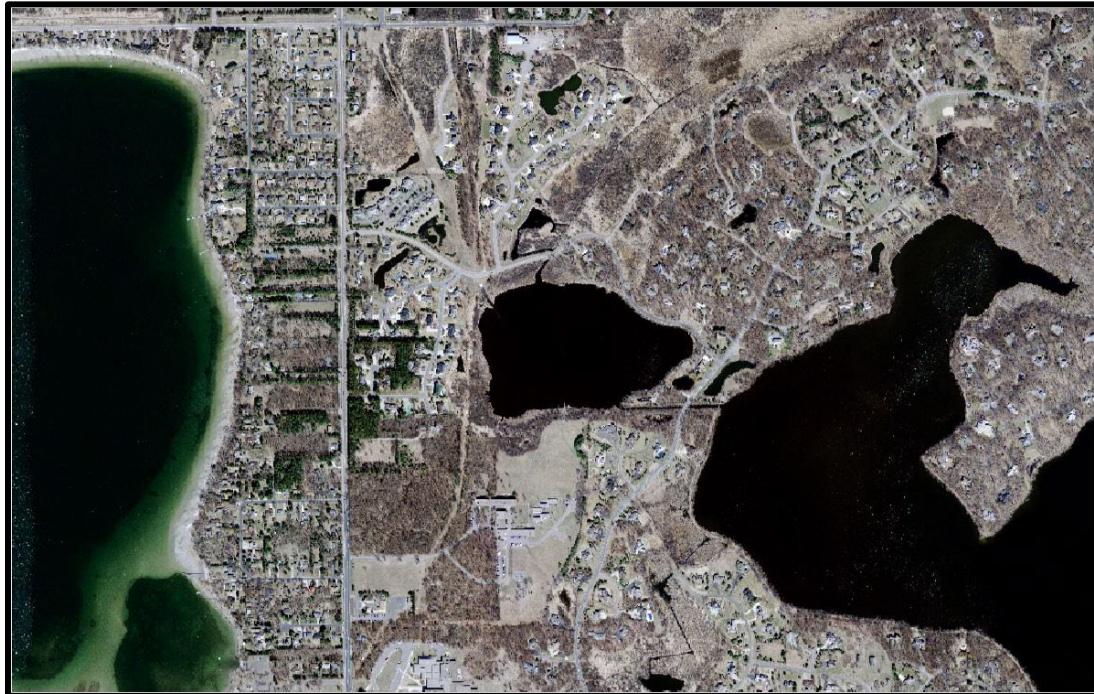
Figure 8: 2009 aerial photo of Charley Lake

In 2009, there is little has change since the 2003 aerial.

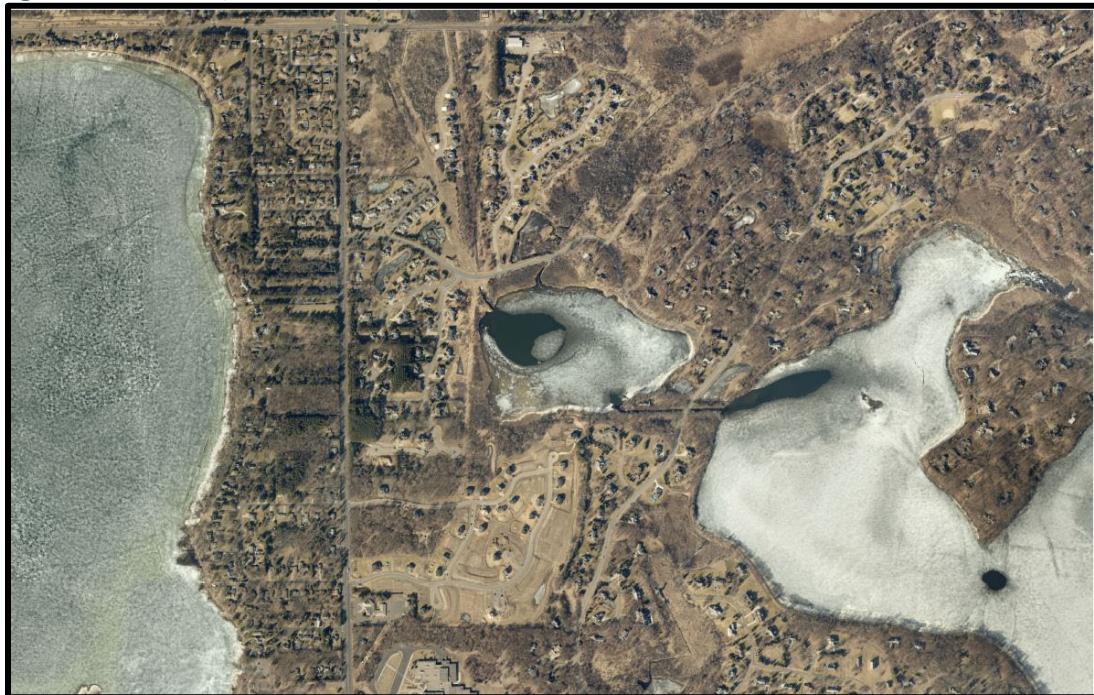
Figure 9: 2015 aerial photo of Charley Lake

In 2015, the convent south of Charley has been demolished, a new residential development has begun, and development has contributed to sediment and nutrient inputs into the lake.
