VLAWMO

VADNAIS LAKE AREA WATER MANAGEMENT ORGANIZATION
Birch Lake Review,
Ramsey County, MN

2024

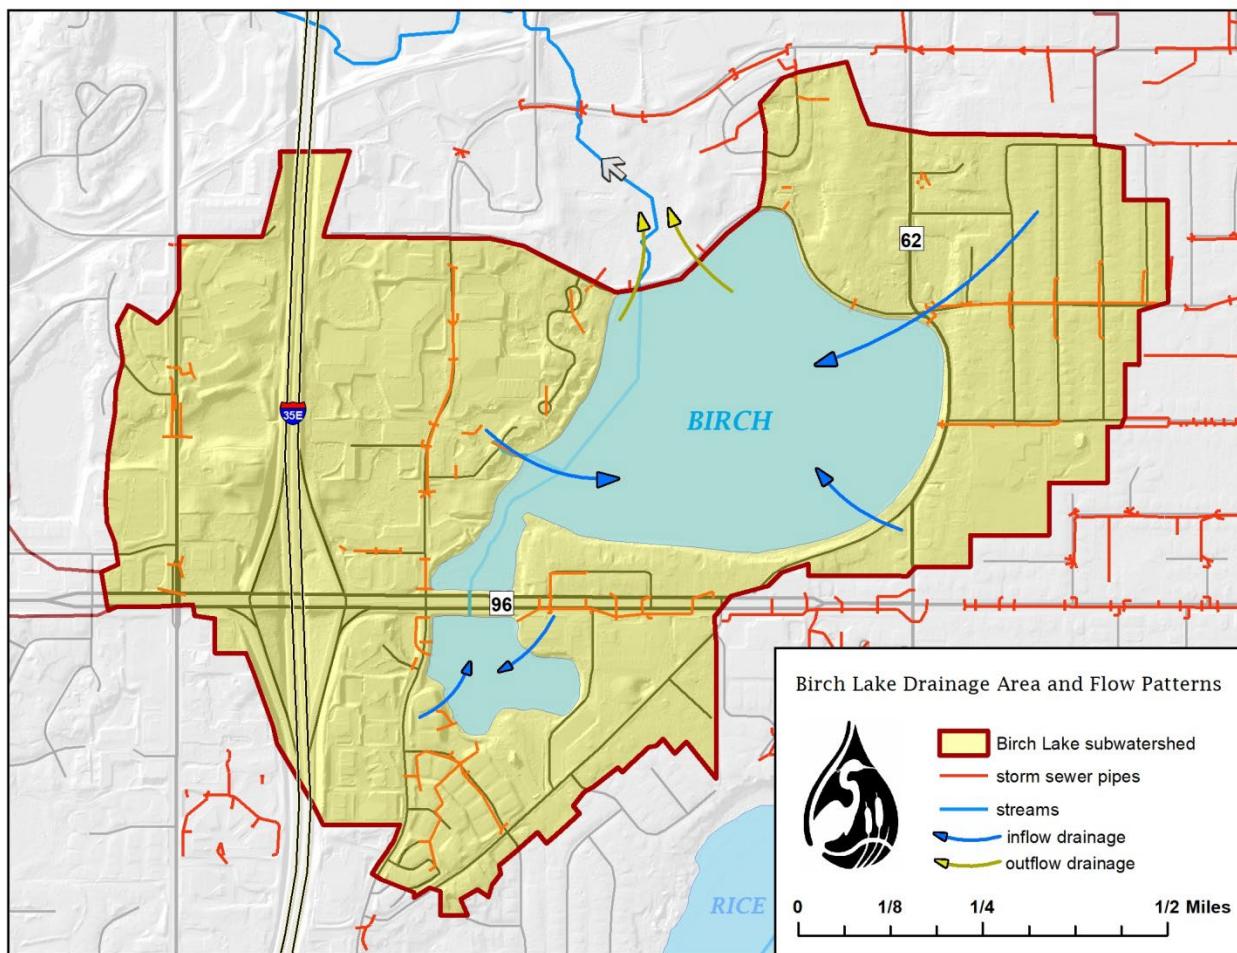
Figure 10: Birch Lake Drainage Area and Flow Patterns

The drainage area (shaded area in Figure 2) into Birch Lake is approximately 575 acres and is about 5 times larger than the surface area of Birch Lake, which is 125 acres. This is a relatively small drainage area to Birch Lake. Lakes with a small drainage area (less than 10:1 ratio) tend to have better water quality.

In 2007 and 2008, VLAWMO collected water samples from 3 areas around the lake where stormwater drains enters the lake to track the levels of nutrients and sediment. Results are shown in Table 1.

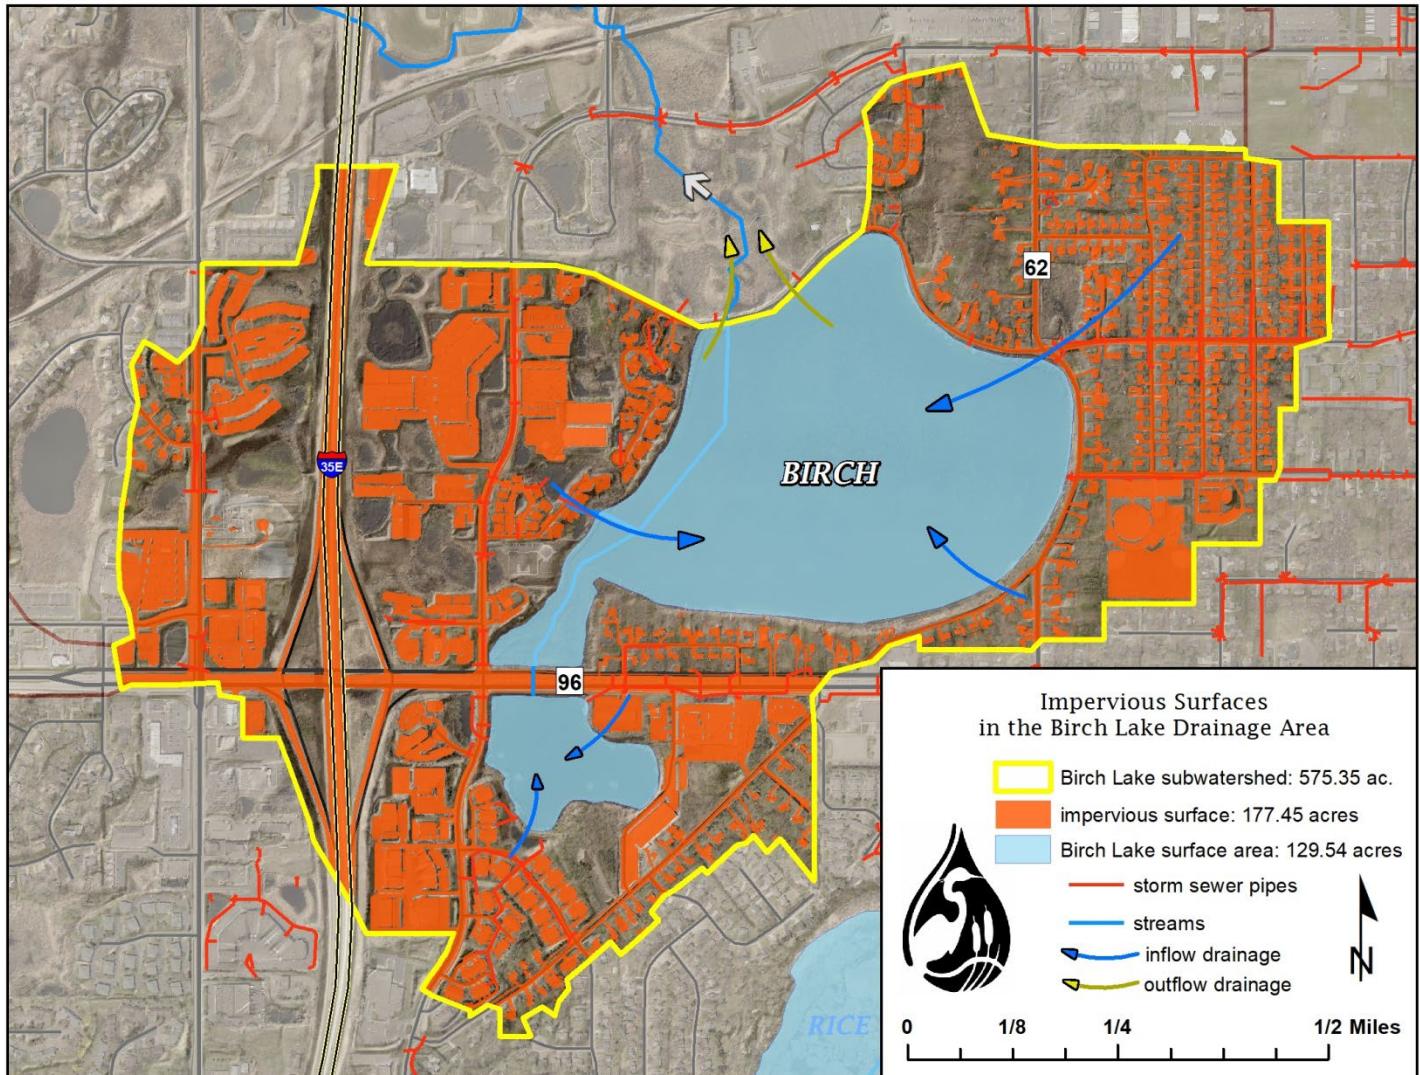
Figure 11: Impervious Surfaces in the Birch Lake Drainage

Figure 11 shows that a large amount of land cover in the Birch Lake Subwatershed is developed, and consists primarily of impervious surface (30.8% of total land cover, including water surface area and undeveloped surface area; not including Birch Lake's surface water area, impervious surface is 39.8% of the total land cover.). The majority of precipitation that falls on those surfaces moves rapidly into downstream lakes, wetlands, and streams.

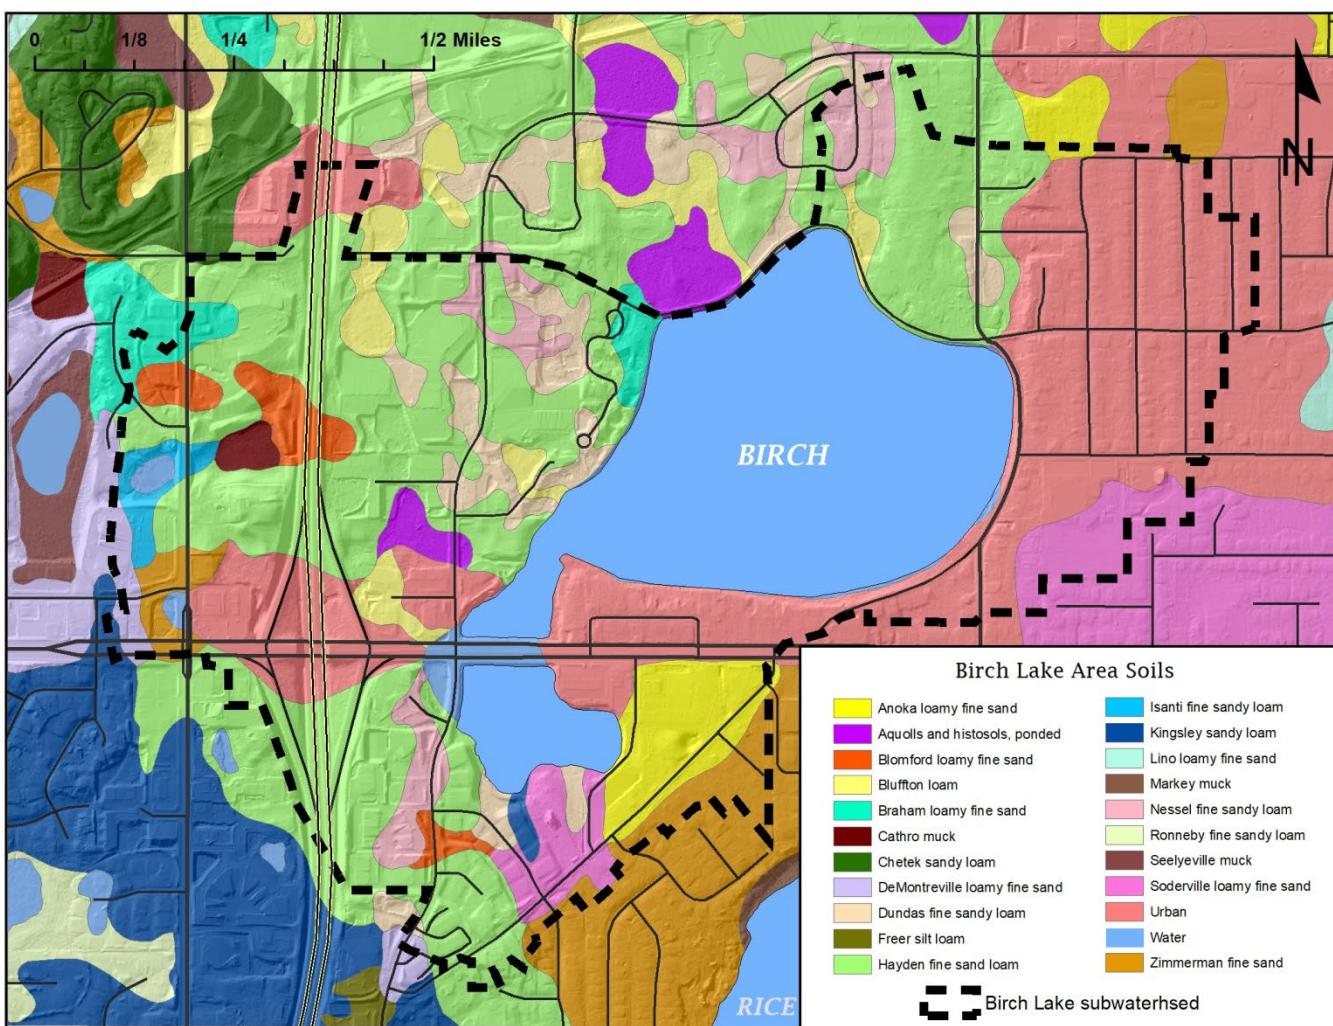
Figure 12: Birch Lake Area Soils

Soils in the Birch Lake Subwatershed are dominated by Hayden fine sandy loam and Urban Land-Zimmerman Complex. Both soils are good for building and residential development. These soils tend to be well drained, allowing water to infiltrate. With development, much of the soil has been compacted, moved, and paved over. Retrofits such as raingardens are especially effective in these soil types and have been added over time.

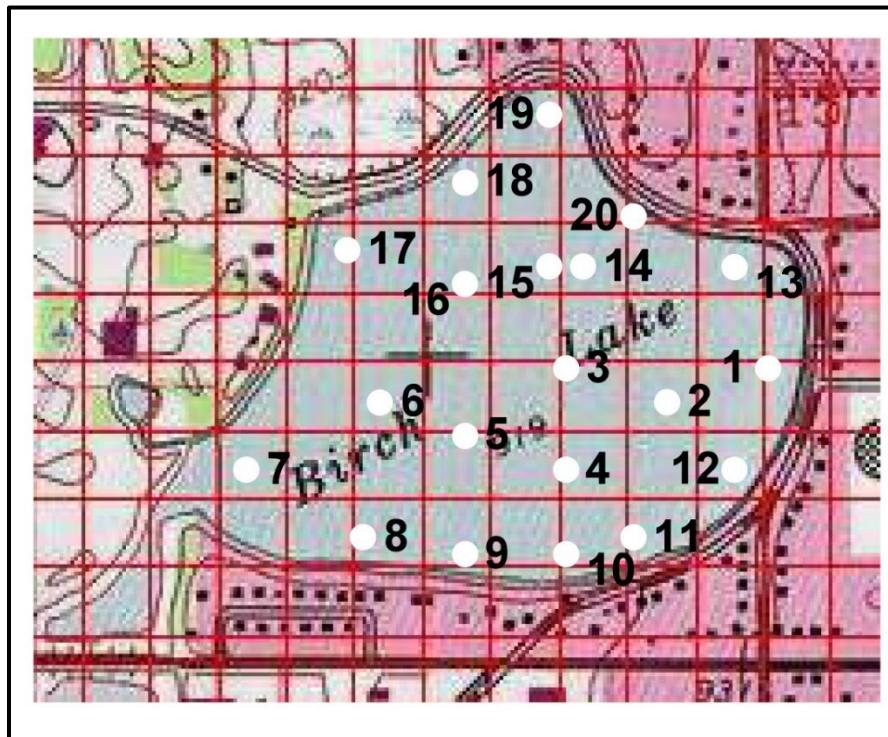
Figure 13: Birch Lake Sediment Sampling

Soils in Birch Lake sediments have also been analyzed. A sediment study in the lake was conducted in 2008 to inform the Aquatic Invasive Species Action Plan that was completed in 2015. The lake sediment study was conducted with uniform sampling of the lake area. A total of 20 samples were collected and analyzed.

A total of 15 parameters were analyzed for each sediment sample (see full list in the report included on the VLAWMO website -> Birch Lake). Lake sediments overall are soft and mucky. Typically high organic matter content is associated with the soft mucky sediments sample sites. Lake sediment phosphorus concentrations at all sites were low.

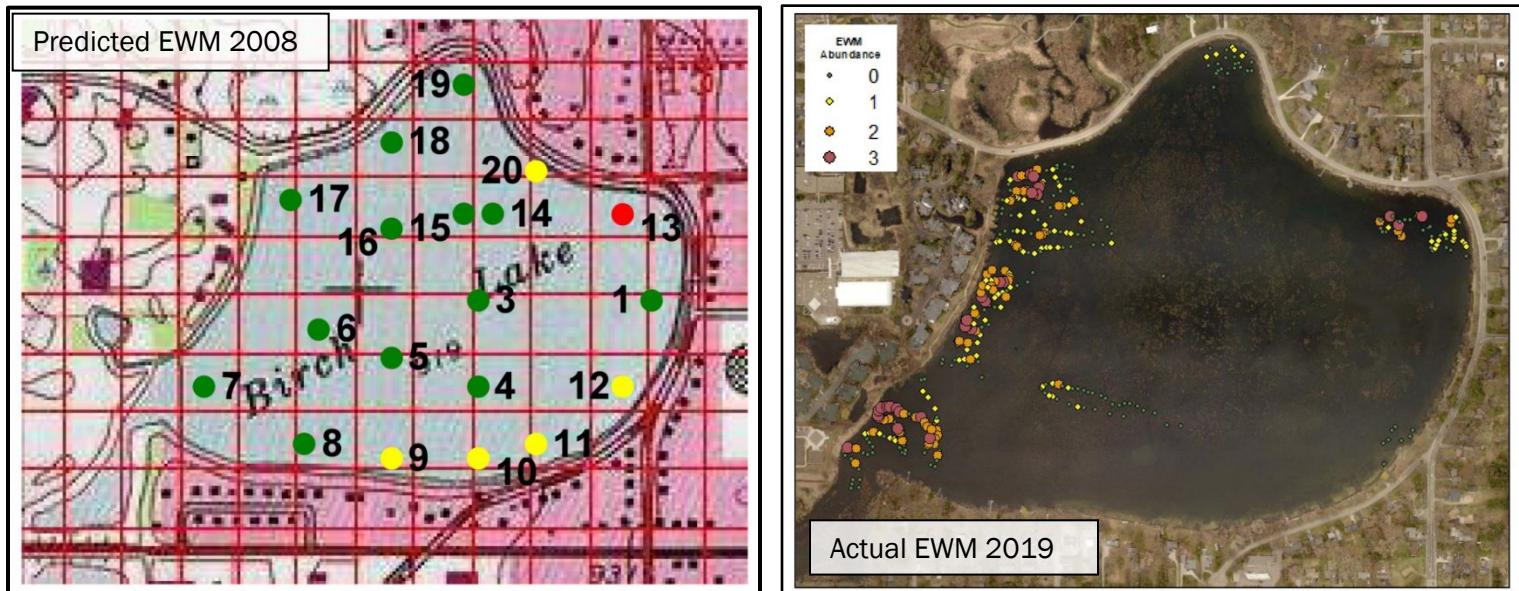
Lake sediment sampling results were also used to predict lake bottom areas with the potential to support nuisance Eurasian watermilfoil (EWM) growth. EWM was first documented in Birch Lake in 2005. Based on the key sediment parameters of NH₄ and organic matter (McComas, unpublished), the predicted growth characteristics of EWM were investigated and predicted. Sediment nitrogen conditions in Birch Lake are relatively high. However, because organic matter content is very high, nuisance milfoil growth was predicted to be rare. EWM may grow widely through Birch Lake, but it was not expected to produce extensive perennial nuisance matting conditions. Ramsey County Soil and Water Conservation Division conducted an aquatic vegetation survey and EWM delineation in 2019, so we are able to compare predicted versus actual growth of this invasive species. EWM has spread since 2008. Predicted areas for colonization of EWM do not closely match with actual colonization that has occurred over time.

Figure 14: Birch Lake Predicted EWM Growth (2008). Green = low, Yellow = medium, and Red = high predicted coverage by EWM versus Actual Colonization (2019)

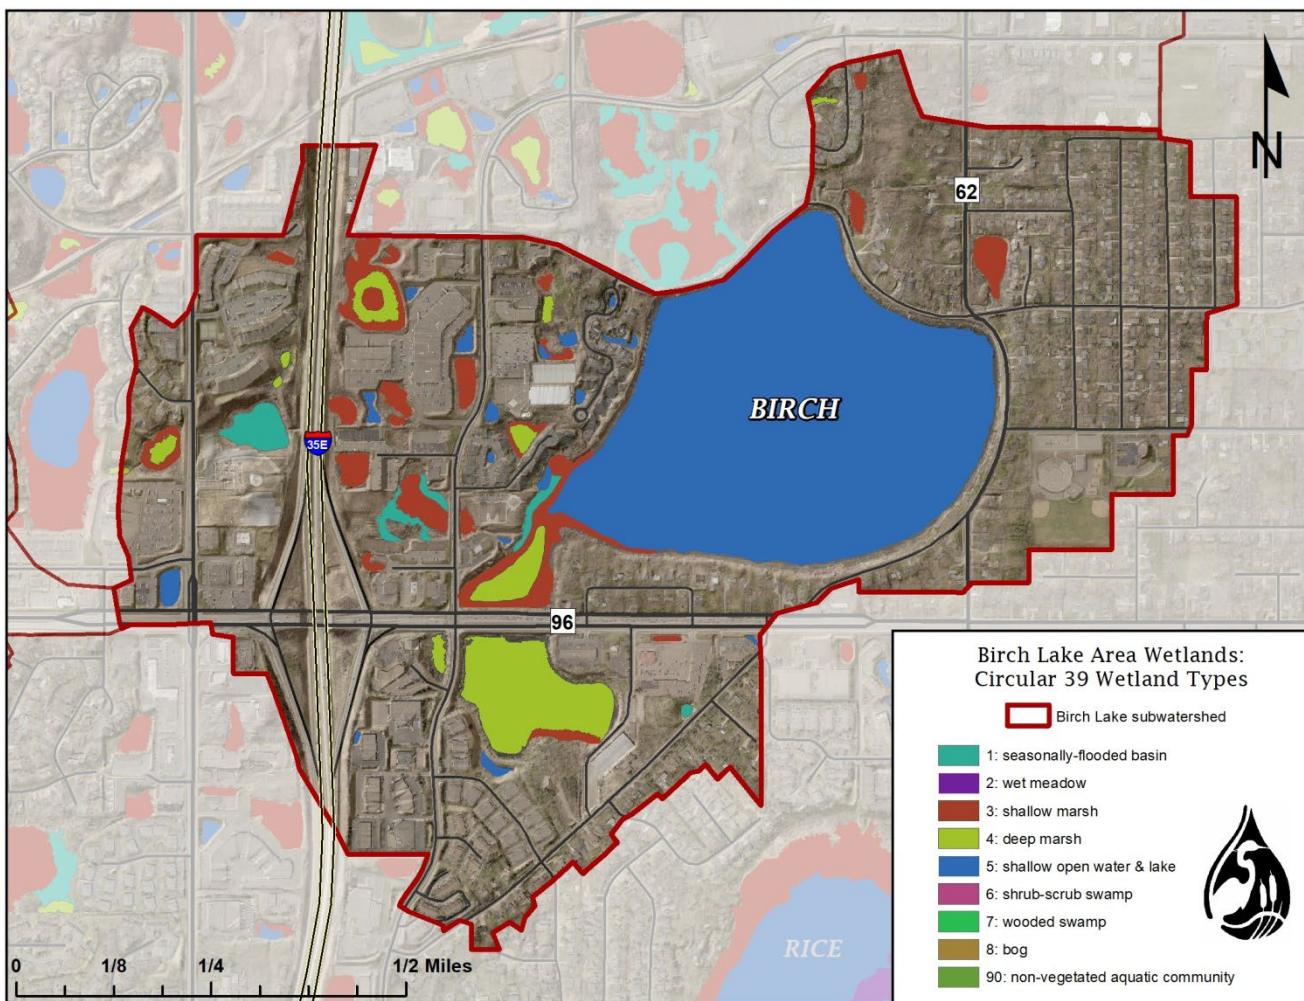
Figure 15: Birch Lake Circular 39 Wetland Types

As Classified by the Circular 39 wetland classification system, the southwest bay of the Birch Lake and the lobe south of Highway 96 (South Birch) have mixed classification of deep and shallow marsh, while the greater area of Birch Lake is classified as shallow open water or lake, as the majority of the lake's perimeter is surrounded by residential development. The southwest corner of the Lake exhibits the most shallow wetland characteristics with predominantly emergent vegetation, and the western shore has the most lightly-developed or altered shoreline habitat.

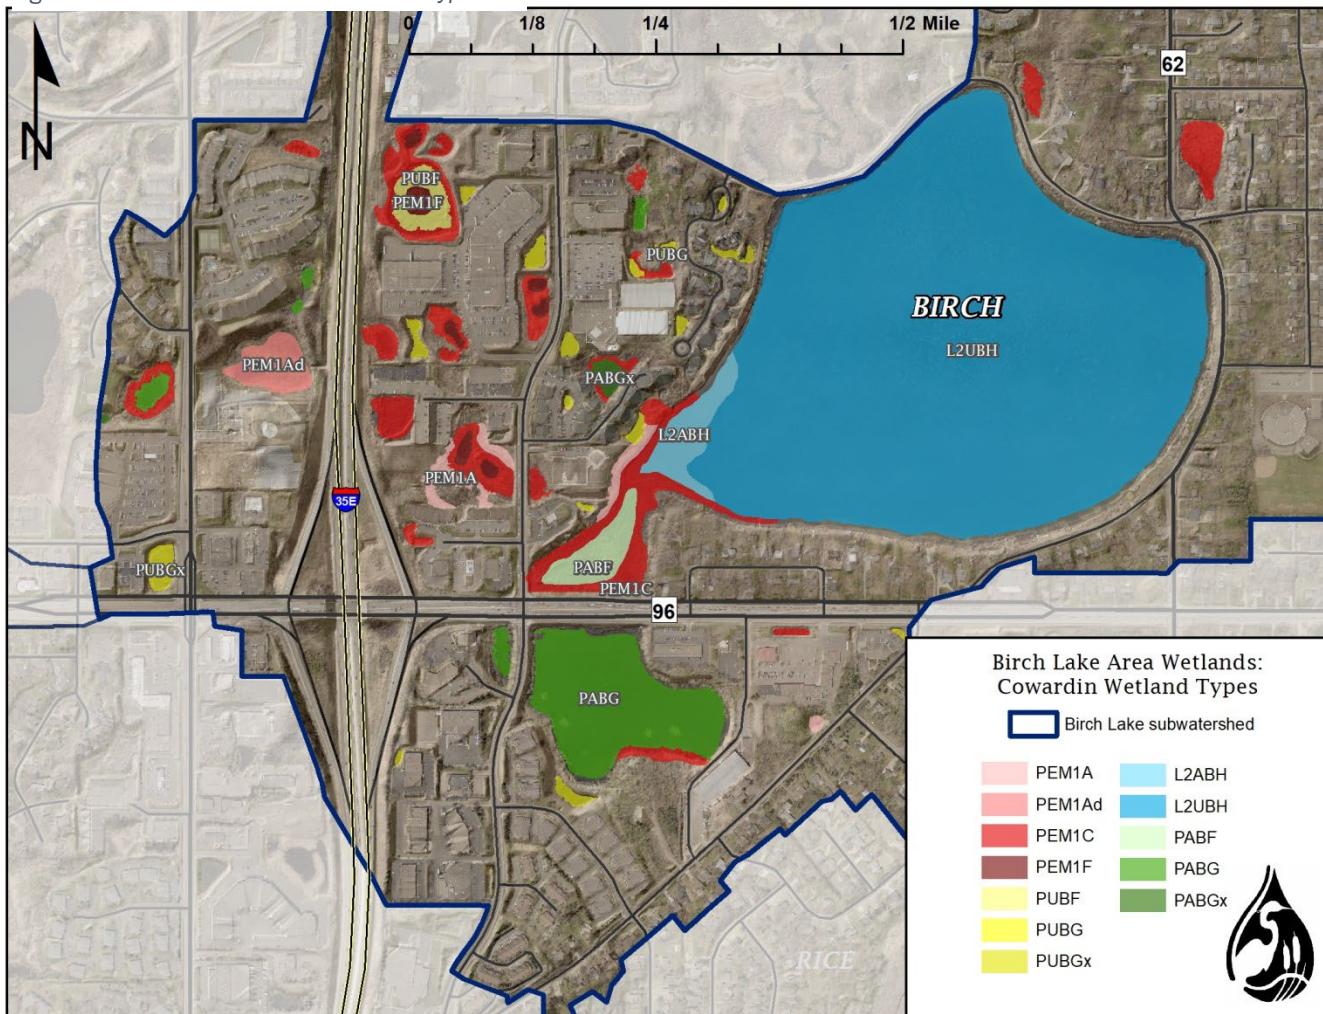
Figure 16: Birch Lake Cowardin Wetland Types

Within the US Fish & Wildlife Service's National Wetland Inventory (Cowardin Classification System), there are three predominant classifications around Birch Lake that are non-Lacustrine (lake): PEM1C, PABF, and PABG, which correspond to Shallow and Deep Marsh wetlands (Figure 16). PEM1C refers to palustrine, emergent, persistent marshes that are seasonally flooded (1C), whereas PABF is identified as a palustrine, aquatic bed, semi-permanently flooded. PEM1C surrounds the southwestern shoreline and PABF encompasses the middle of the southwest bay. PABG is identified as being palustrine, aquatic bed, and intermittently- exposed, and is identified as nearly the entire South Birch basin. These areas within the Birch Lake basin and along the shoreline add up to 19.8 acres.

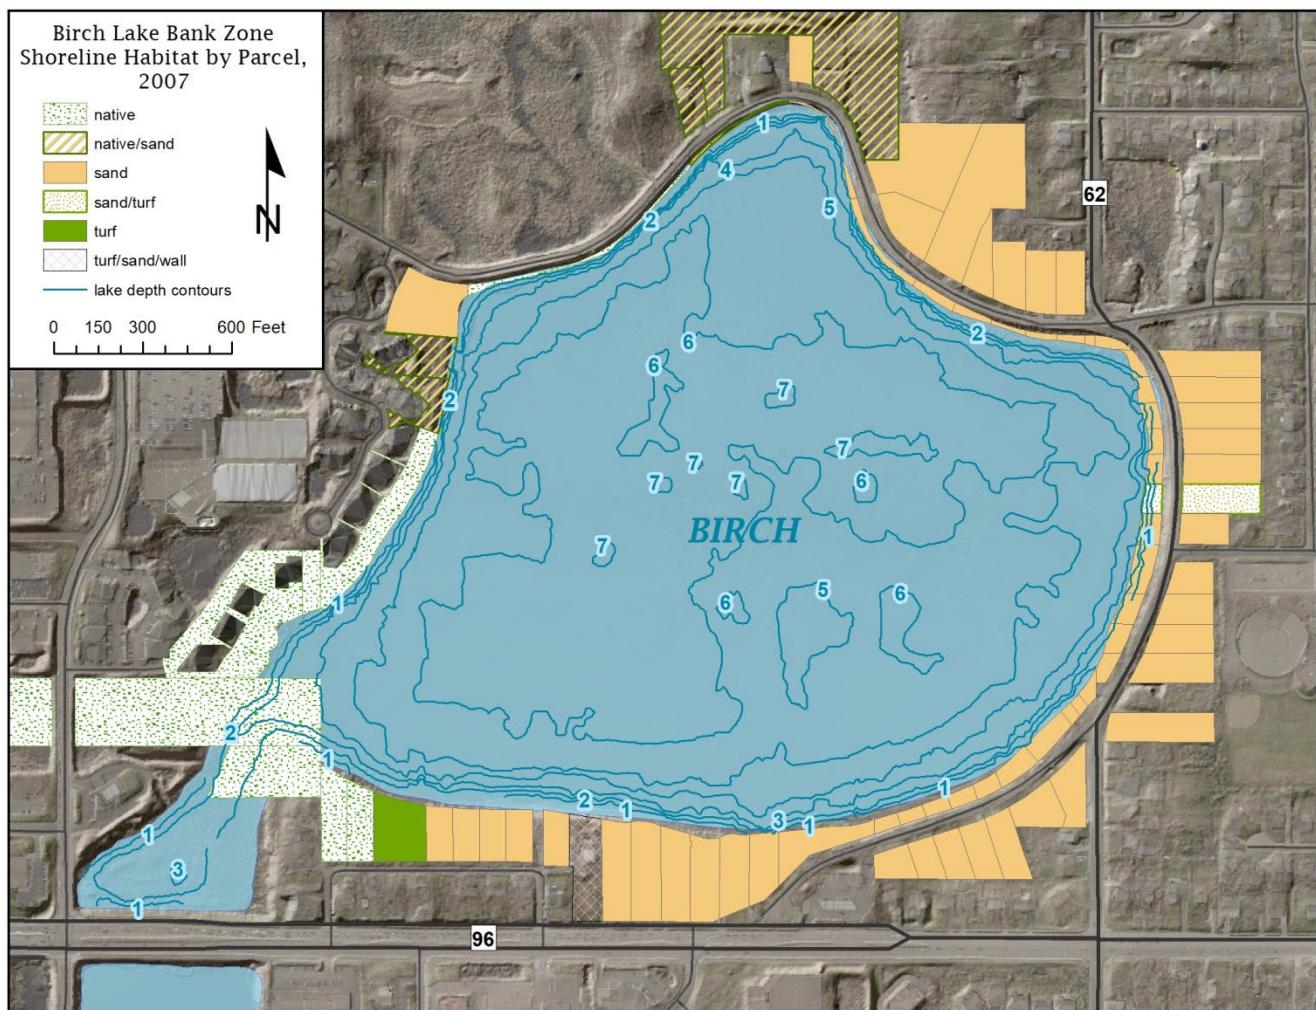
Figure 17: Birch Lake Bank Zone Shoreline Habitat by Parcel

A shoreline survey was conducted by VLAWMO and Ramsey Conservation District (RCD) staff in 2007 (The report was published in 2008). Sixty parcels were evaluated for this effort. Based on our subjective criteria, approximately half of the sites were mostly natural or naturalized, while the other half of parcels were cleared to the shore. There were no signs of major erosion problems. Thirty parcels were deemed to have high potential for shoreline restoration. Nineteen of the properties that are cleared to the shore were determined to have good potential for restoration to a more natural shoreline. By creating a buffer of natural vegetation along the shoreline, there will be more filtering of chemicals from lawns and roads before it reaches the water. Homeowners on Birch Lake should be encouraged to implement these types of landscaping project. Grants and design assistance are available through VLAWMO and the Ramsey Soil & Water Conservation Division to help homeowners with these projects.

A 25-50 foot buffer of natural vegetation that extends both onto land and into water and covers at least 75% of a property's frontage is ideal for the a lake ecosystem. Twenty-five percent of the lake frontage can be mowed and/or used as a beach area. For some people, this requires a change in their idea of what a nice shoreline looks like. Reestablishing natural conditions improves water quality by limiting the amount of

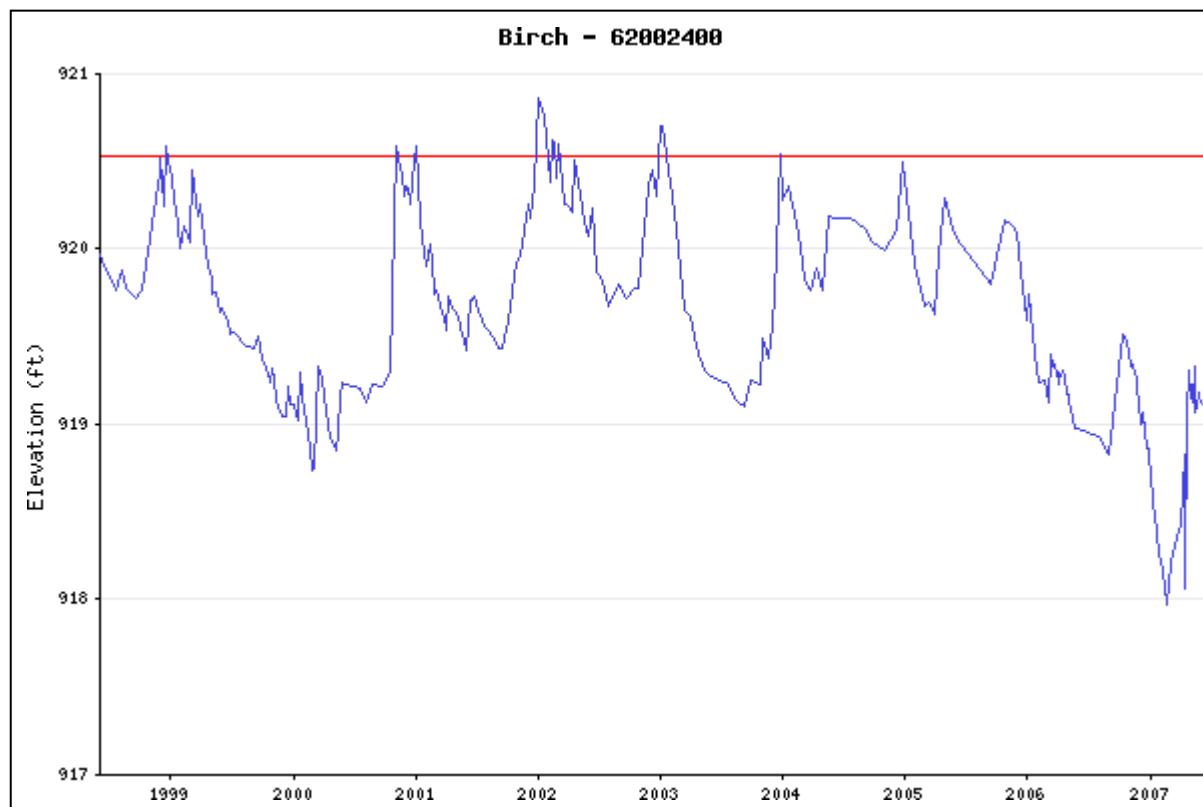
Figure 19: 10-year Hydrograph of Birch Lake

Water levels have fluctuated in Birch Lake since records were taken starting in June 1930 when the lake was dry. The highest recorded level was in 1952 when the lake was 7 feet deep. Water levels from 1998 through 2007 are shown in Figure 19. Birch Lake was approximately 2 feet below its historical average when the original SLMP was developed in 2007. After an especially wet period in 2018-2019, the maximum lake depth exceeded 1952 levels and was 7.4 feet deep. This shows that lakes are dynamic systems that vary over time.

When looking at the lake level data from 1930 to present, there have been other times when the lake level was lower than it was in 2007. The lake was lower in the late 1930s, 1948–1949, 1959, and 1989–1990. In 2007, it was predicted that Birch Lake levels would once again rise to its historical average. That has indeed occurred. As of, 2019, the lake was 7.4 feet deep.

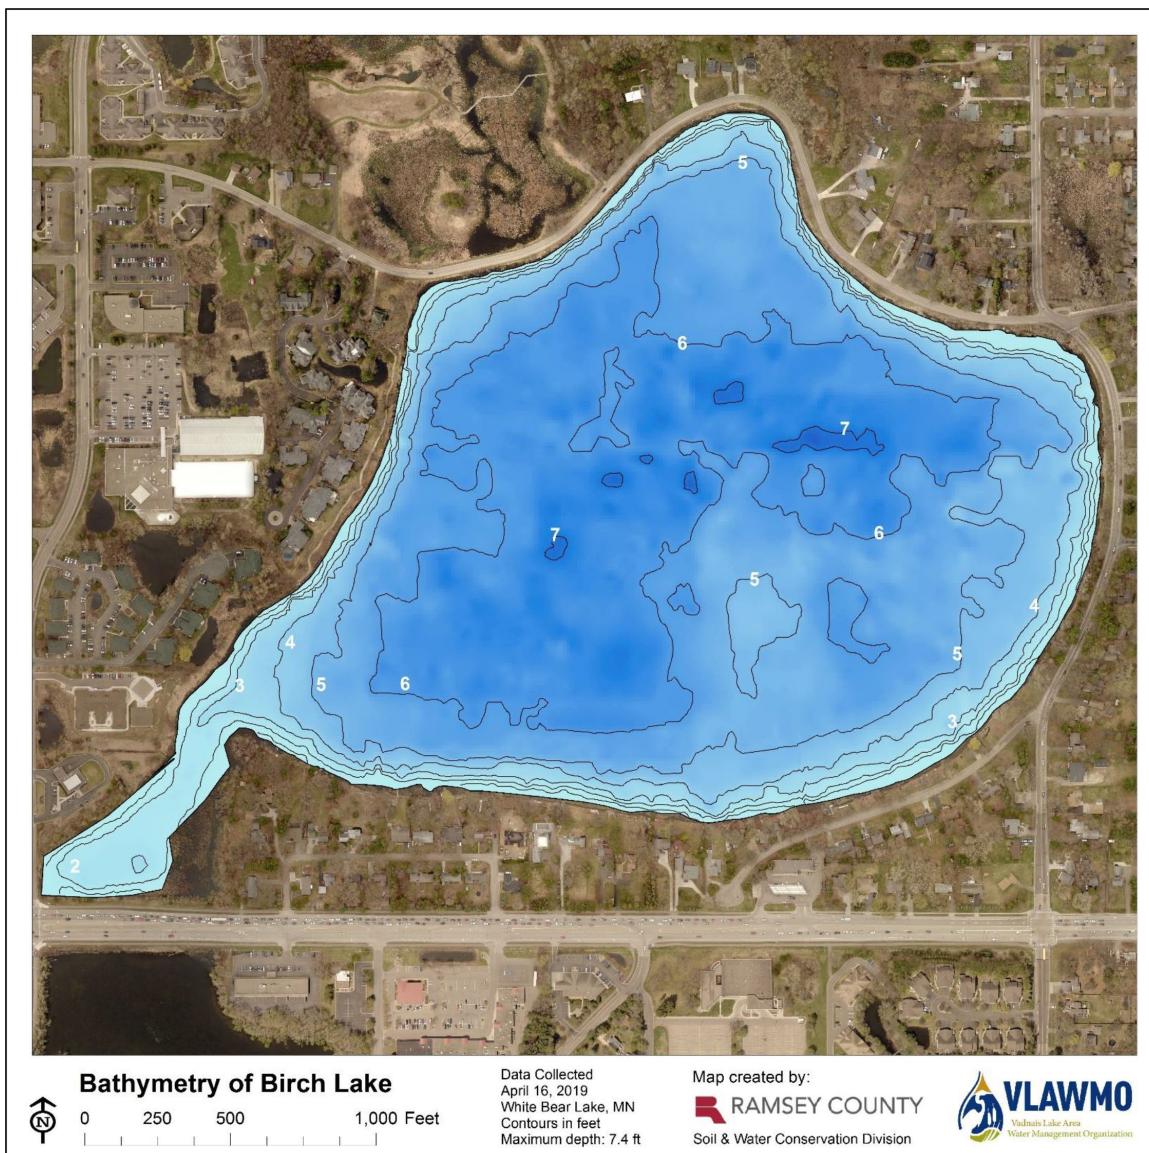
Figure 20: Birch Lake Depth with 1-foot Contours

A bathymetry survey was completed by Ramsey County Soil and Water Conservation Division on April 16, 2019, to develop a map of the bottom of Birch Lake and determine depths. The survey was conducted early (about 1-week post ice out) to capture depths before aquatic vegetation became too thick. Thick vegetation could register as lake bottom and give erroneously shallow readings. Birch Lake has a maximum depth of 7.4 feet. It follows a typical lake bottom shape, with shallower areas along the outer areas and deeper sections towards the middle. Birch Lake has small pockets that are 7-feet deep in the middle of the lake.

Figure 3. Depth of Birch Lake with 1-ft contours

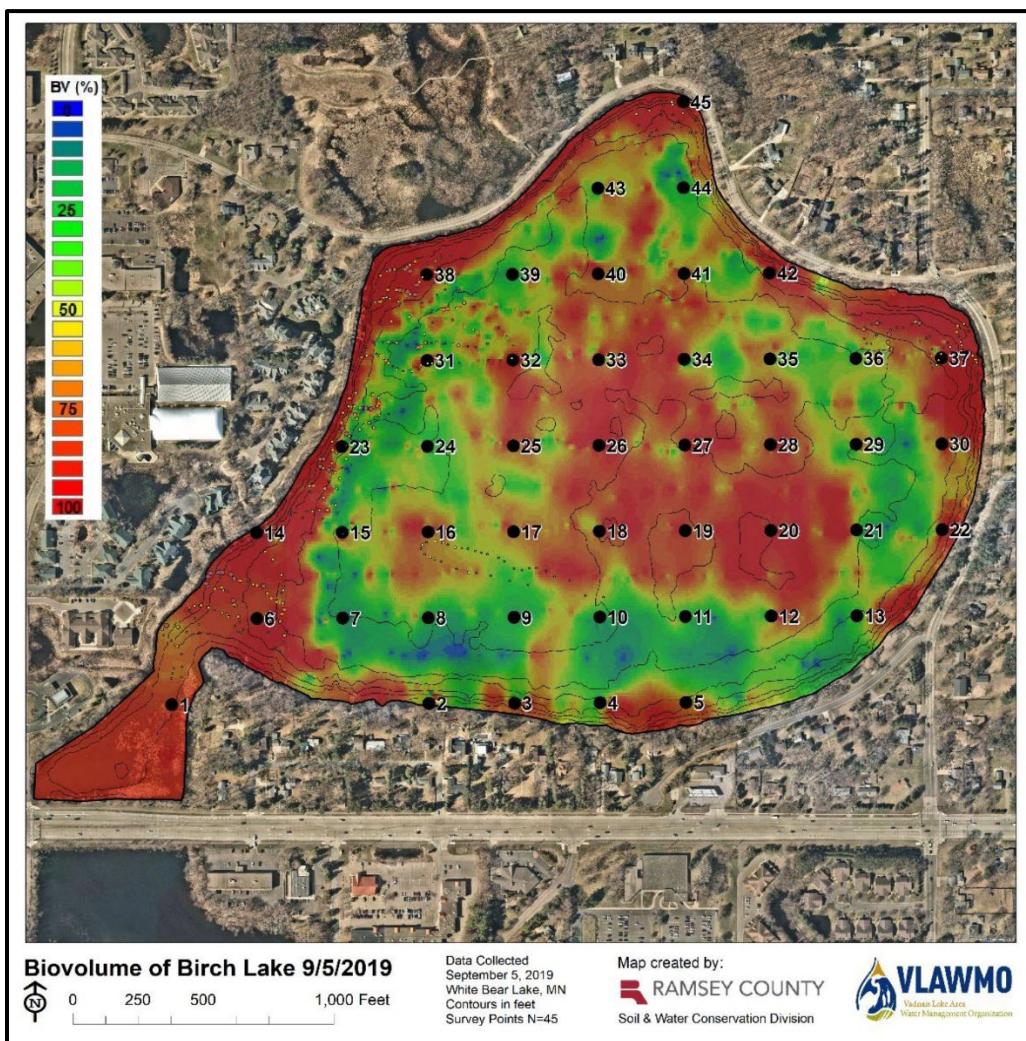
Figure 21: Birch Lake Biovolume

Ramsey Soil and Water Conservation Division conducted a biovolume and aquatic vegetation survey on September 5, 2019. Biovolume measures the density of plant life within the lake. Blue signifies 0% plant life, and red signifies 100% plant life. At depths greater than 4-6 feet, there is commonly no plant life in Minnesota lakes. Plant growth is limited because the sun does not penetrate the water column below those depths enough to allow photosynthesis to occur. Birch Lake has abundant plant life throughout the lake, even in its deepest pockets (Figure 21).

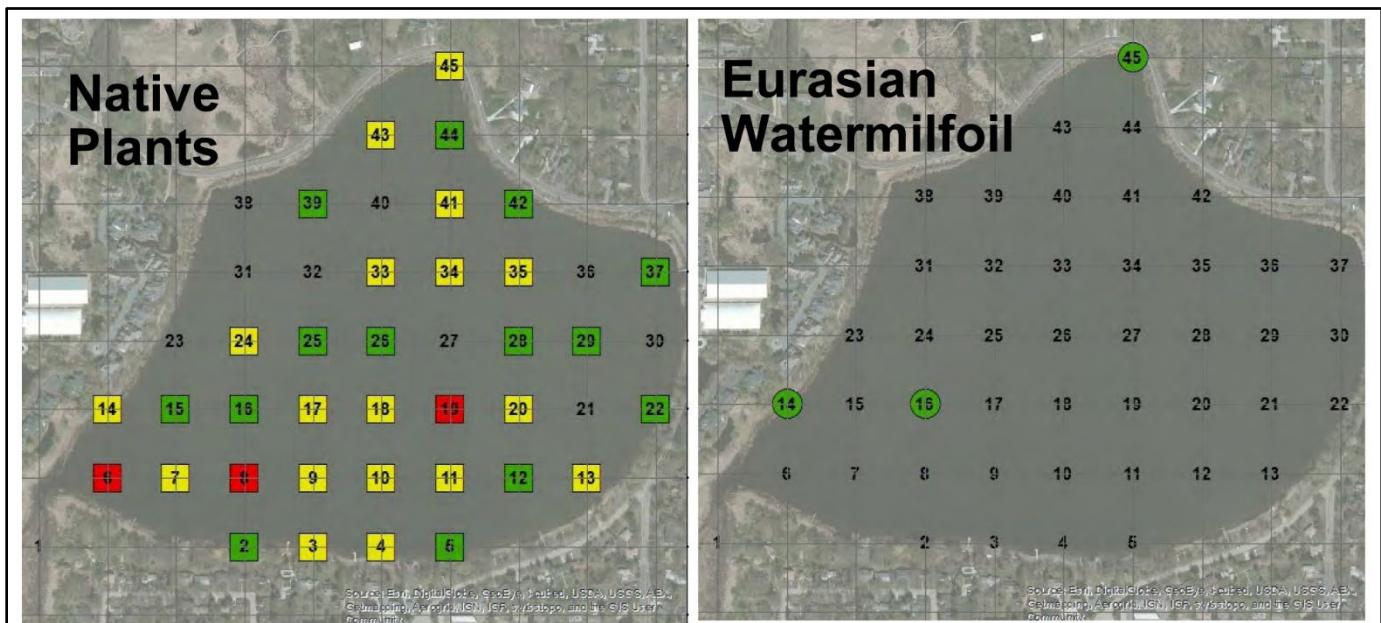
Figure 23 : Birch Lake Native Plant and EWM Locations 2013

Figure 4. Aquatic plant coverage maps for September 5, 2013.

[top] Native plant coverage was about 95 acres.

[bottom] Eurasian watermilfoil, a non-native species, coverage was about 8 acres.

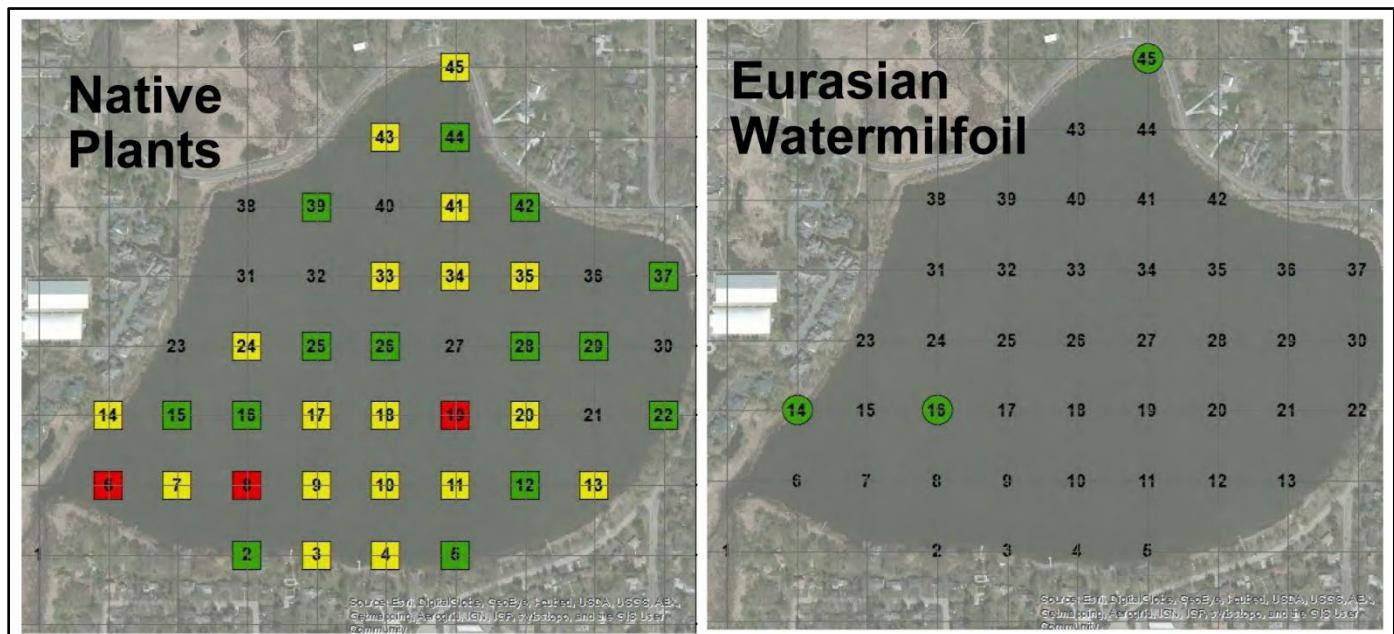
Figure 24: Birch Lake Native Plant and EWM Locations 2015

In 2015, aquatic plants in Birch Lake were checked at 13 points on September 8, 2015 using the same sites that were sampled in 2013. Results of the 2015 plant check indicated that aquatic plants were similar in abundance compared to the 2013 survey. In 2015, Fern pondweed and Water celery were the dominant plants, which was also the case in 2013. The plant community in Birch Lake in 2015 was similar to conditions in 2013. In 2013, the lake was about 1 foot lower in depth, and plants may have been closer to the surface. Plant distribution and coverage indicated that the lake remained in a healthy condition.

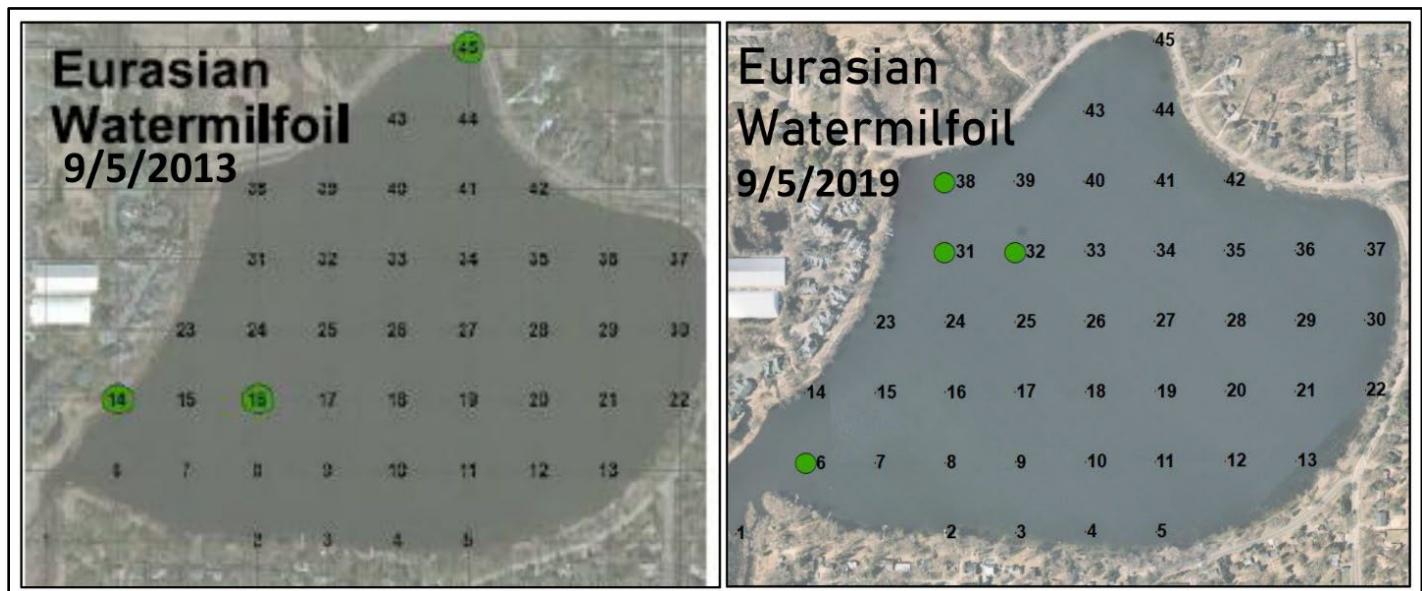
Figure 25: Birch Lake Native Plant and EWM Locations 2015 compared to 2019

Figures show the sections of Birch Lake where Eurasian watermilfoil had been detected in the 2013 survey (points 14, 16, and 45) as well as where it had been observed in the 2019 survey (points 6, 31, 32, 38). The northeast was also re-visited due to an EWM sighting between points 36 and 37 on 9/5/2019.

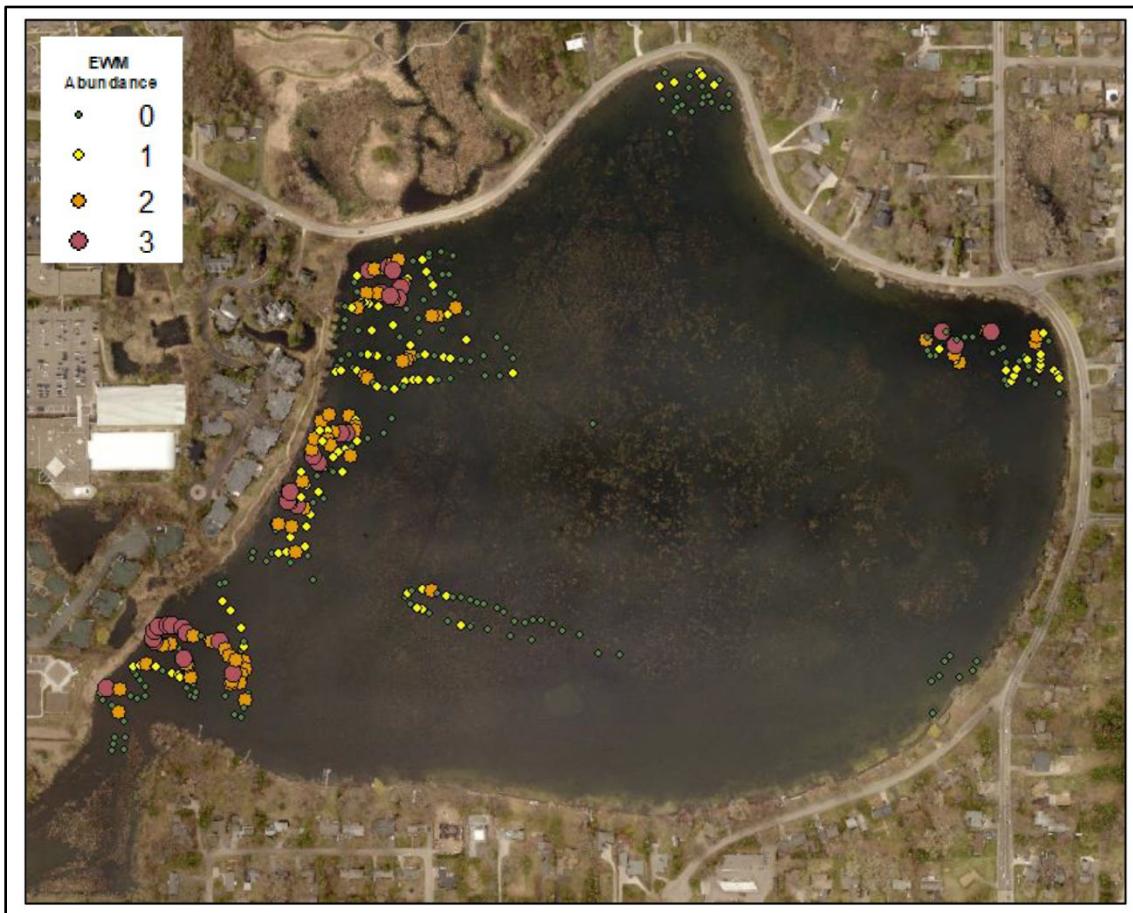
Figure 26: Birch Lake EWM Delineation 2019

Consistent with the MNDNR's manual *Guidance for Delineating Invasive Aquatic Plants for Management*, the target areas were transected in a zig-zag pattern while staff took GPS points to note observation locations and results. Observation points are indicated in the figure below for each target area identified.

Eurasian watermilfoil is widespread in Birch Lake, primarily along the western shoreline and the northeast corner of the lake. Due to the shallow littoral nature of Birch Lake, EWM is not restricted to the shore areas, although it is currently most prevalent in the 3-5 foot depth range. **Total acreage for Eurasian watermilfoil is about 11.4 acres, a rise from the 8 acres found in the 2013 survey.**

This is a 42.5% increase in EWM on Birch Lake.

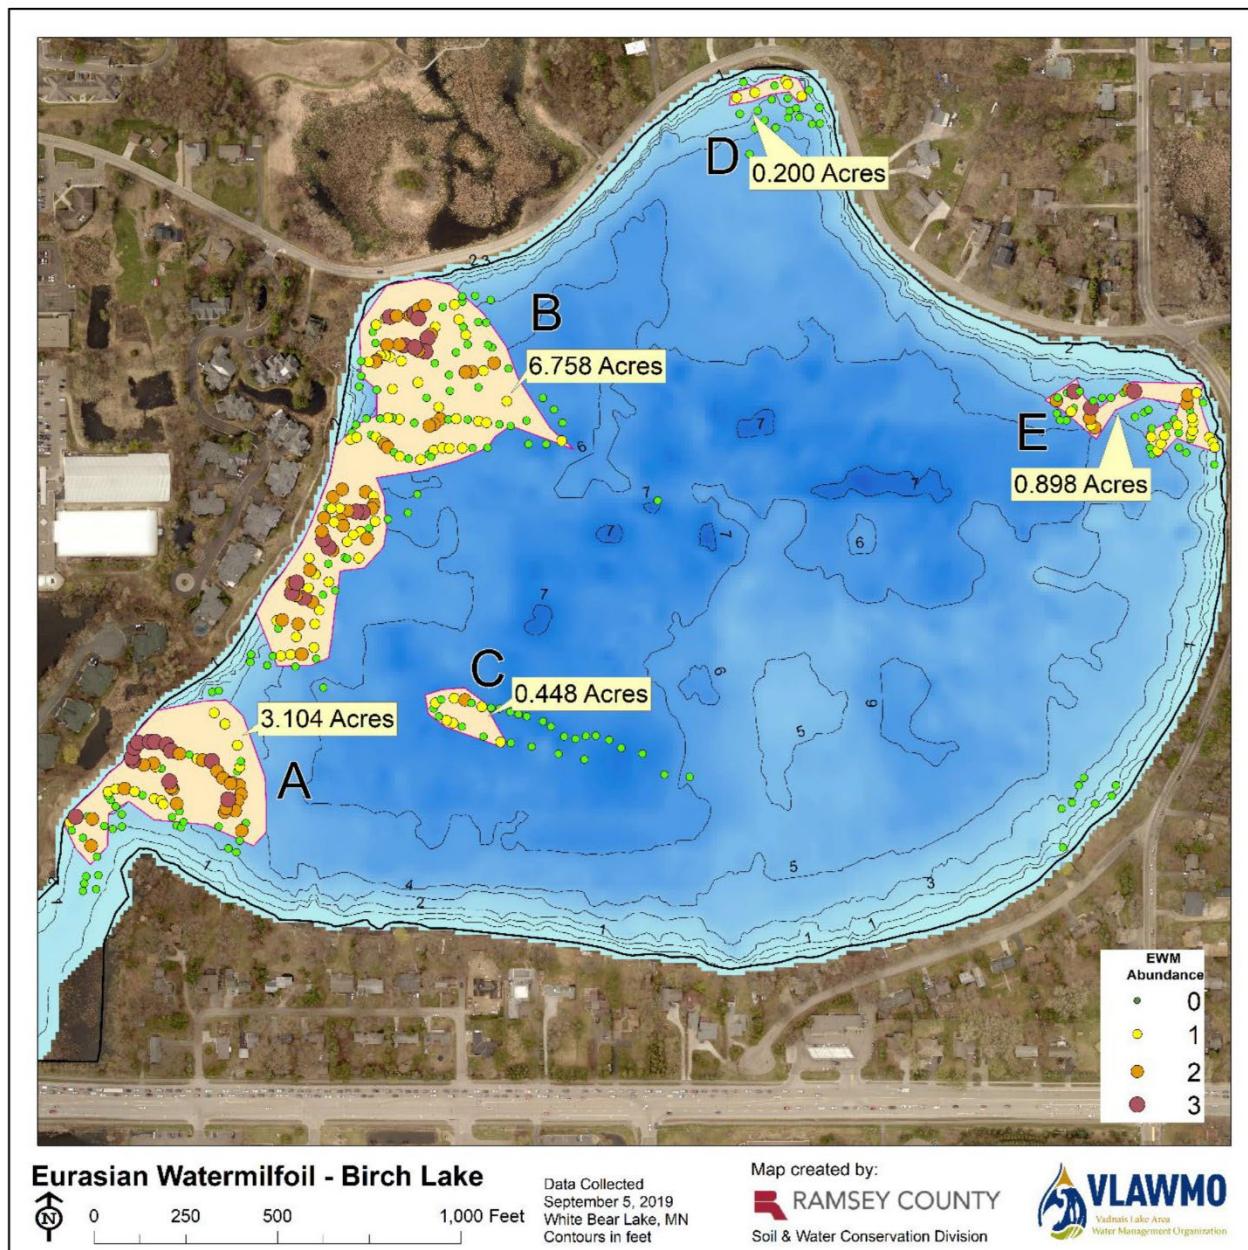
Figure 27: Birch Lake EWM Extent in 2019. Total coverage is 11.4 acres.

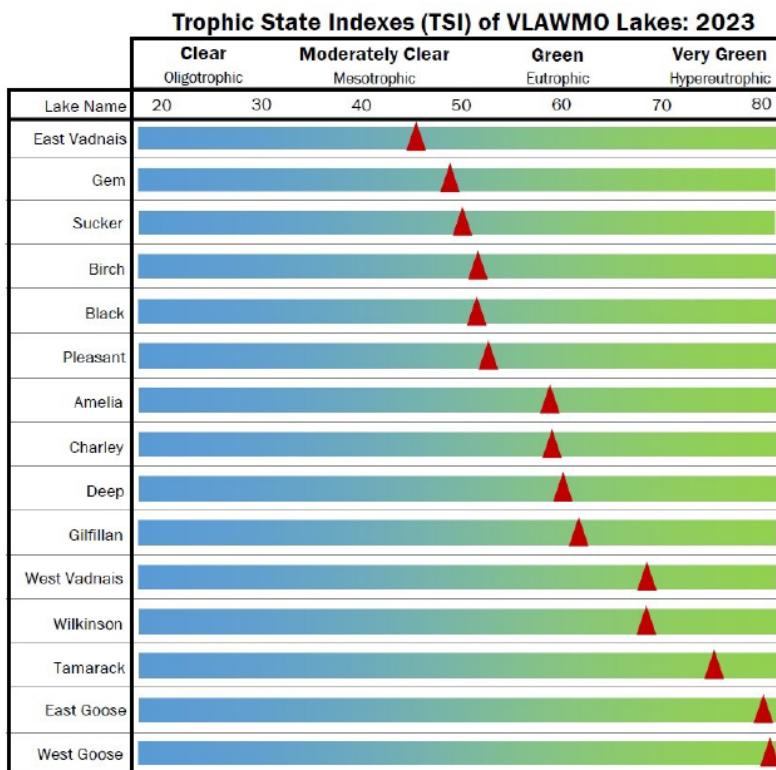
Figure 21: TSI scores for VLAWMO lakes

Birch Lake is shallow and falls between moderately clear/mesotrophic and green/eutrophic classification on the Trophic State Index (TSI) (shown below using the Carlson scale, MPCA). Birch Lake had recent scores of 48 (2022) and 51 (2023).

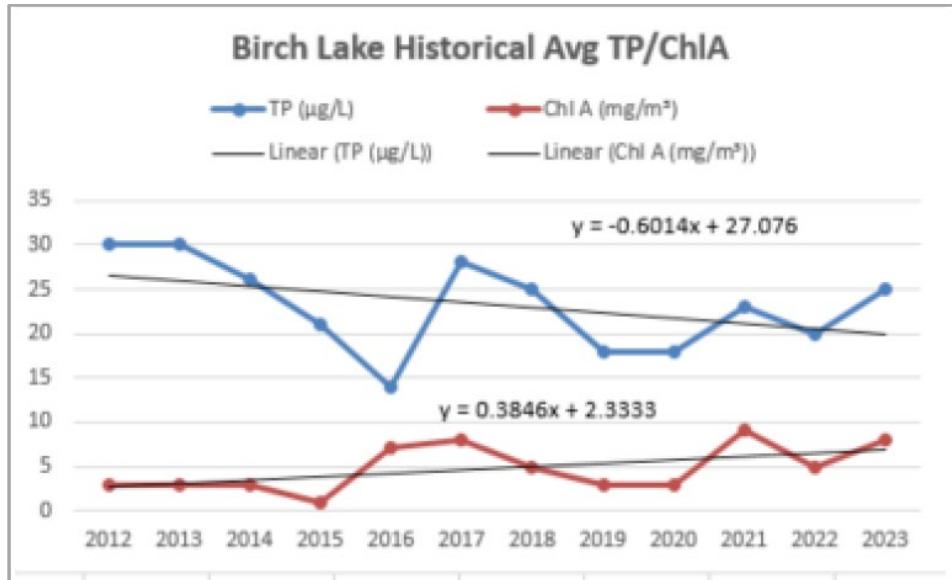
Figure 30: Historical Water Quality Averages in Birch Lake

Figure 30: The graph shows results of TP/Chl-a with a linear trend through time. TP levels are below the State Standard (60 $\mu\text{g/L}$). Chl-a hovers around the value of 5 mg/m^3 .
