VLAWMO

VADNAIS LAKE AREA WATER MANAGEMENT ORGANIZATION
Birch Lake Review,
Ramsey County, MN

2024

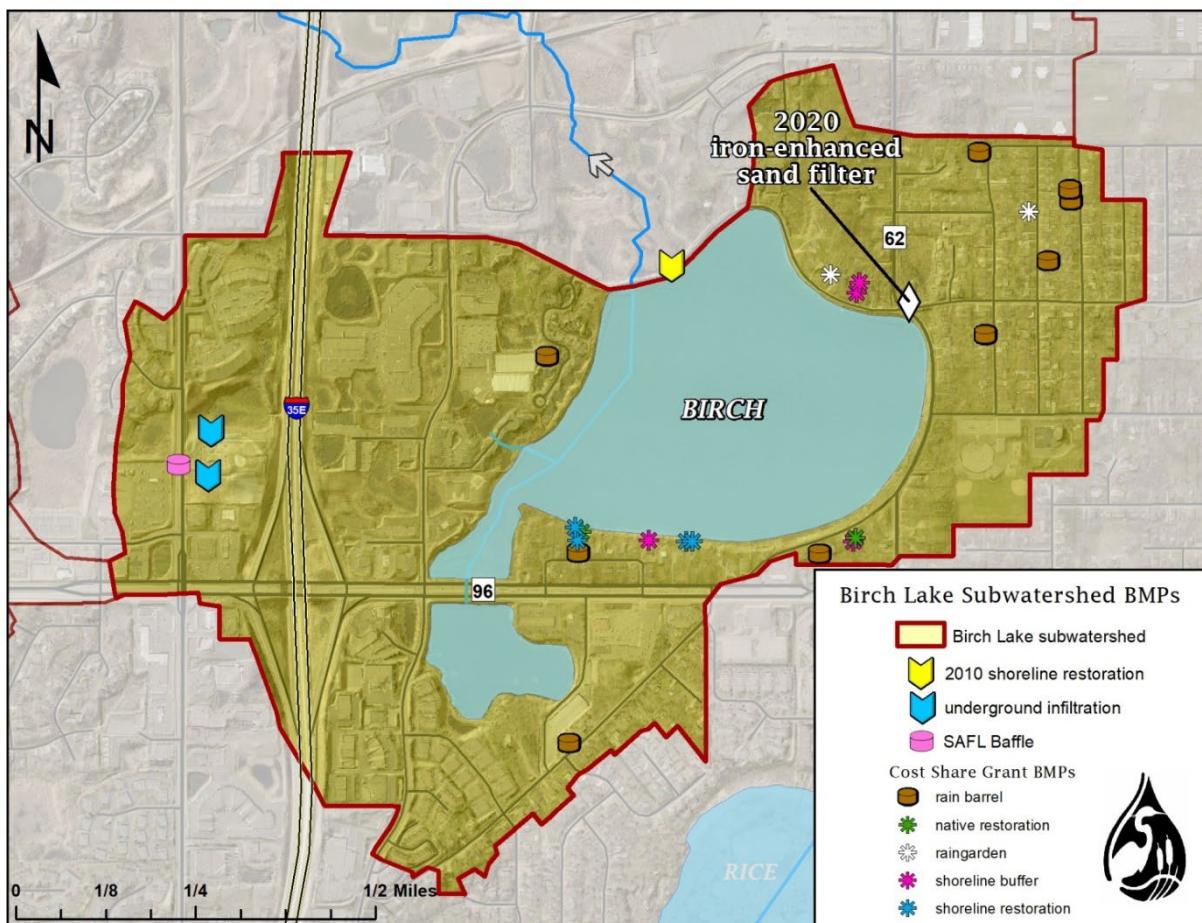
Figure 31: Birch Lake Subwatershed Implemented BMPs

Best Management Practices (BMPs) are implemented to improve and protect water quality. Common small-scale examples of BMPs include raingardens, infiltration basins, shoreline restorations, rain barrels, and native plantings. Larger BMPs include stormwater retention basins, iron-enhanced sand filters, weirs and stormwater conveyance retrofits, and in-lake treatments such as an alum treatment, rough fish management, or aquatic vegetation management. Many smaller-scale BMPs have been implemented in the subwatershed area. An iron-enhanced sand filter was constructed on the northeast corner of the lake in 2020 to treat stormwater and reduce nutrient loading input into Birch Lake. This filter is being constructed at a hotspot nutrient input location identified by retrofit analysis.

Summary of BMPs implemented:

- Large shoreline restoration on the north shore of Birch Lake, completed in 2010. The maintenance agreement was reauthorized for an additional 10 years in 2024. Maintenance is completed by VLAWMO with partnership from the City of White Bear Lake.

- Development of the Pillars senior living facility in 2017, Lunds & Byerlys grocery store in 2018, and subsequent reconstruction of Centerville Road prompted installation of underground infiltration cells and SAFL Baffle stormwater treatment.

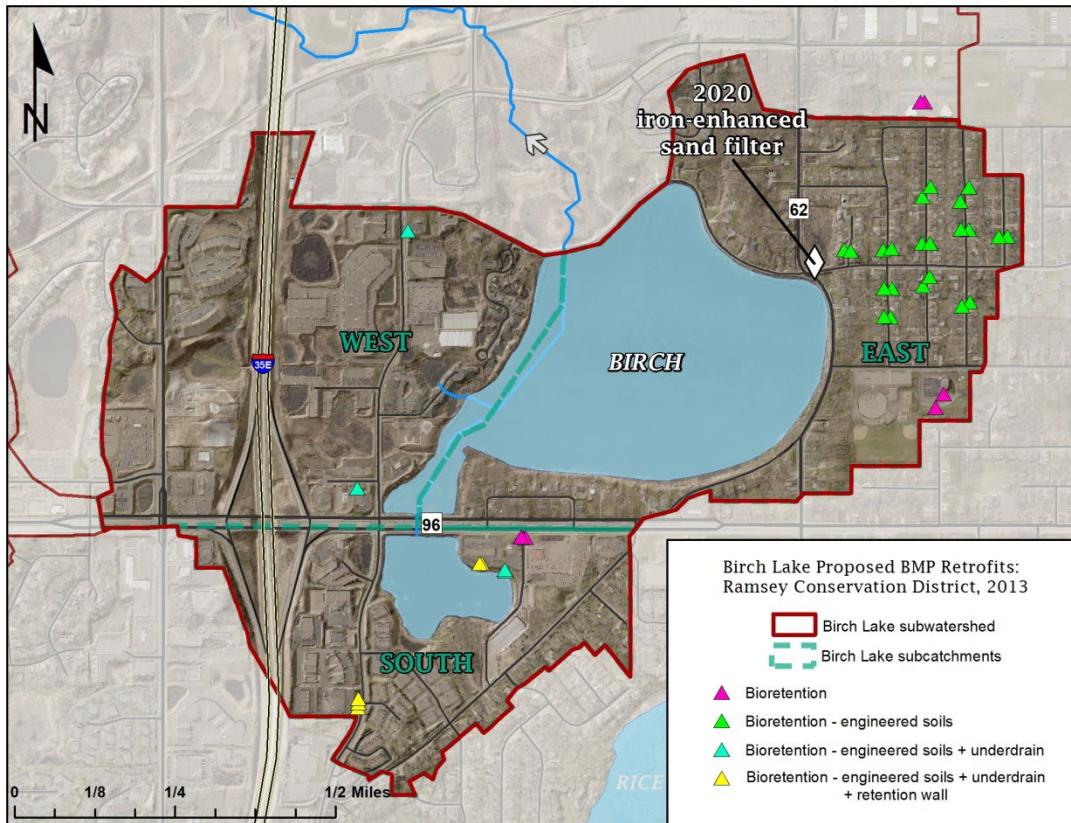
Retrofit locations were identified for the east, west, and south subwatershed areas of Birch Lake.

Figure 32: Retrofits identified for the Birch Lake subwatershed. The east side of the subwatershed had the most options. The iron-enhanced sand filter project (for construction in 2020) was selected for implementation for large-scale treatment of the storm sewer system, rather than individual residential raingardens.

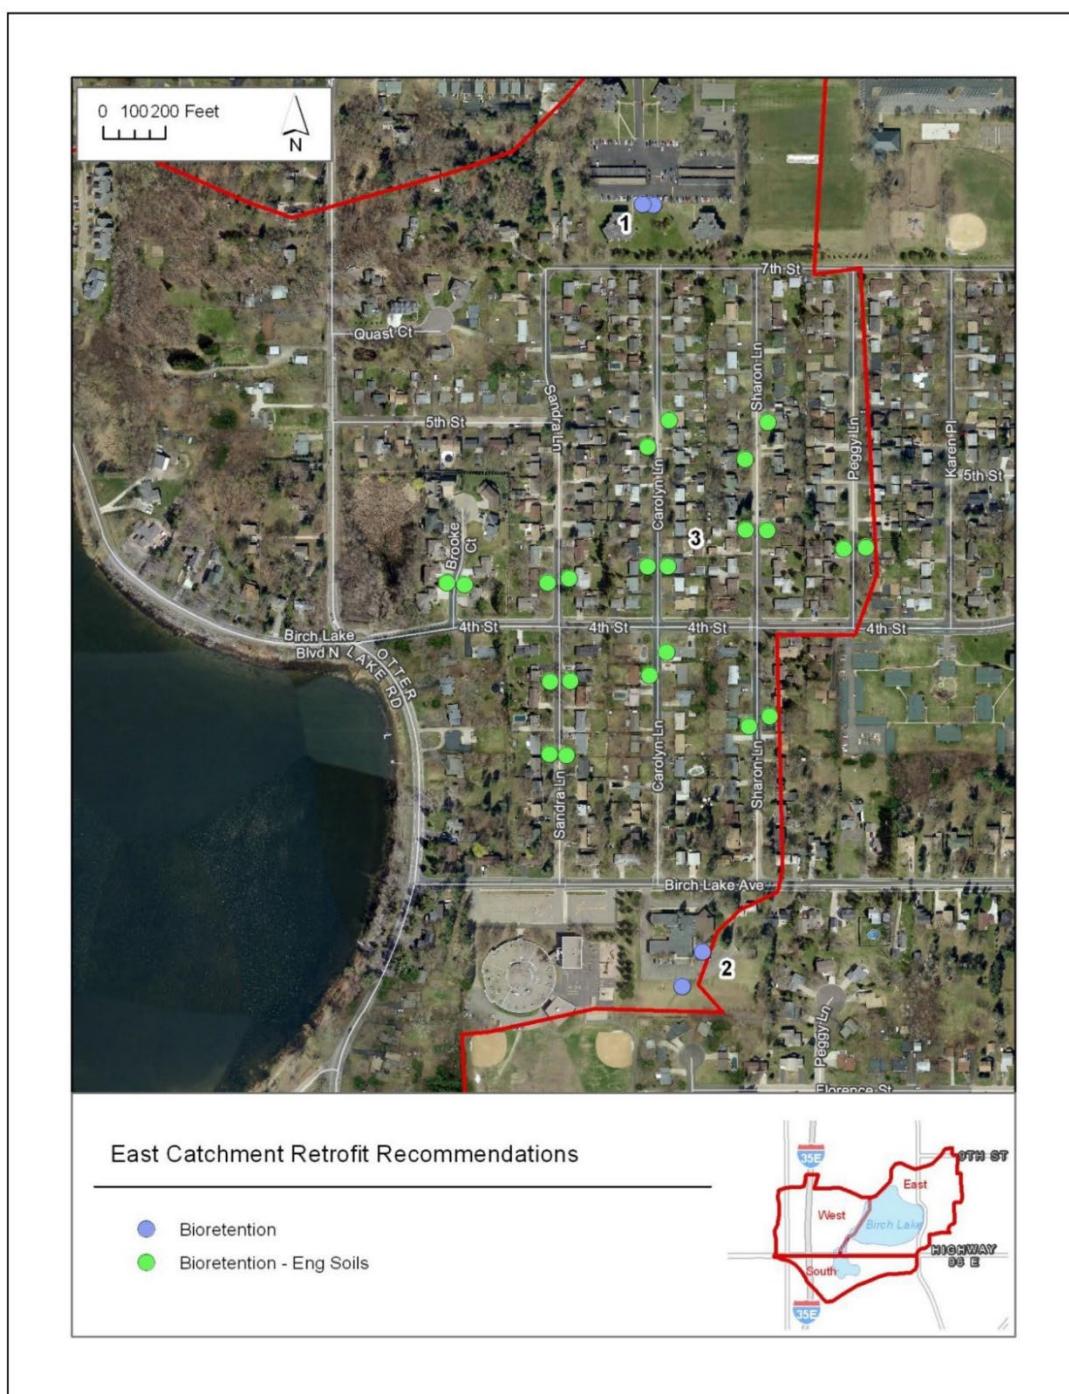
Figure 33: Retrofits identified for the east side of Birch Lake.

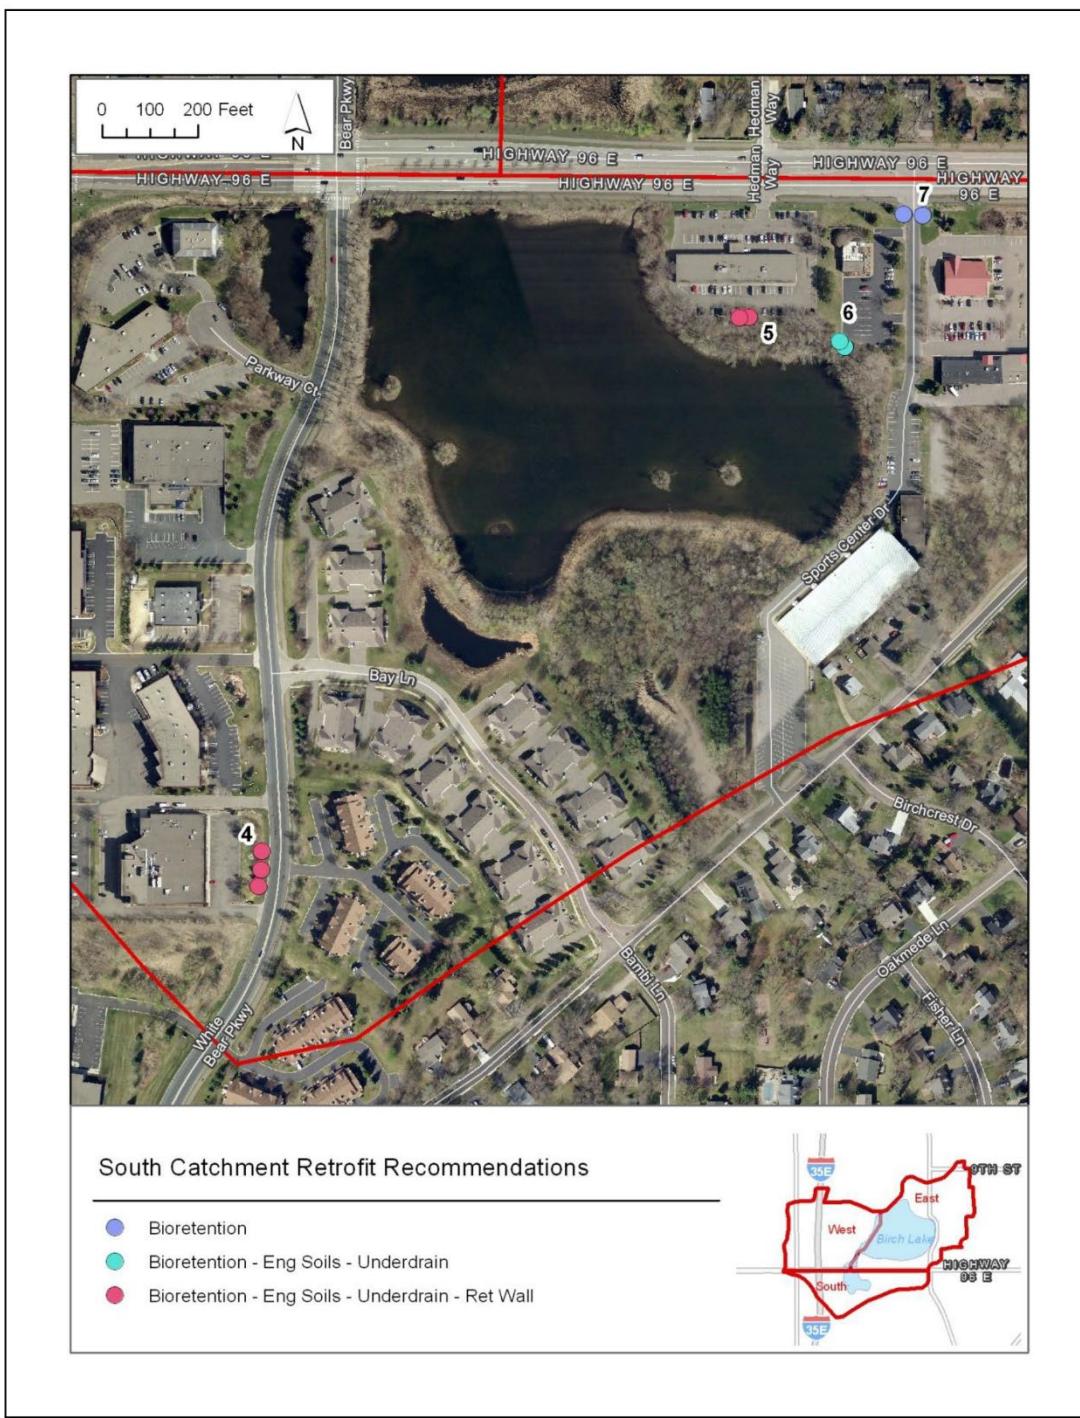
Figure 34: Retrofits identified for the south side of Birch Lake. Nine locations were identified for this side of the lake.

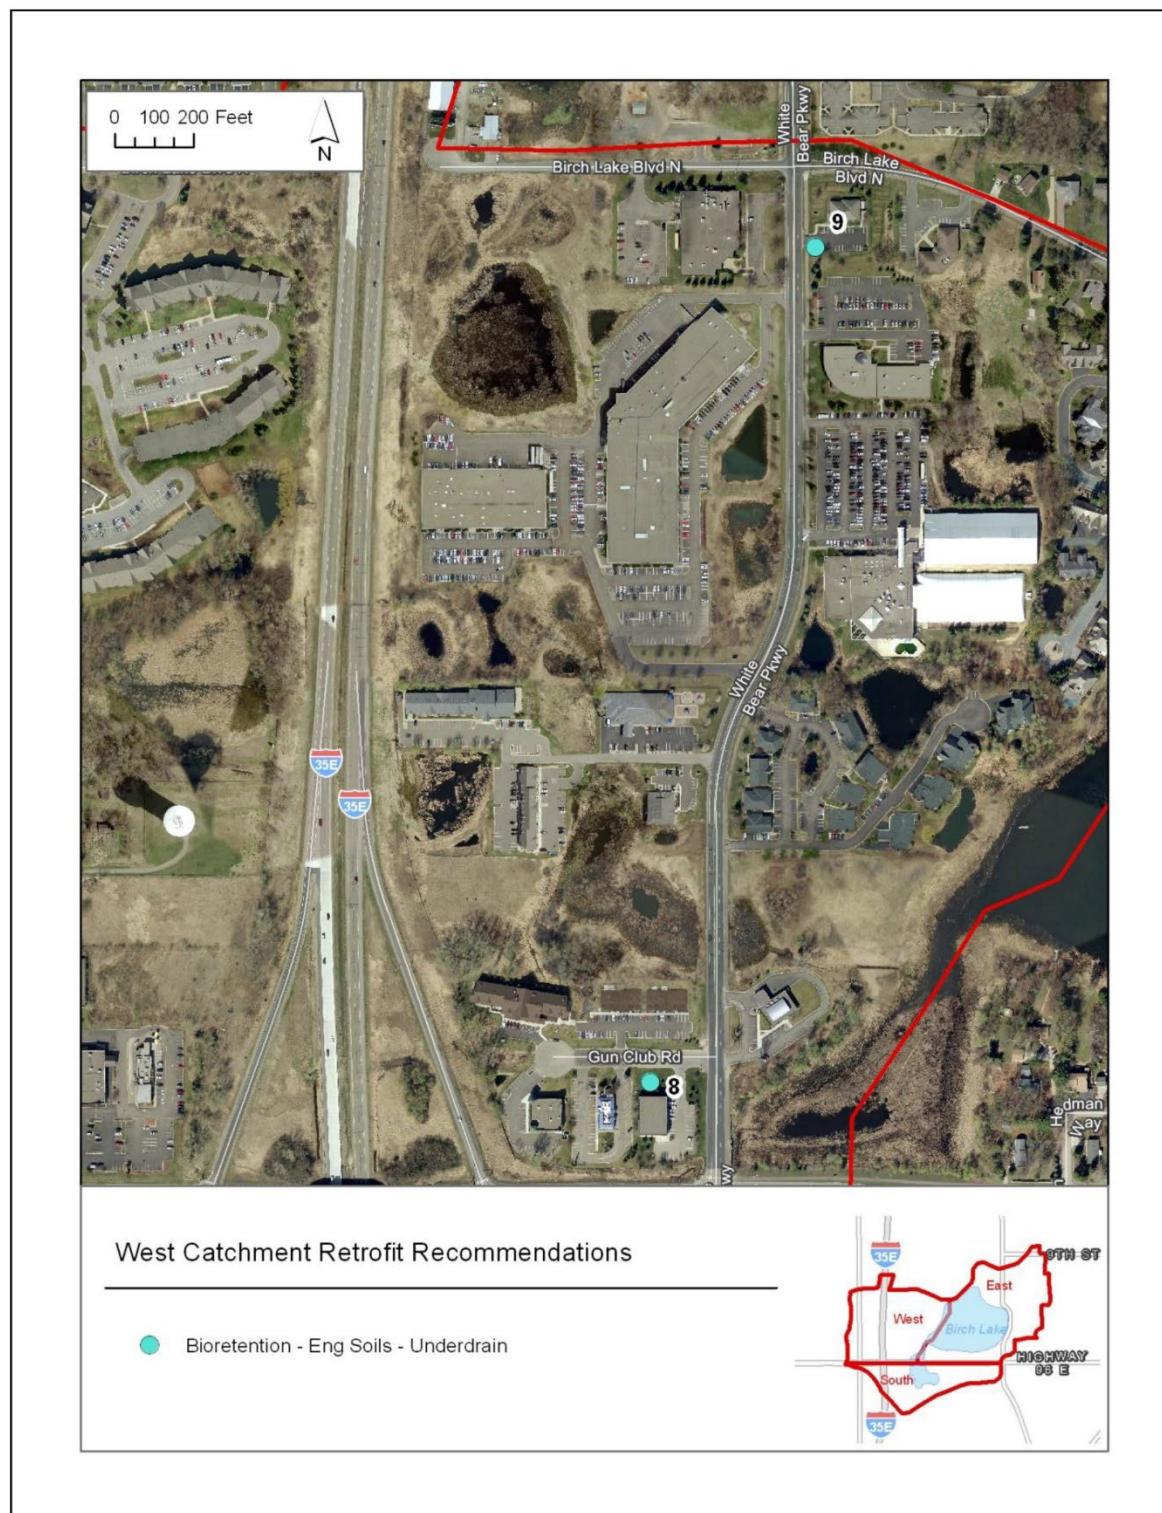
Figure 35: Retrofits identified for the west side of Birch Lake. Only 2 locations were identified for this side of the lake.
