VADNAIS LAKE AREA WATER MANAGEMENT ORGANIZATION
Pleasant Lake Review,
Ramsey County, MN

2024

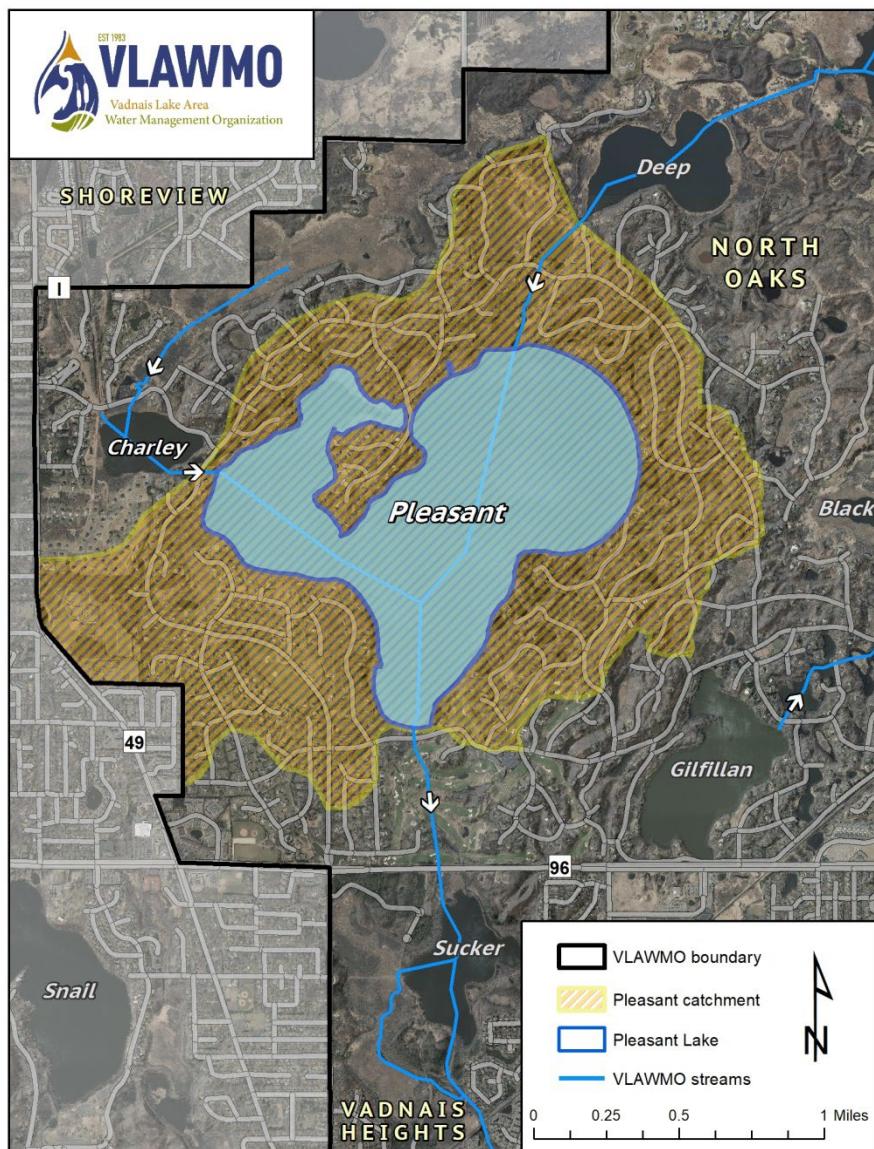
Figure 9: Pleasant Lake Drainage Area

Pleasant Lake receives direct inflow from Charley Lake as part of the SPRWS water network that moves water from the Mississippi River to McCarrons Water Treatment Plant. Water is pumped into Charley Lake, flows via a channel into Pleasant Lake, links via an underground culvert network into Sucker Lake, and then to East Vadnais Lake via Pleasant Lake Channel that flows west from Wilkinson Lake. A **subcatchment** is an area of land that drains locally to a central location. The subcatchment drainage area surrounding the Lake is comprised of an area of 1,852 acres; Pleasant Lake itself is 625 acres. The subcatchment to surface area ratio is relatively low; however, the effective subcatchment of Pleasant Lake includes the Mississippi River.

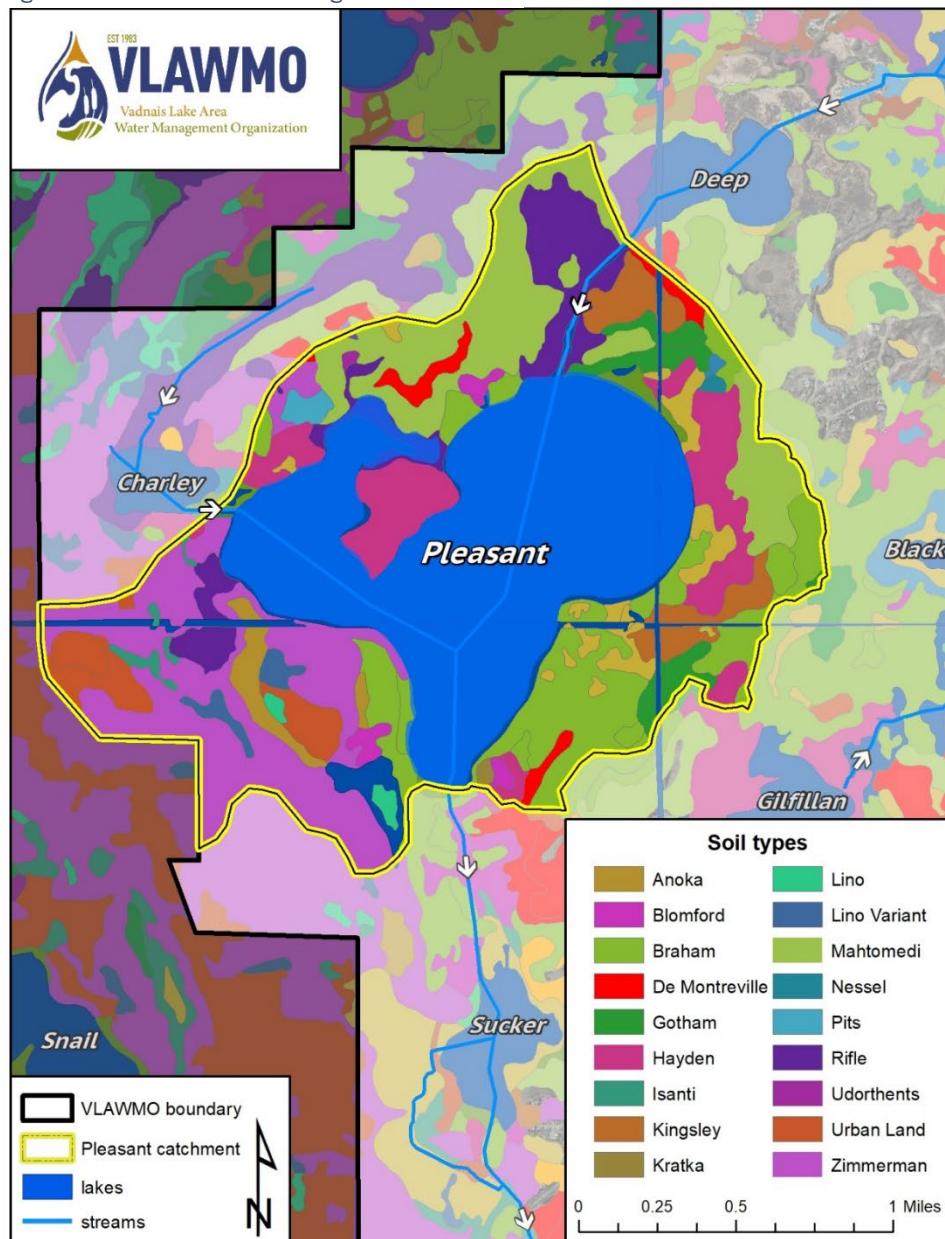
Figure 11: Pleasant Lake Drainage Soils

A variety of soil types are found around Pleasant Lake. Dominant types include: Mahtomedi, Braham, Hayden, Blomford, and Rifle. Areas that were developed first tend to have deep, well-drained to excessively drained soils. Runoff is low in these areas; permeability tends to be fairly rapid. These areas include: Mahtomedi, Braham, and Hayden soil types in the north, south, and eastern areas. Hayden soils make up the peninsula. These soils are fine, sandy loam that is well drained, surface runoff is medium to rapid, and permeability is moderate. Blomford soils, to the west, and Rifle soils, along the Deep Channel to the north, are deep, poorly drained soils. Blomford soils consist of loamy, fine sand. Rifle soils consist of muck and are common in wetlands and bogs. Source: UC-Davis, *SoilWeb*.

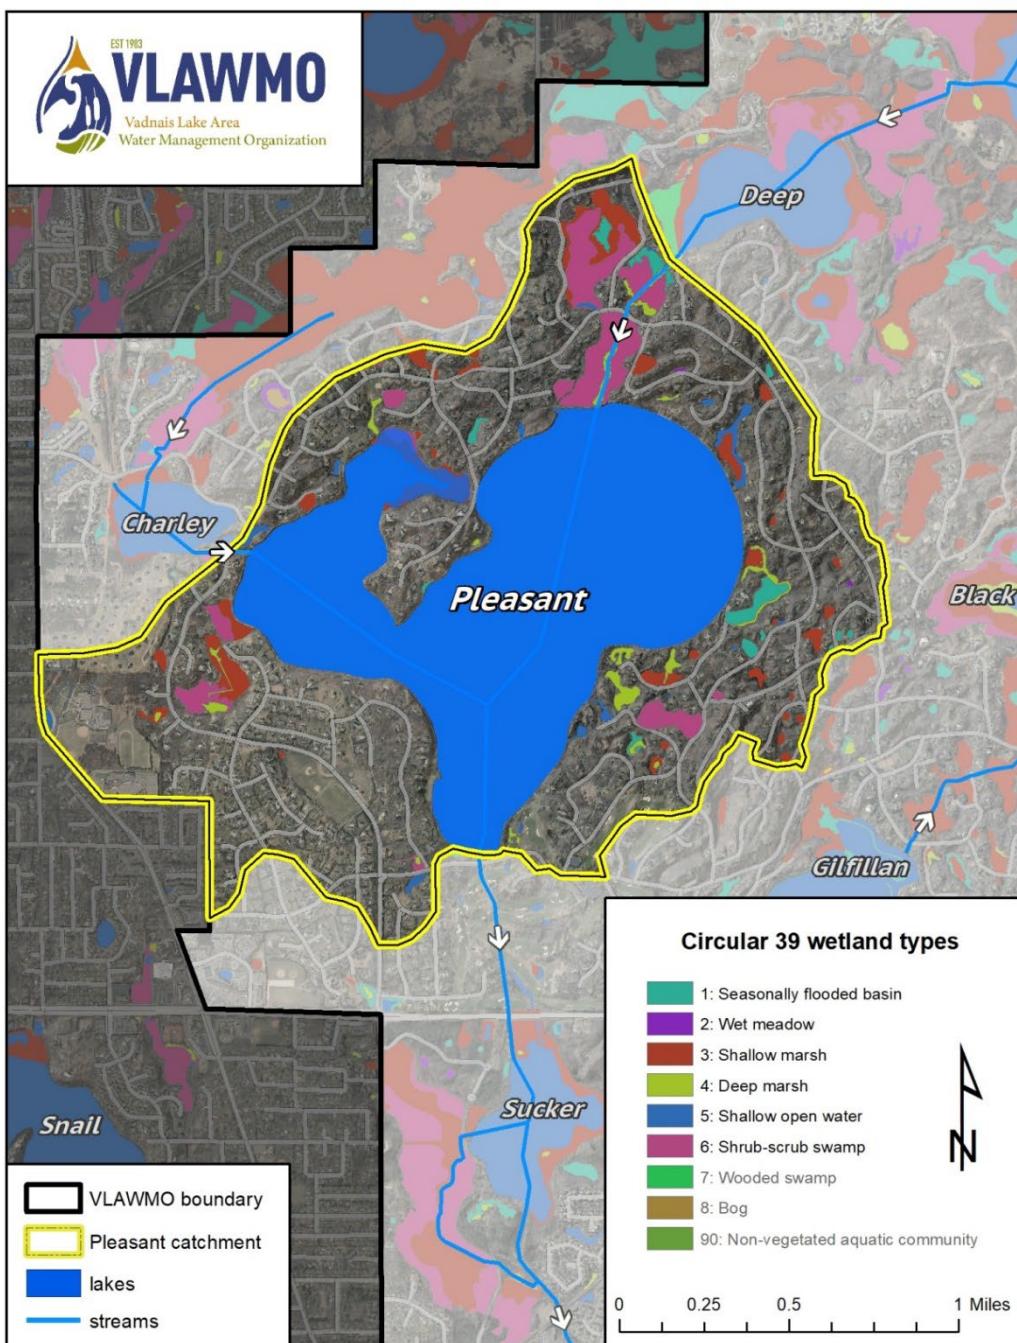
Figure 12: Pleasant Lake Drainage Wetlands

Areas around Pleasant Lake have been the focus of development over recent decades. Wetland areas have been slightly reduced. Some areas remain, especially along the Deep Lake Channel, along the eastern shore, and a small area on the western shore. These wetlands are primarily shrub-scrub (type 6) wetland fringes, shallow marsh (type 3), and deep marsh (type 4).

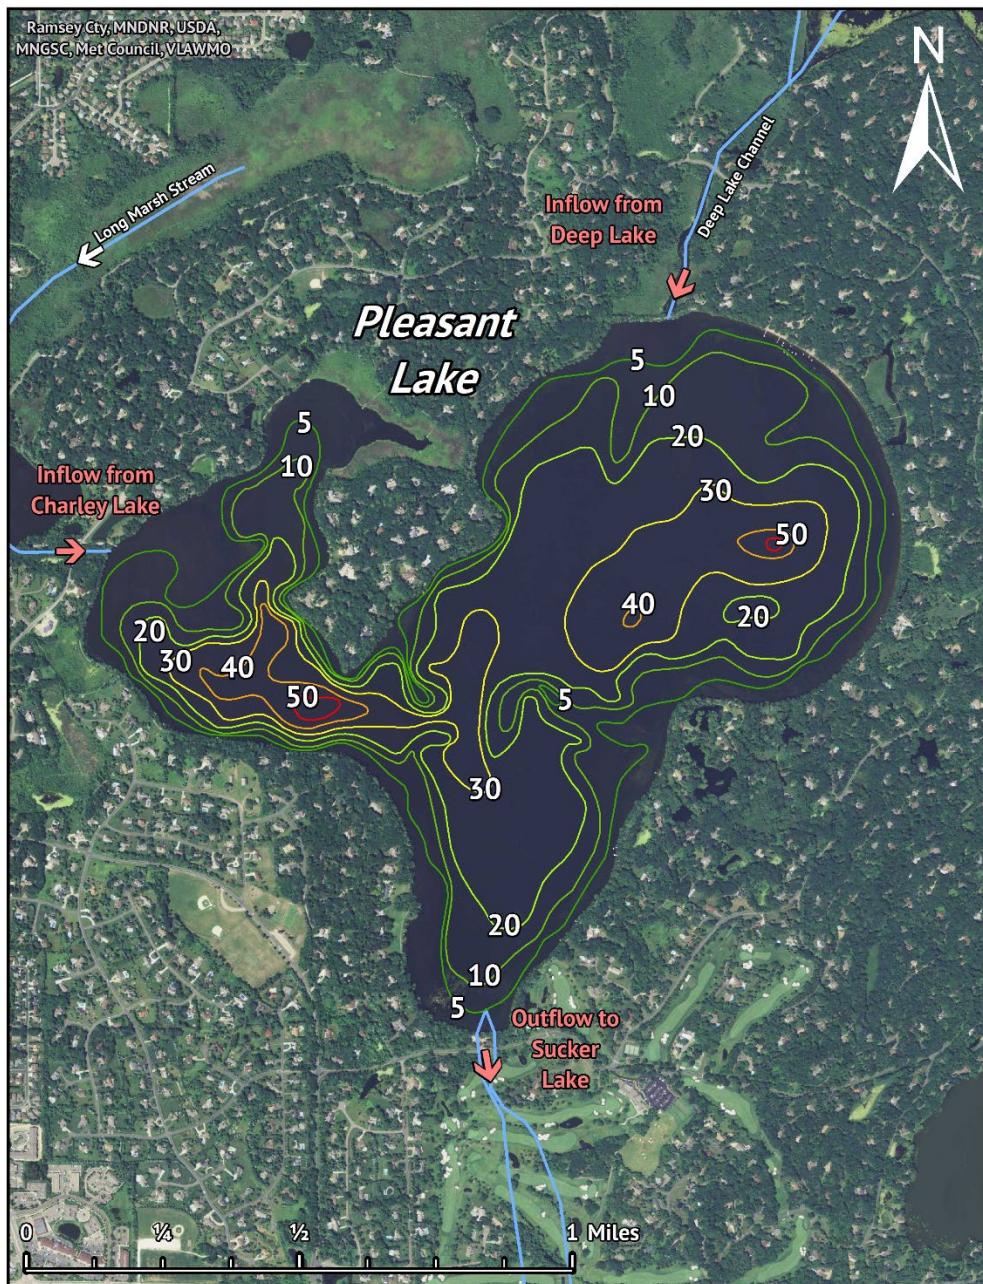
Figure 14: Pleasant Lake Depth Map

Pleasant Lake has a maximum depth of 58 feet. It generally follows a typical lake bottom shape, with shallower areas along the outer portions of the lake and deeper sections towards the middle. Pleasant Lake has 2 deep pockets, 1 in each basin of the lake. The size and shape of Pleasant influence the way wind moves across the lake and contributes to erosion. Locations especially prone to erosion include the peninsula, SW tip, and NE shoreline. Bathymetry was updated in 2023. The resulting figure is shown below with 0.3 m contours.

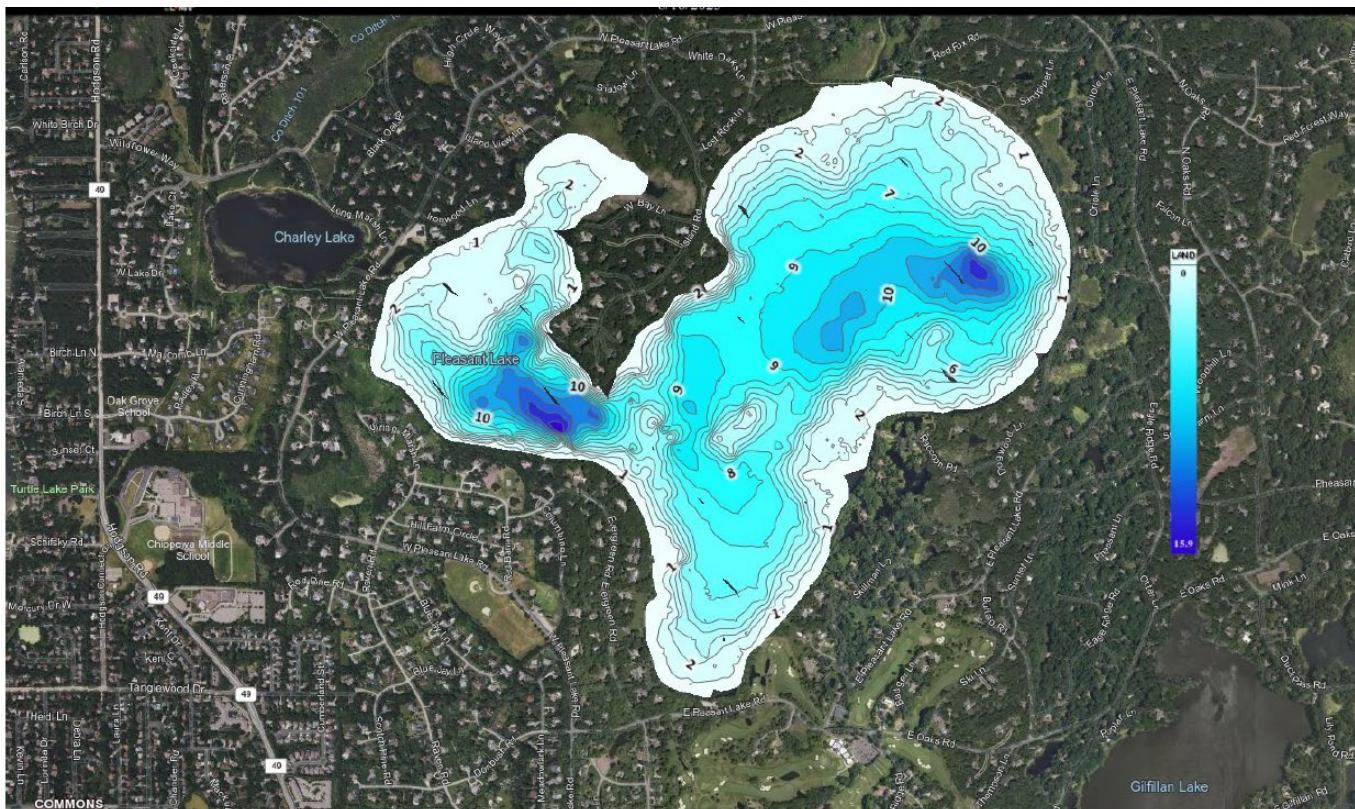
Figure 15: Pleasant Lake 0.3-m contours with depth in meters taken on August 18, 2023

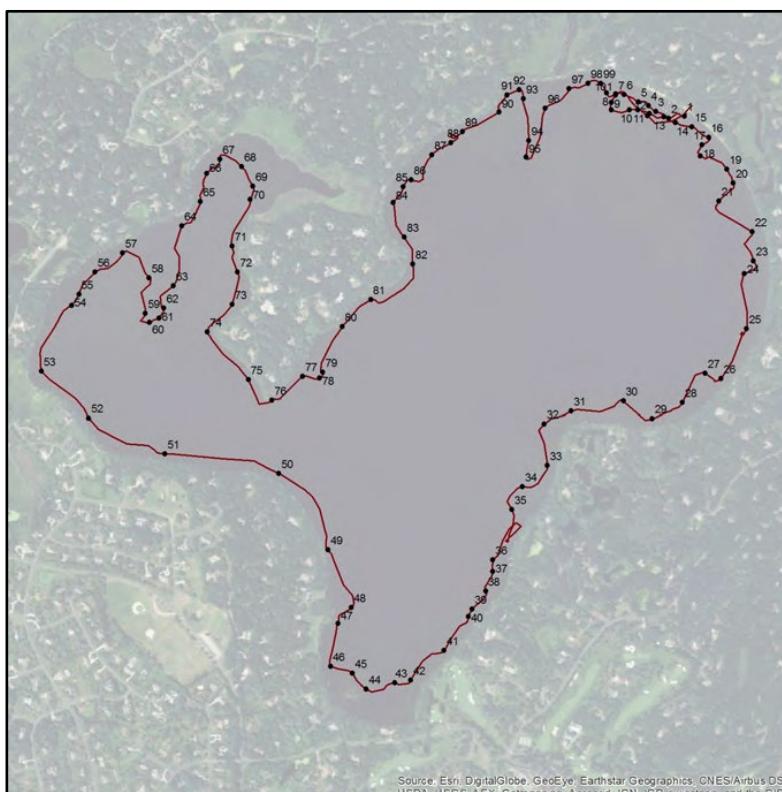
Figure 16: Pleasant Lake Aquatic Plant Survey Points 2018

Abundance in Blue Water Science reporting was calculated as a percentage of total points and density at each point on a 1-5 scale (5 = most dense). Data were collected at 102 points, located in the littoral zone. Coontail was the dominant species sampled. It was found at 81/102 (79%) points. Overall, 14 species were documented, 2 of which are invasive. Eurasian watermilfoil was found at 11 points; Curly Leaf pondweed was found at 12 points. Mechanical removal was recommended for the swimming area and boating areas. For more information, see the Pleasant Lake Aquatic Plant Delineations.

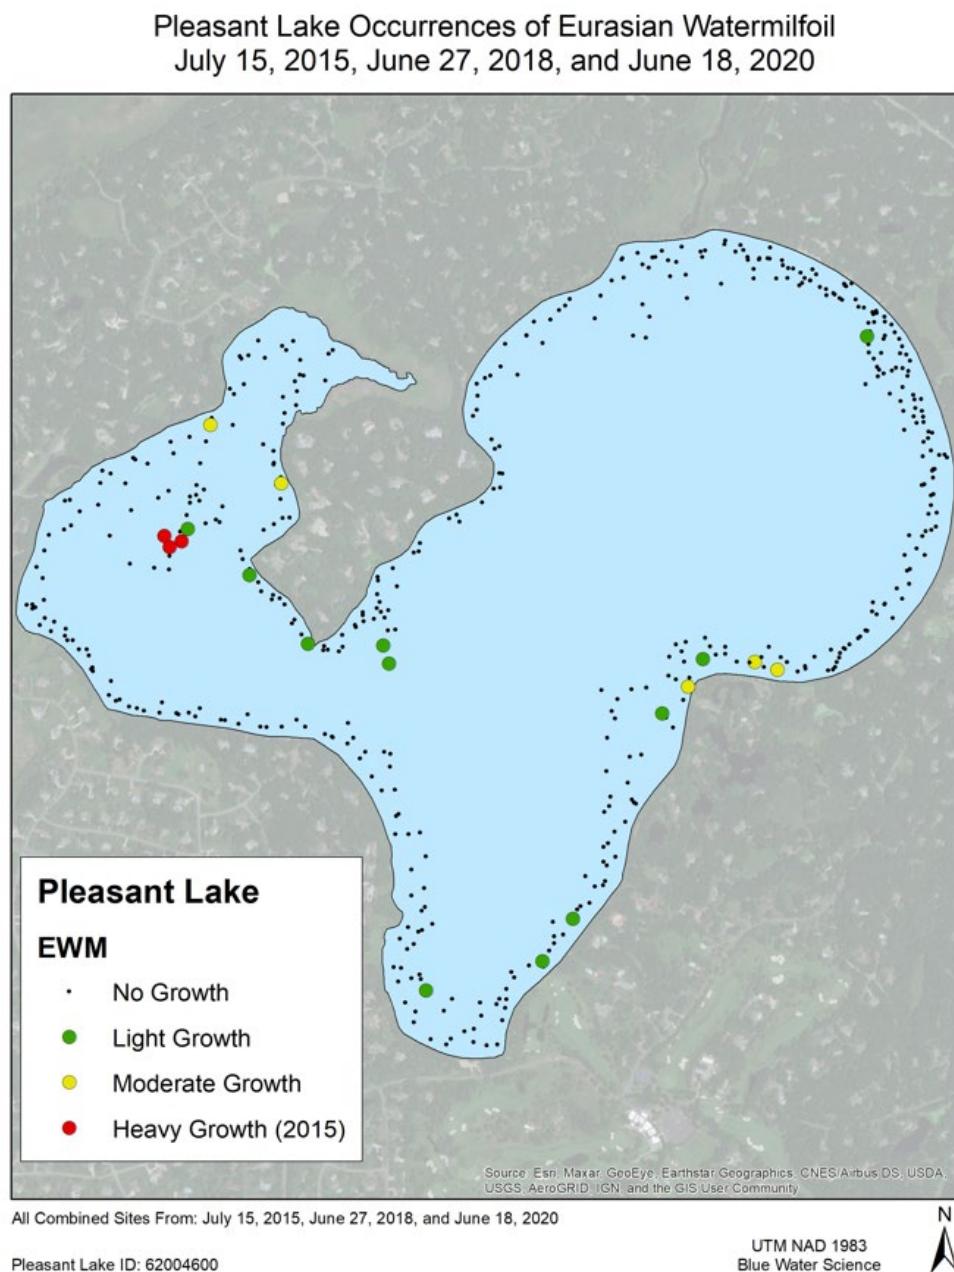
Figure 17: Eurasian Watermilfoil distribution and density by Blue Water Science, combining data from 2015, 2018, and 2020. Numbers are the designation for the sample point ($N = 102$). Points shown indicate Eurasian Watermilfoil present. Color codes for density are: green = light, yellow = moderate, and red = heavy growth.

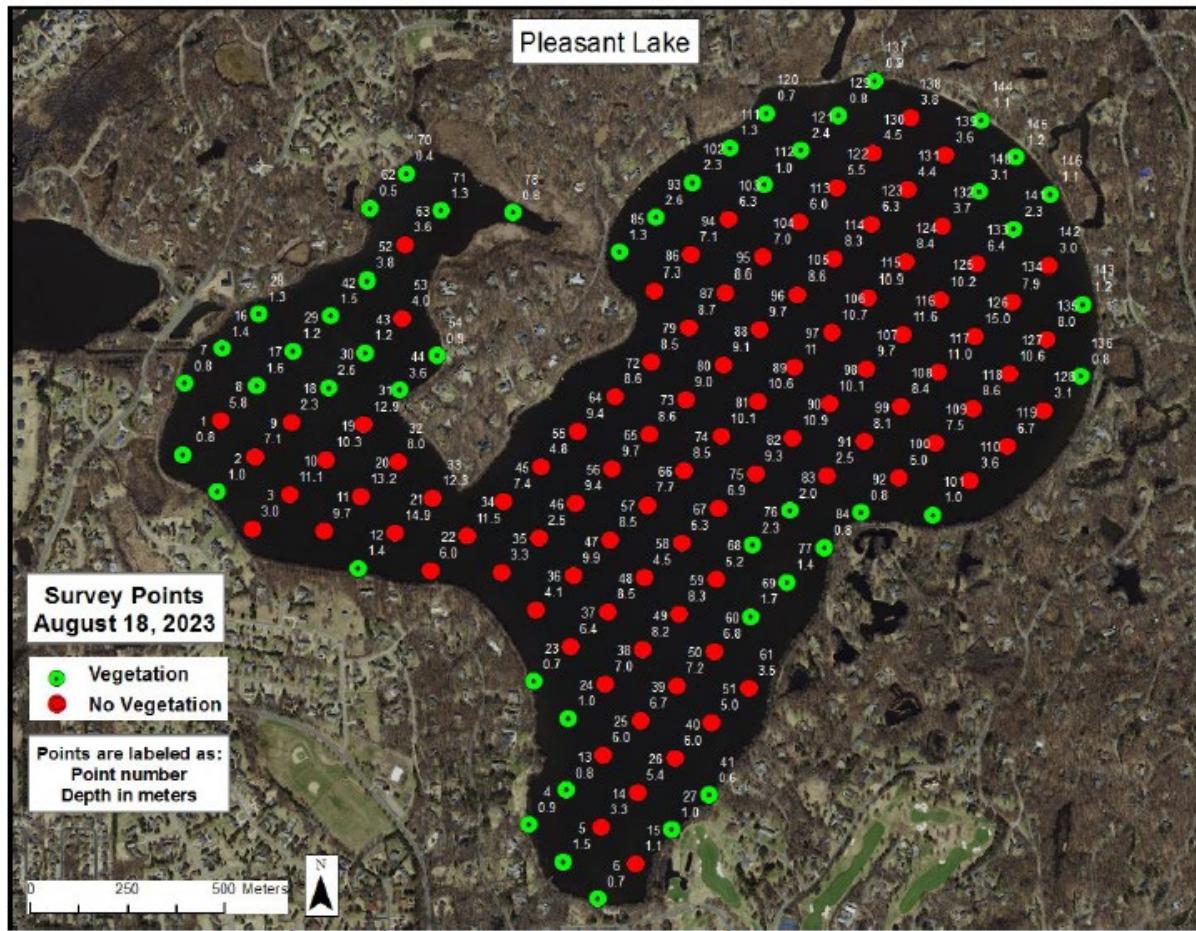
Figure 18: Aquatic Vegetation sample points from 2023

Figure 2. Pleasant Lake vegetation point intercept survey locations. N=146.

The aquatic vegetation and biovolume was updated in 2023 as shown below. A final graphic was reported to show the extent of open water vs. vegetation, which showed that ~80% of Pleasant Lake has no or only light aquatic vegetation. 17 species were detected on this survey in 2023, 2 of which are invasive.

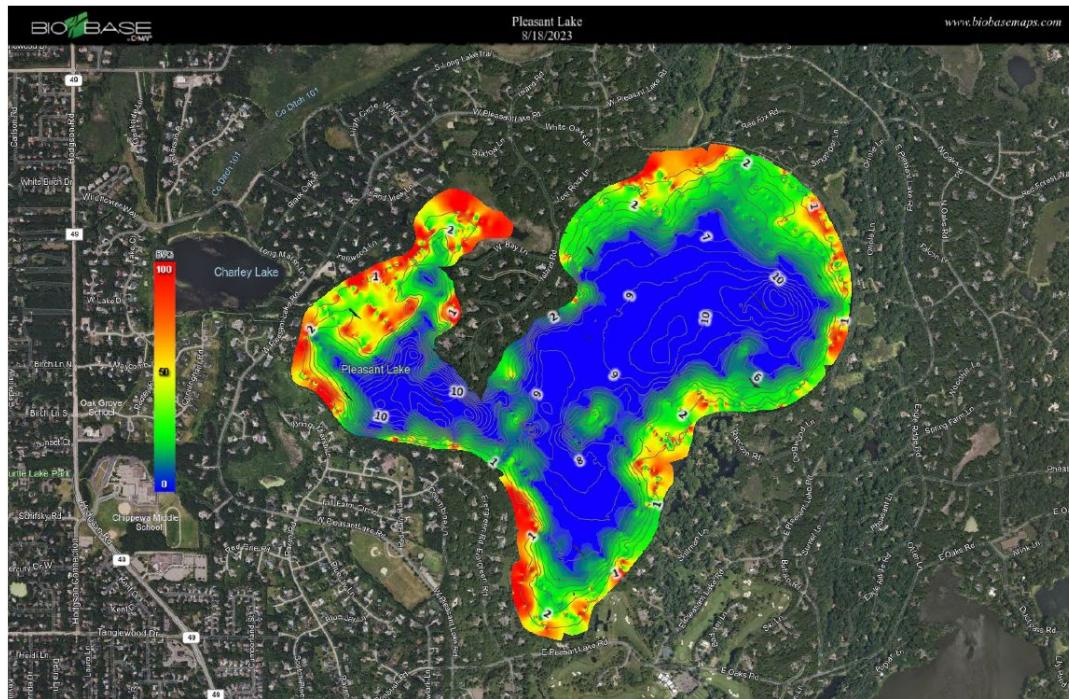
Figure 19: Pleasant Lake vegetation biovolume with 0.3-m contours taken on August 18, 2023. Percent values range from zero to one hundred; Blue = 0%, Yellow = 50% and Red = 100%.

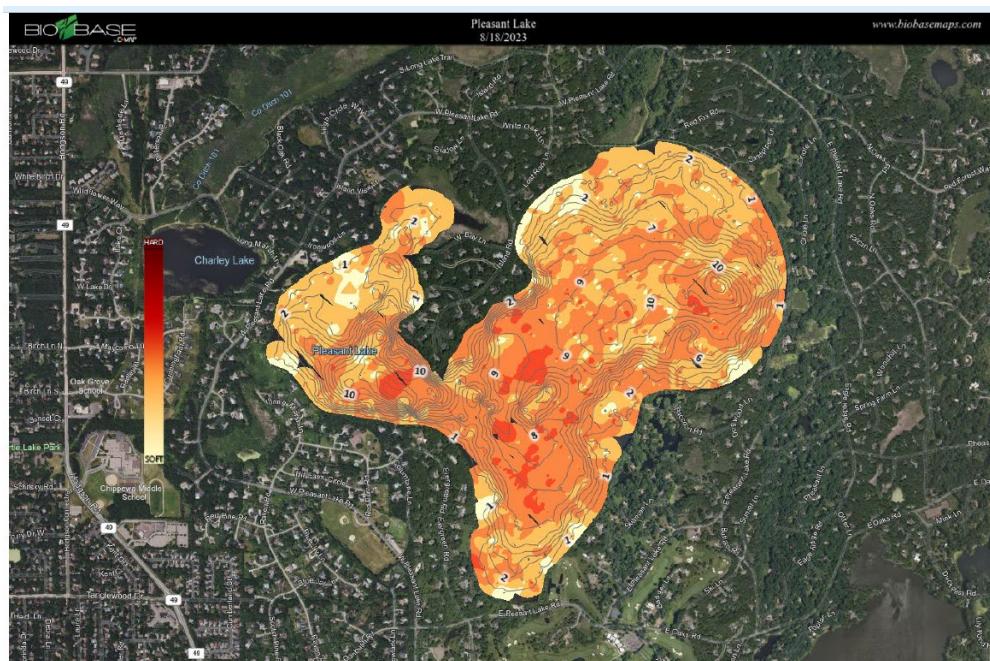
Figure 20: Pleasant Lake bottom composition values with 0.3-m contours taken on August 18, 2023.

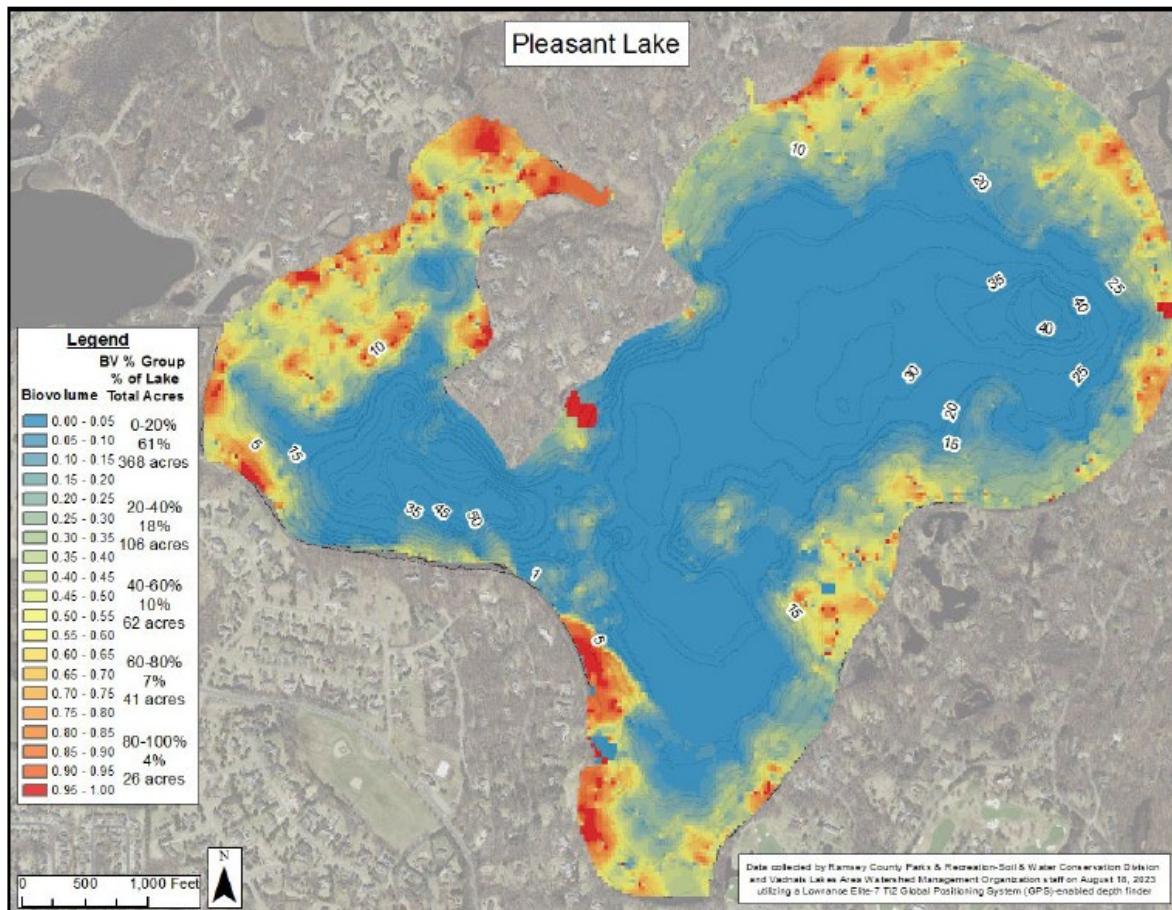
Figure 21: Pleasant Lake vegetation biovolume on August 18, 2023. Percent values range from zero to one hundred; Blue = 0%, Yellow = 50% and Red = 100%. Quintiles by percent and total acres of the lake.

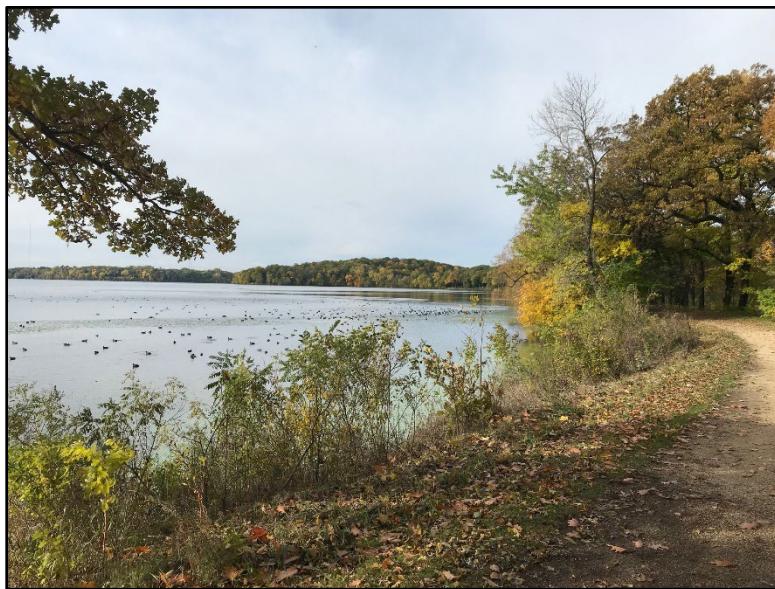
Shoreline buffer zone and gravel trail on Pleasant Lake. Photo by Tyler Thompson.

Buffer zones provide protection for water bodies and are a focus of management efforts statewide. The North Oaks community incorporates buffer zones into planning and ordinances. NOHOA owns the buffer zone area around Pleasant Lake. The shoreland ordinance states that: “Vegetation may not be altered, trimmed, or removed within 20 feet of the ordinary high water level of any public water without first obtaining the approval of the City Forester” (Shoreland Ordinance). That buffer zone includes a 10-12-foot-wide gravel walking trail that nearly encircles the lake. Erosion of shoreline areas encroaches upon the walking trail and compounds with water-quality concerns to make stabilization of these areas a high priority.

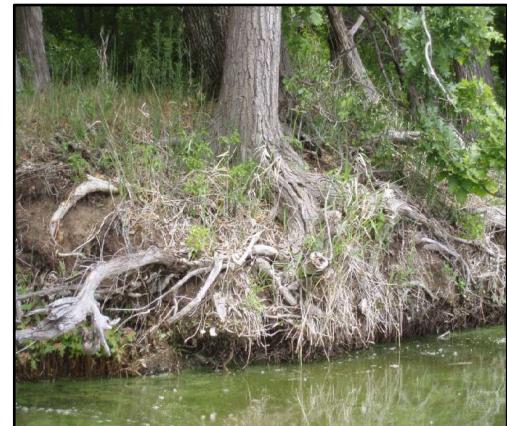
Photo (right) of undercut bank on Pleasant Lake from Kerber et al. 2017.

A shoreline study was also completed by Great River Greening in 2009 to identify priority areas for remediation. Bank stabilization projects have been conducted following that study. Success has been hampered by the wind-driven wave action that continues to undercut banks and erode installed plantings.

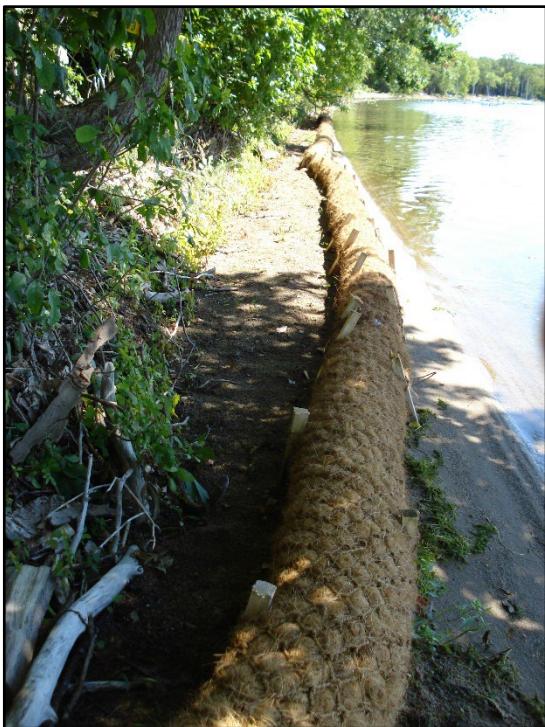
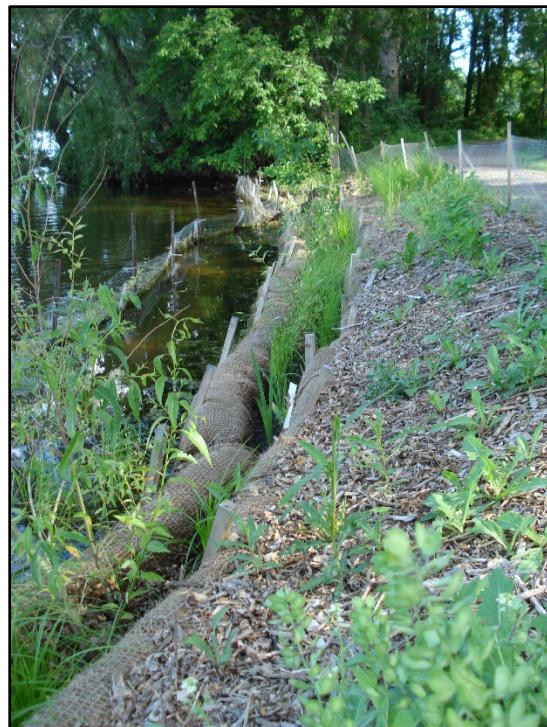
Shoreline stabilization projects in 2007 (left) and 2009 (right). Wave action has limited success of these projects. Photos by Tyler Thompson.

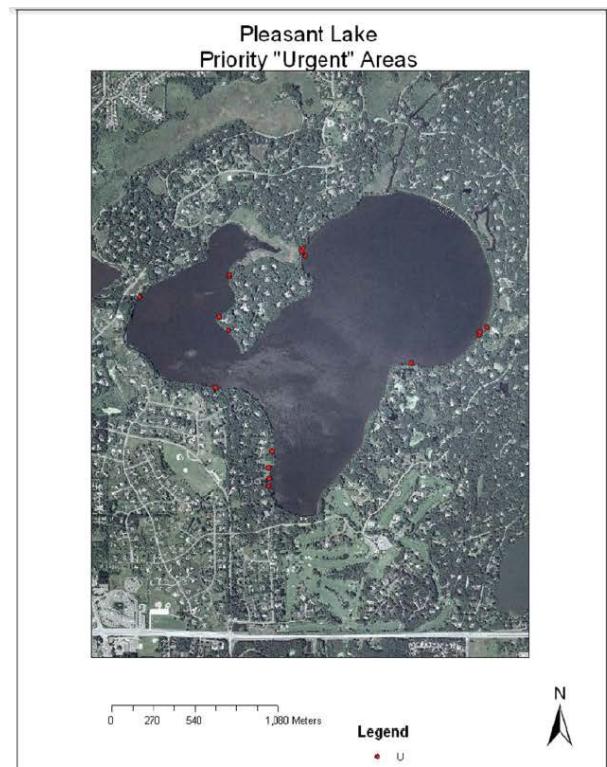
Figure 22: Priority areas for shoreline stabilization. From Kerber et al 2017: “Notice that the shoreline shows signs of erosion around almost the entire lake; however, there is increased erosion priority areas on the SW tip of the lake, on the NE corner, and around the peninsula. It is possible that the increased erosion in these areas is due to the fetch across the lake causing an increase in wind and wave energy on the shoreline.”

Conclusions of the Great River Greening study were supported by the UMN Sustainability study. The Great River Greening study identified priority areas for shoreline remediation. One map is included here. Additional maps can be found in the previous reports. Both studies identified a lack of shoreline vegetation and encroachment by invasive species (e.g., Common Buckthorn) in the buffer zone. These factors contribute to erosion problems on Pleasant Lake. Exacerbating issues include wind/wave action and rise and fall in lake surface elevation due to water pumping (Report, 2017).

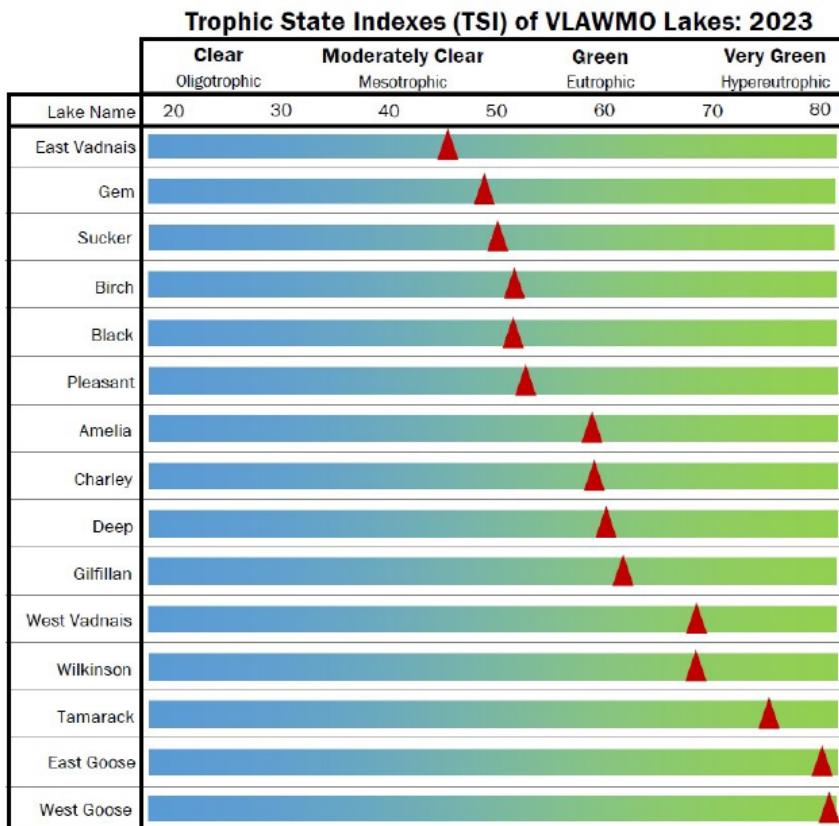
Figure 23: TSI scores for VLAWMO lakes

Pleasant Lake is deep and falls between the moderately clear/mesotrophic and green/eutrophic classifications on the Trophic State Index (TSI) (shown below using the Carlson scale, MPCA). Pleasant Lake had a score of 53 (2022) and 53 (2023).

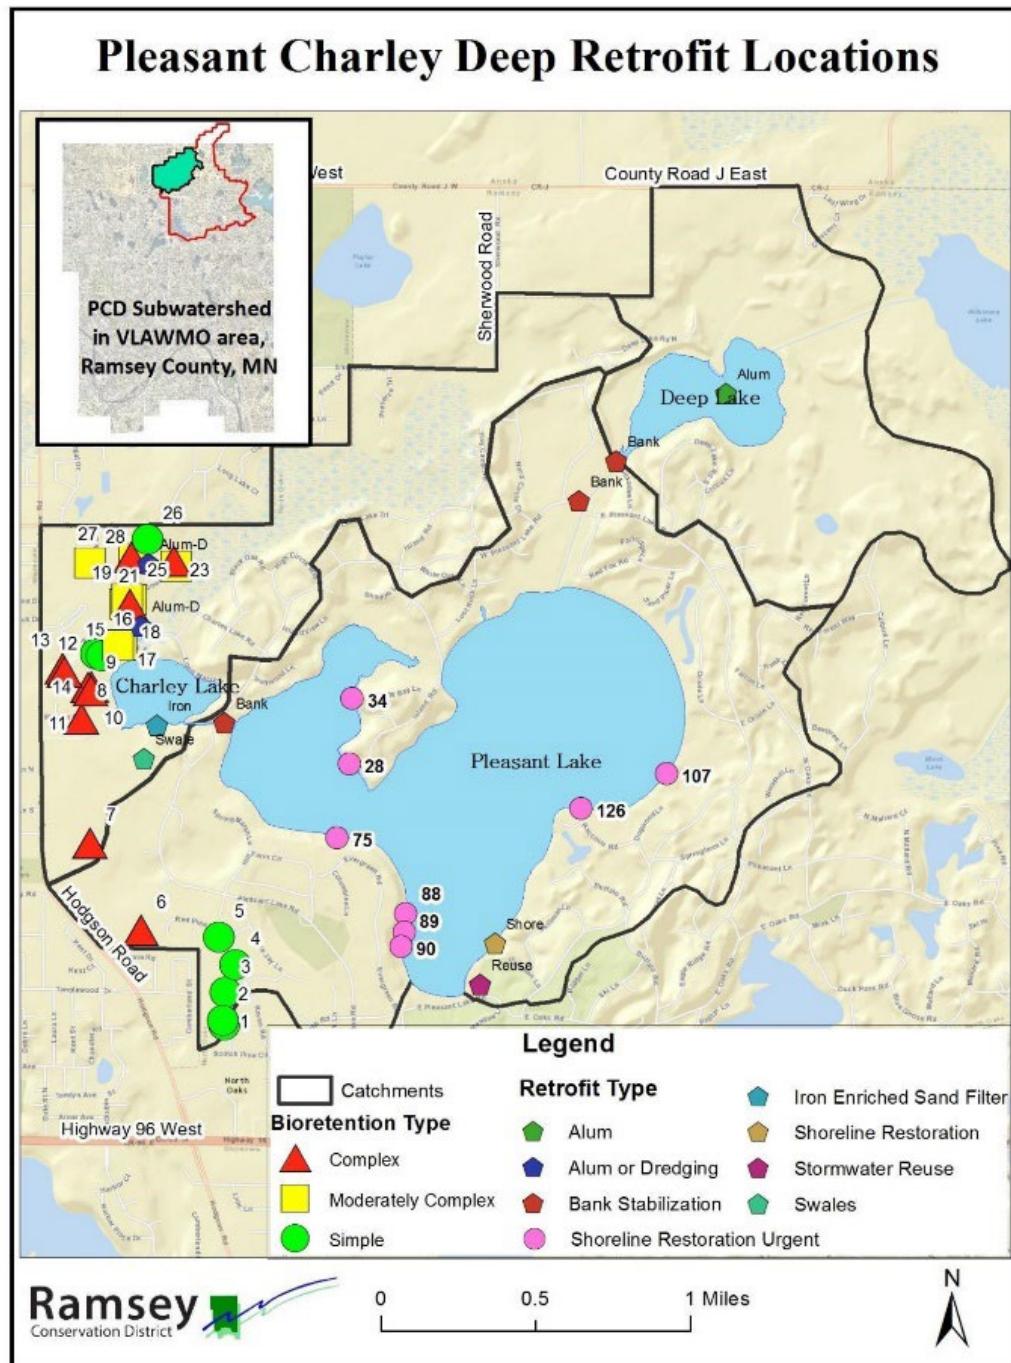
Figure 28: BMP retrofit locations identified in the 2015 Pleasant-Charley-Deep Retrofit Report.

In 2015, the Ramsey Conservation District completed a Retrofit Report for the Pleasant-Charley-Deep subwatershed, assessing possible areas and locations for implementing BMPs for improving water quality. The Report described the lake's land catchment area as having a low base load risk for contributing external loading due to buffering capacity of preserved and undeveloped land, low density residential in the south, the newest residential area's distance from the lake and higher-than-standard stormwater treatment.

The Report identified ~20 possible projects within the Pleasant Lake subcatchment and specified locations in urgent need for shoreline stabilization. These locations are supported by the earlier (2009) study that identified many of the same locations. Recommendations from the retrofit report should be considered as management steps continue forward for Pleasant Lake.
