VADNAIS LAKE AREA WATER MANAGEMENT ORGANIZATION
Wilkinson Lake Review,
Ramsey County, MN

2024

1.1 INTRODUCTION

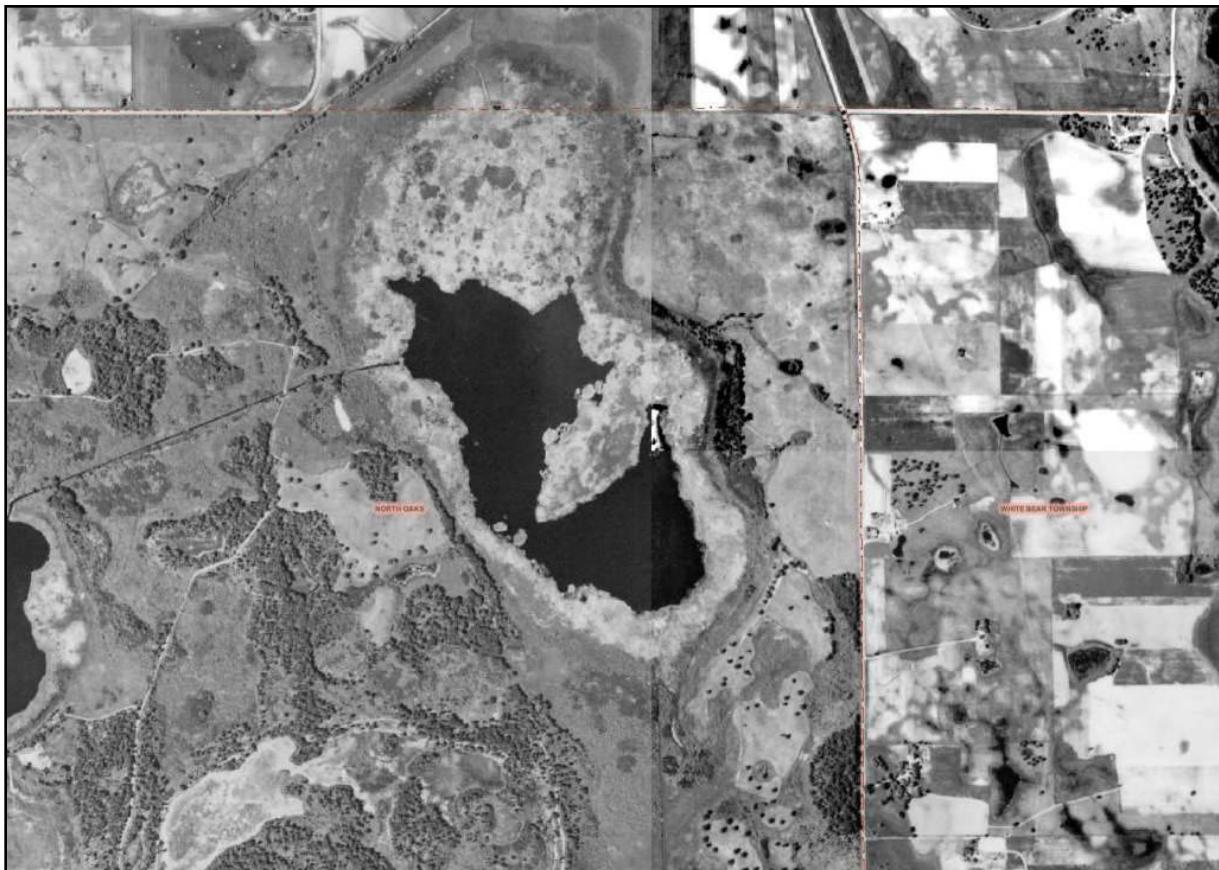
Figure 2: 1940 aerial photo of Wilkinson Lake. In 1940, the area is largely undeveloped and Interstate 35E has not been constructed yet. The roads now known as County Road J and Centerville Road were constructed. To the east and north of the lake, there is agricultural land. The “island” in Wilkinson Lake is considerably larger in 1940 than it is currently, perhaps due to lower water levels.

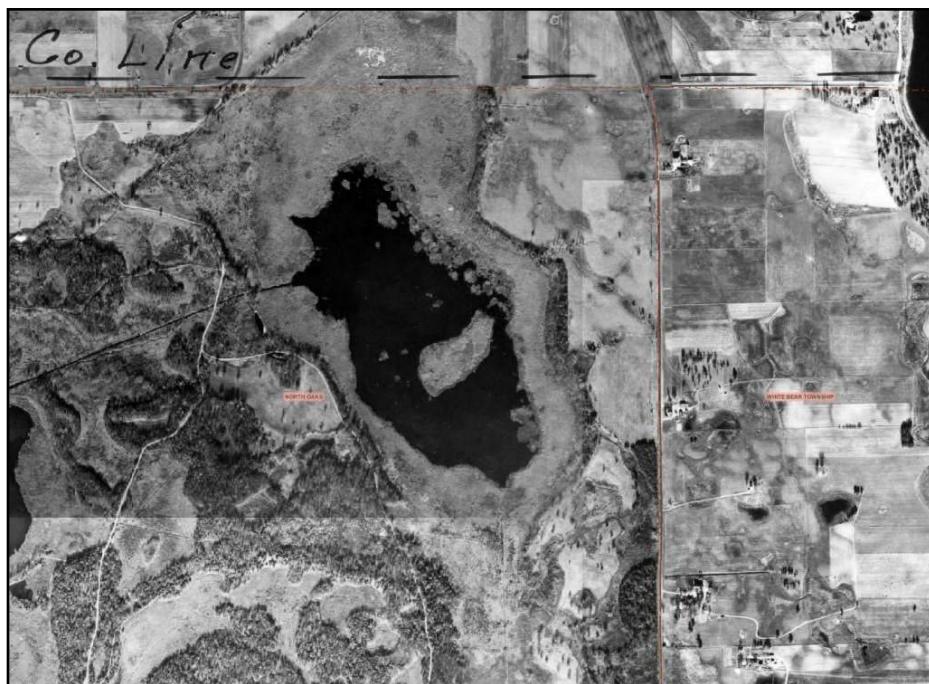
Figure 3: 1953 aerial photo of Wilkinson Lake. In 1953, there is still no development around the lake. Water levels are higher at this time.

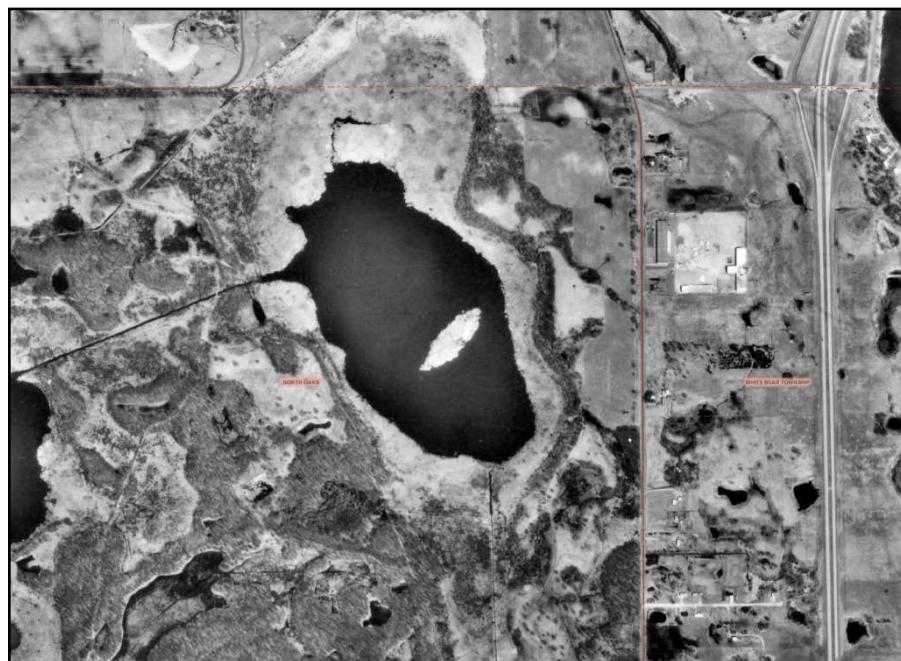
Figure 4: 1974 aerial photo of Wilkinson Lake. By 1974, Interstate 35E has been constructed and some industrial development has occurred on the east side of the lake. The property is now owned by Schwing America, Inc.

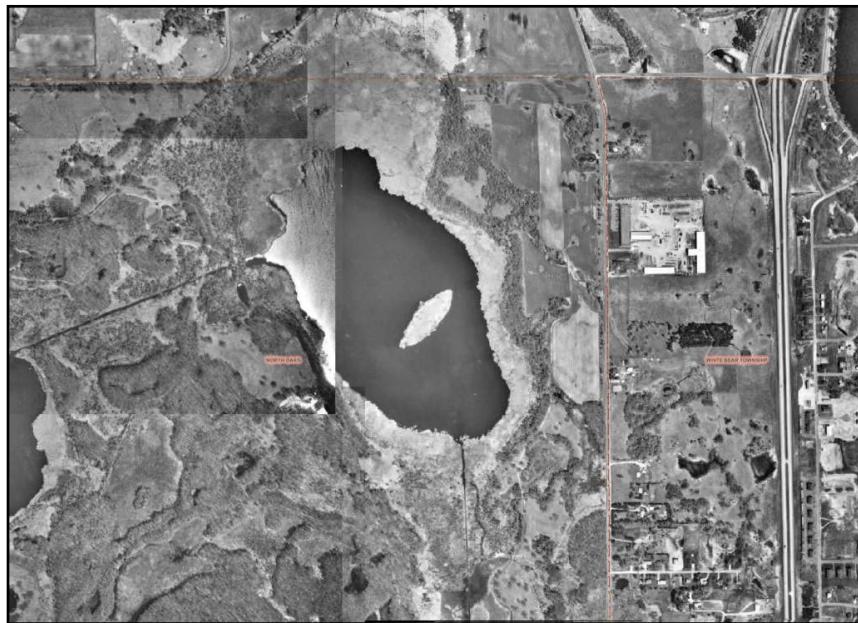
Figure 5: 1985 aerial photo of Wilkinson Lake. In 1985, more residential development has occurred east of the lake.

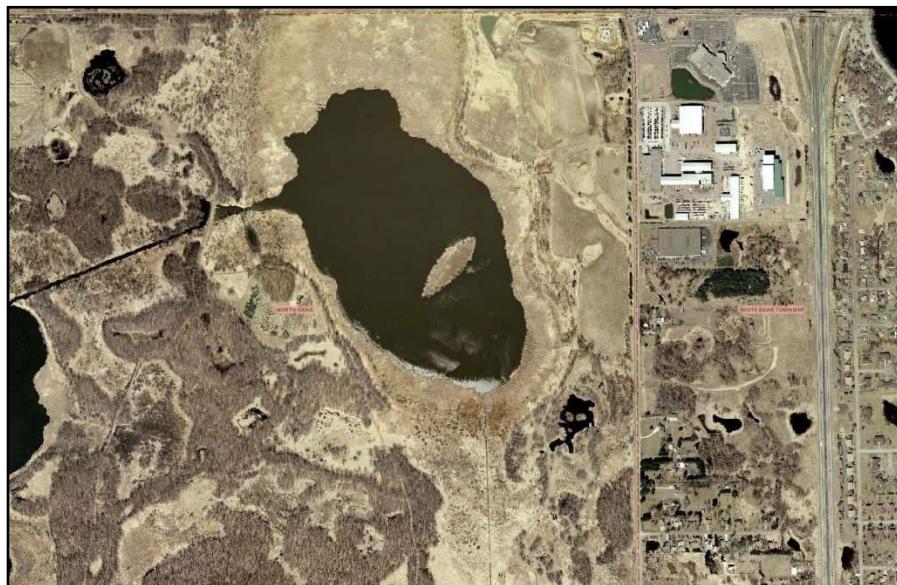
Figure 6: 2003 aerial photo of Wilkinson Lake. By 2003, more industrial and commercial development has occurred on the east side of the lake. Grading work has begun for what is now known as Waverly Gardens.

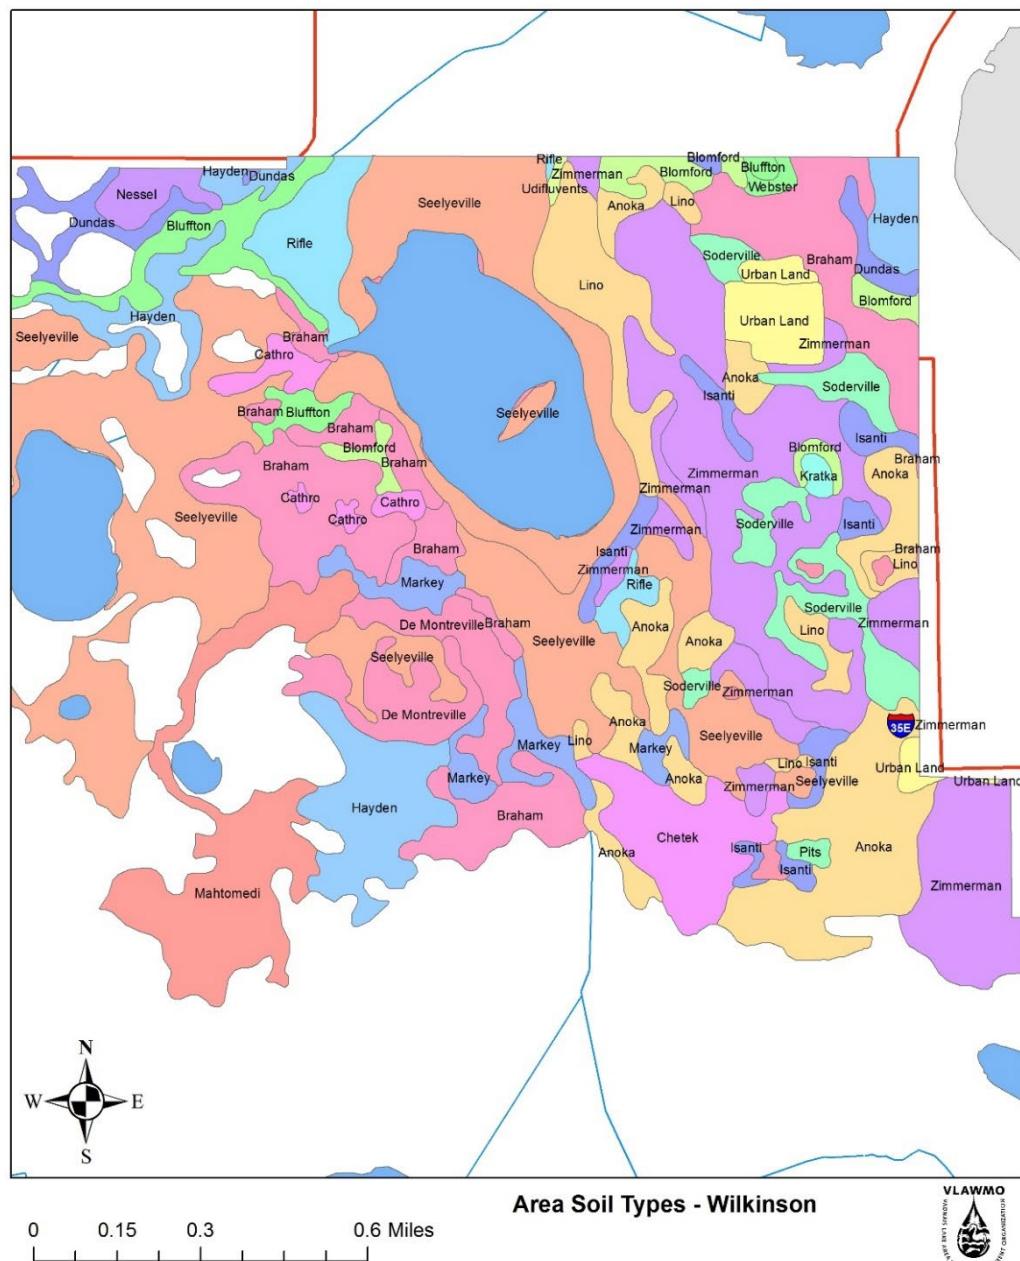
Figure 10: Wilkinson Lake area soils

The soil directly around Wilkinson Lake is Seelyeville, which is an organic muck. The soils near the lake are of the mucky types (Rifle, Markey, Cathro). Soils on the upland areas include Hayden, Zimmerman, Isanti, and Anoka, which are all fine sandy loams. These soils are suitable for parkland and development.

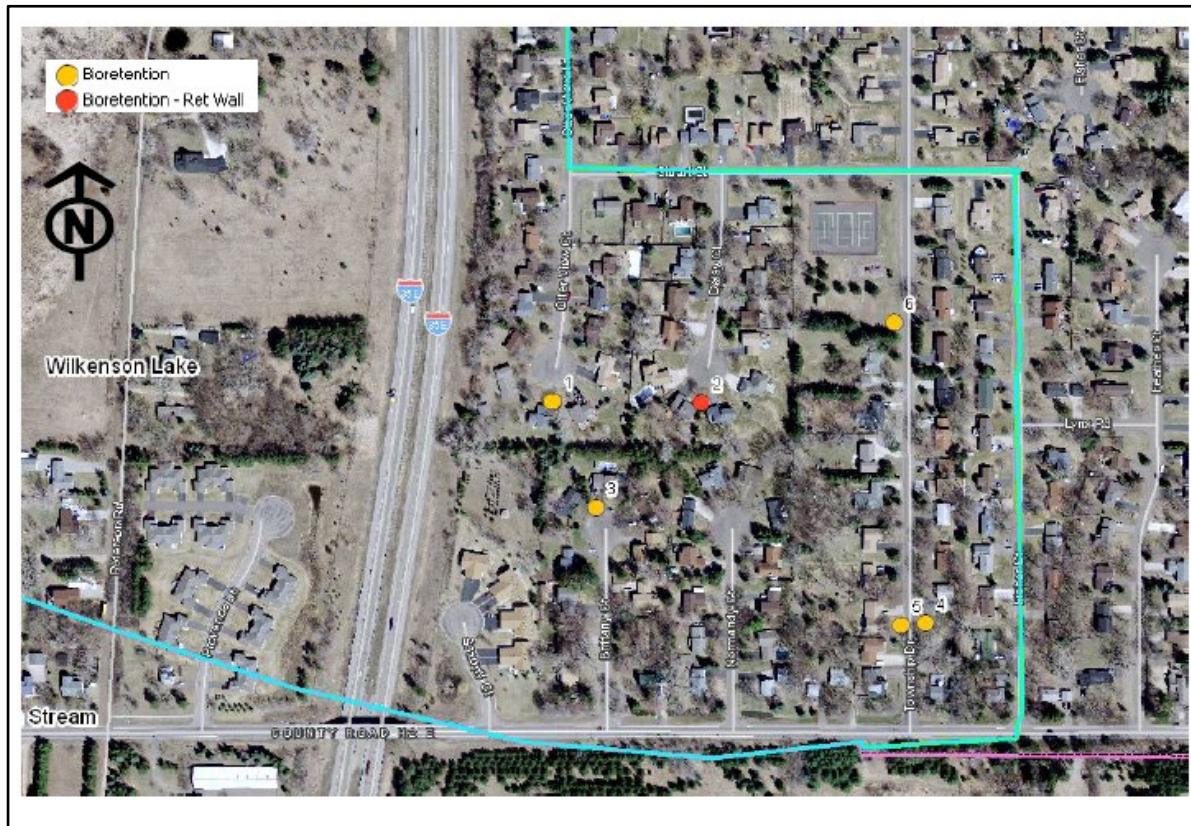
Figure 21: Locations recommended for possible retrofit BMPs.

During the reconnaissance process, it was found that the commercial/industrial area and townhomes located in the north east corner of the catchment were receiving adequate treatment before draining in to Wilkinson Lake. In addition, according to VLAWMO staff a storm sampler collecting water quality samples that drain from this area have also shown that the runoff is receiving treatment upstream before entering Wilkinson Lake. A neighborhood in the south east corner of the catchment was identified as a potential location for a cluster of six simple bioretention cells. This neighborhood receives little treatment before it drains in to a ditch system connected to the south east corner of the wetland complex attached to Wilkinson Lake. If all six bioretention cells are installed at around 250 square feet each it is calculated that 5.3 lbs of TP would be removed from the catchment resulting in a 1.2% decrease from the base load. Possible pollutant-load reductions were fairly low. Additional feasibility investigation was completed to increase possible opportunities for BMPs.

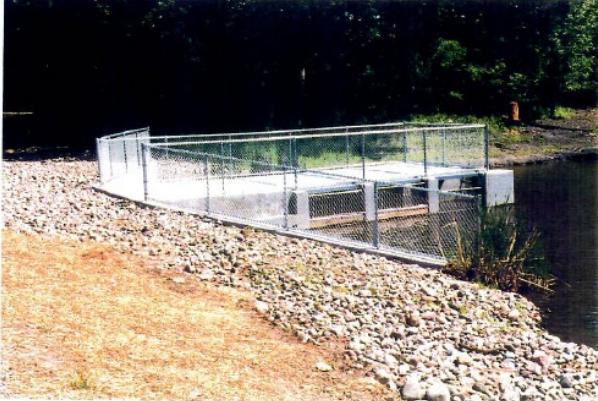
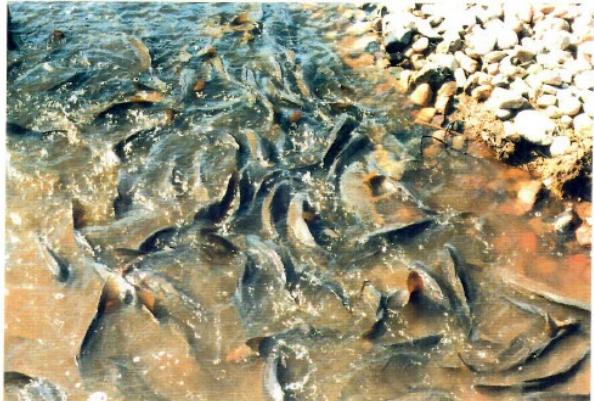
1994 NOC Fish barrier construction	Carp attempting to get into Wilkinson Lake to spawn but trapped below the new barrier

- NOC construction of permanent fish barrier in 1994, follow-up drawdowns to remove invasive common carp, and ongoing maintenance of the barrier
- Invasive common carp removal with VLAWMO and Carp Solutions (2019-present) with collaboration from NOC as the landowner where temporary barriers and removal is conducted
- Construction of a deep-water wetland to the south of Wilkinson Lake (fall 2023), in partnership with NOC, MLT, RC SWCD, SPRWS, Houston Engineering as part of VLAWMO's participation in the small, priority watershed grant program which is administered by the MPCA and funded by the EPA. Site enhancement and monitoring are currently underway (2024)

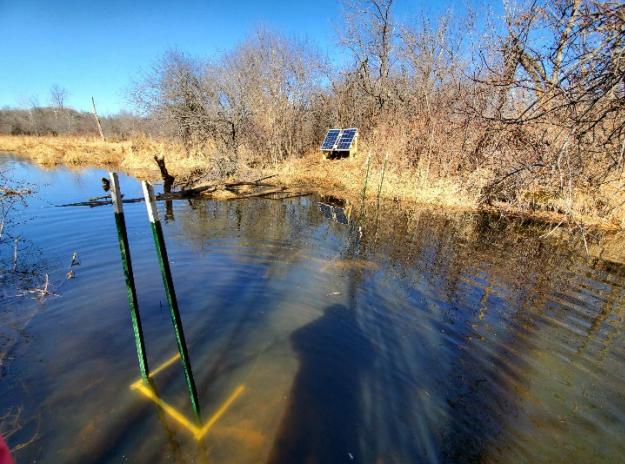
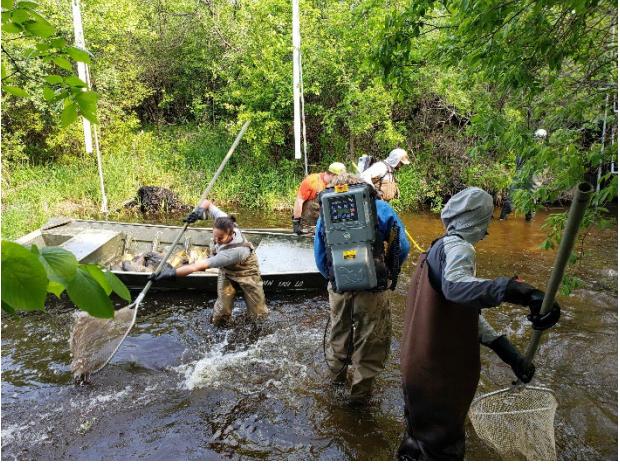
Antenna placement as part of VLAWMO/Carp Solutions carp removal effort (2020)	Carp removal by VLAWMO/Carp Solutions

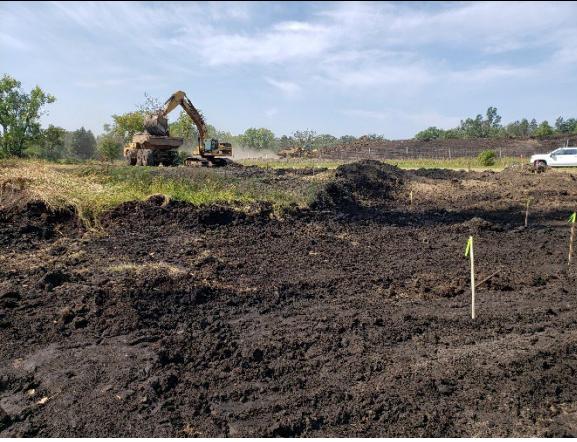
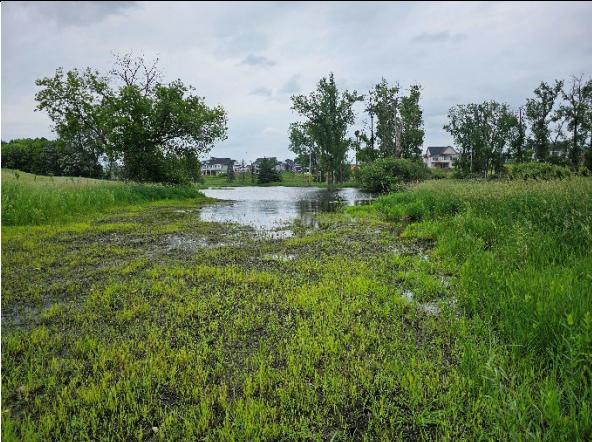
Wilkinson deep-water wetland construction (fall 2023)	Wilkinson deep-water wetland following vegetation establishment (summer 2024)
