**VADNAIS LAKE AREA WATER MANAGEMENT ORGANIZATION**  
**Amelia Lake Review,**  
**Ramsey County, MN**

**2024**

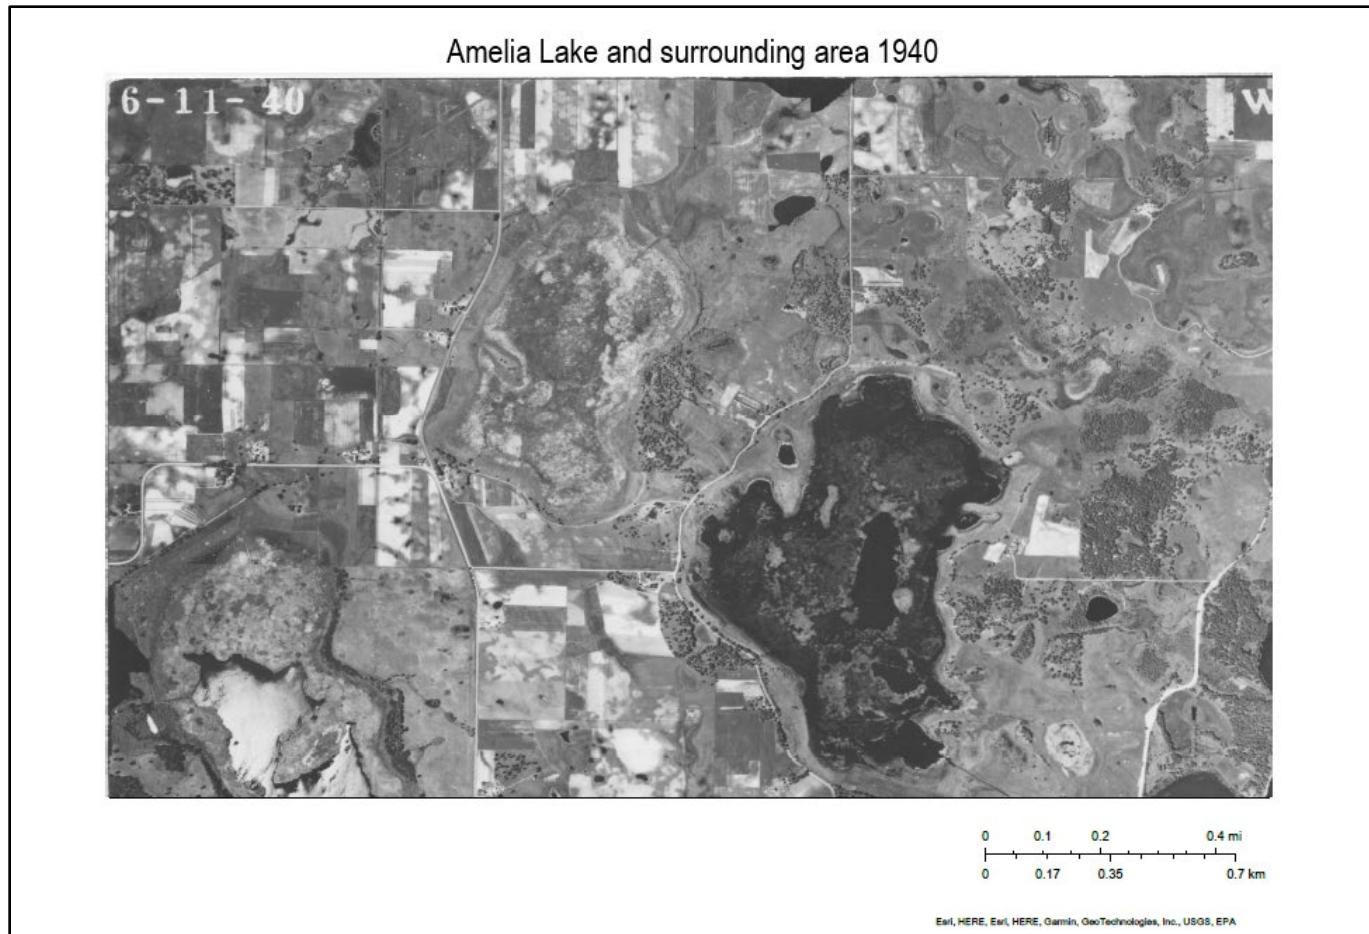
Figure 4: 1940 aerial photo of Amelia Lake

In 1940, the Amelia Lake basin contained thick wetland vegetation and dryer areas, due to draining that occurred decades earlier. It was used for hay harvest by local farmers. This use was possible because, in the early 1900s, an illegal ditch was put in to the west to drain the lake and make it suitable for agriculture.

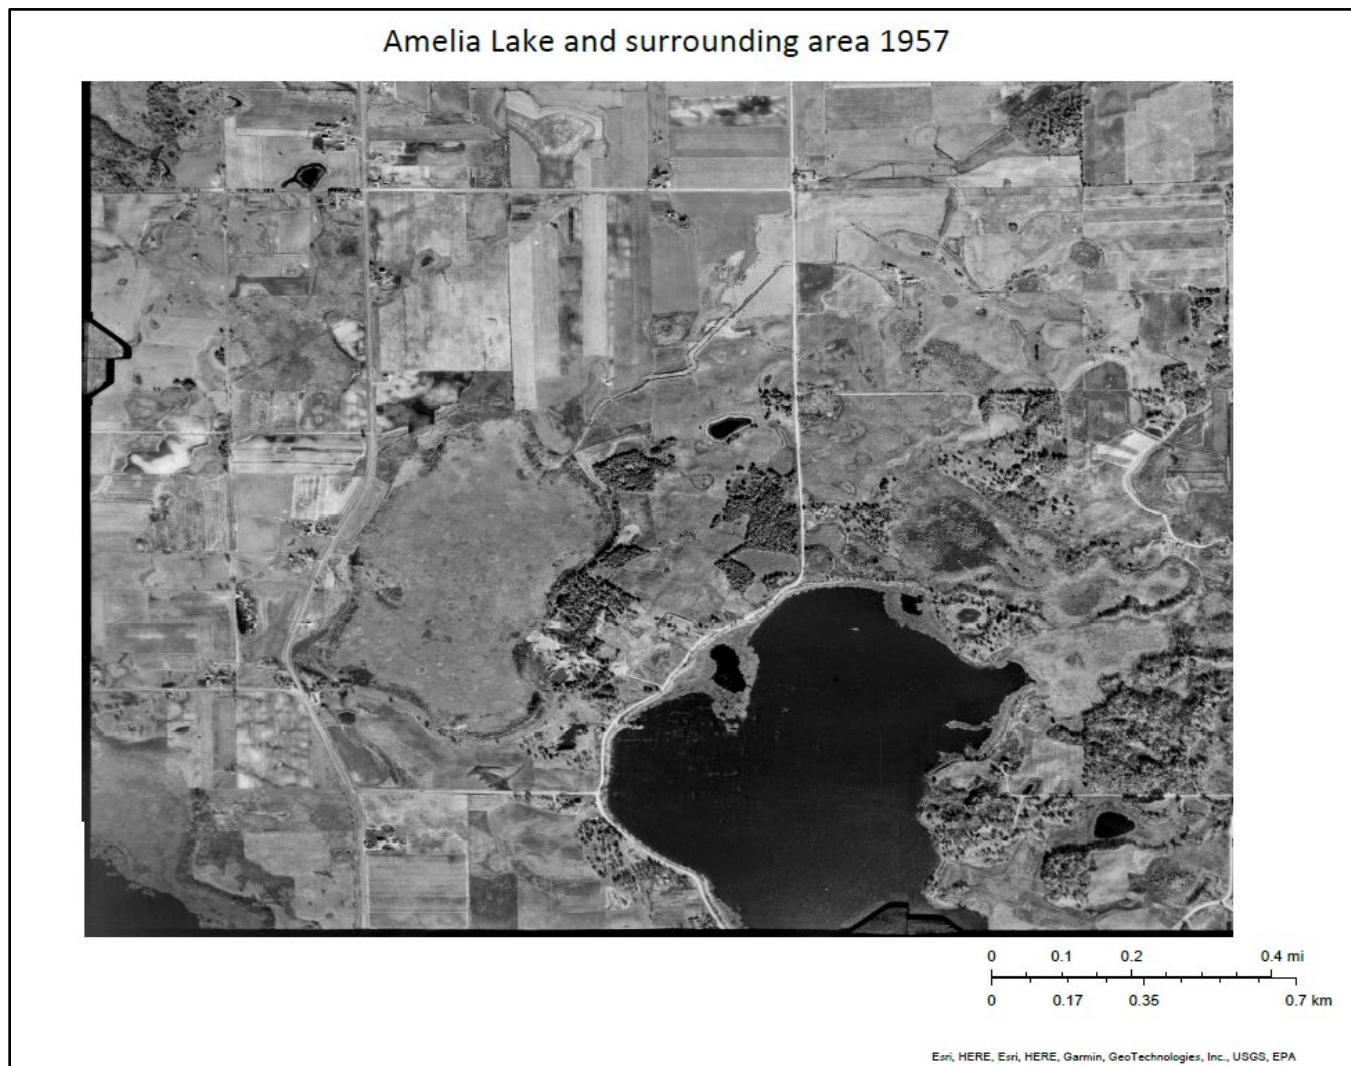
Figure 5: 1957 aerial photo of Amelia Lake

In 1957, the ditched area had not yet been addressed. A mix of wetland vegetation and agricultural haying was still present. In the 1940s and 1950s, a gravel mining operation was active on the east side of the lake. This mining operation has had lasting effects. In the area where mining was conducted, the deepest water levels are still found today. This pool was excavated as part of the mining operation. In the 1950s and beyond, the gravel-pit area was a known party spot for locals. It is rumored that large trash, even possibly vehicles, might have been deposited into the pool. The extent of this lore is not known by VLAWMO staff.

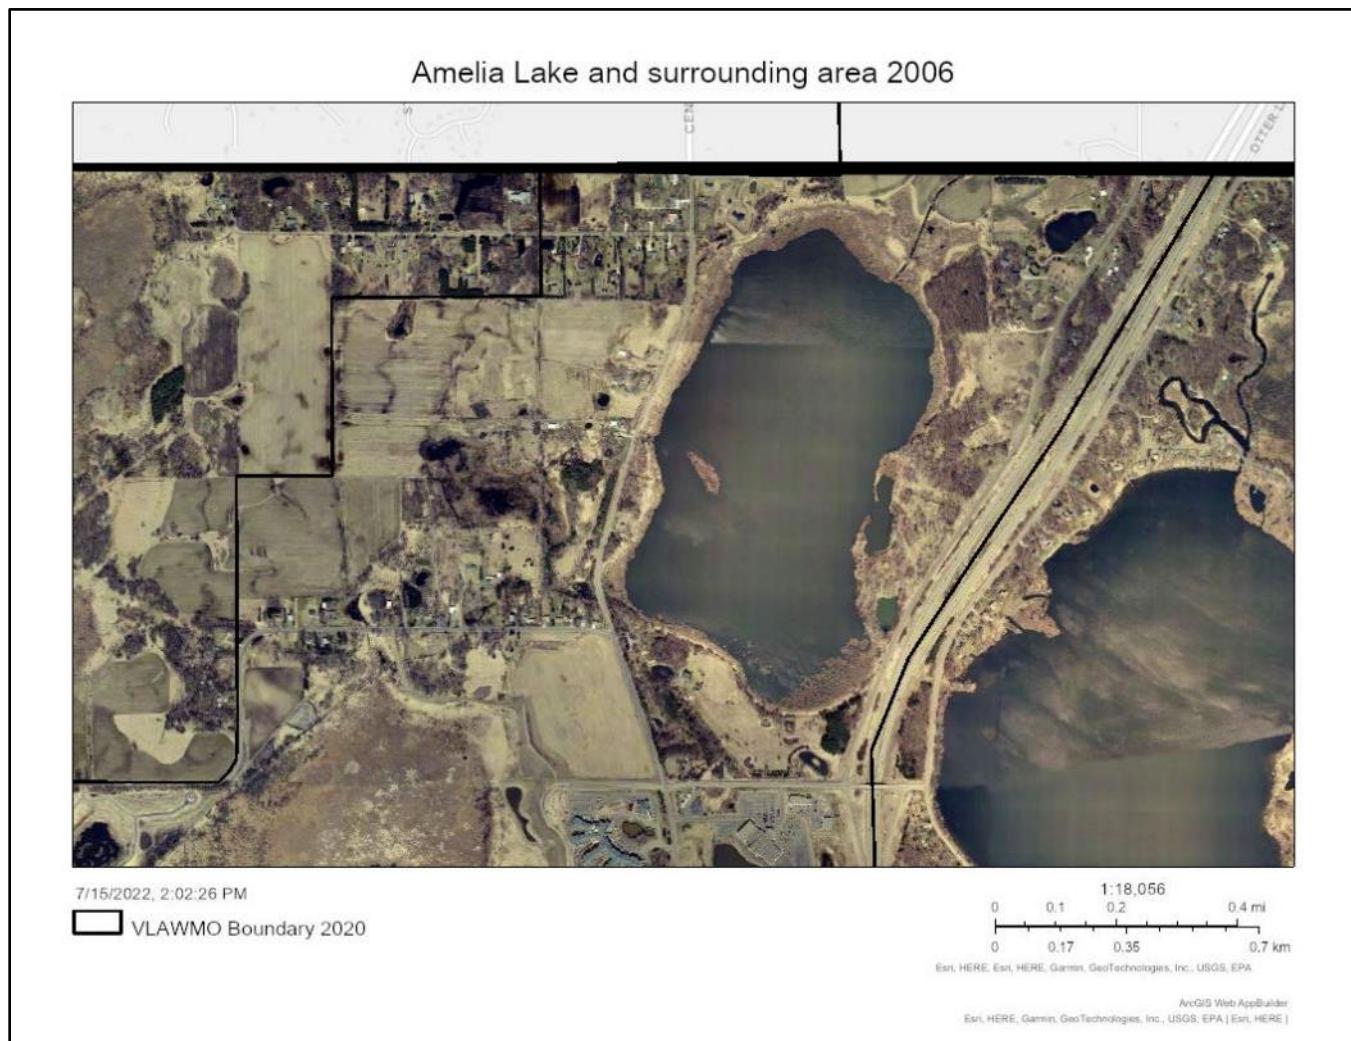
Figure 7: 2006 aerial photo of Amelia Lake

By 2006, increased development in the area is visible, along with continued upgrades and additions to the road network. Residential development around the lake consists primarily of low-density, larger lot residential properties. Prior to this image, two major proposals were unsuccessful that could have dramatically changed the conditions of the lake. One of those was a proposal by the Metro Sanitation Department to use the old gravel-pit land to the east of the lake as a landfill. Neighbors and SPRWS provided evidence of potential threats of this activity to the drinking water resource, and the proposal was not pursued further. In the late 1980s, a proposal for high-density development was also put forward for this same area. That was also not successful. High-quality wetlands and a small prairie remnant are still present in this area today.

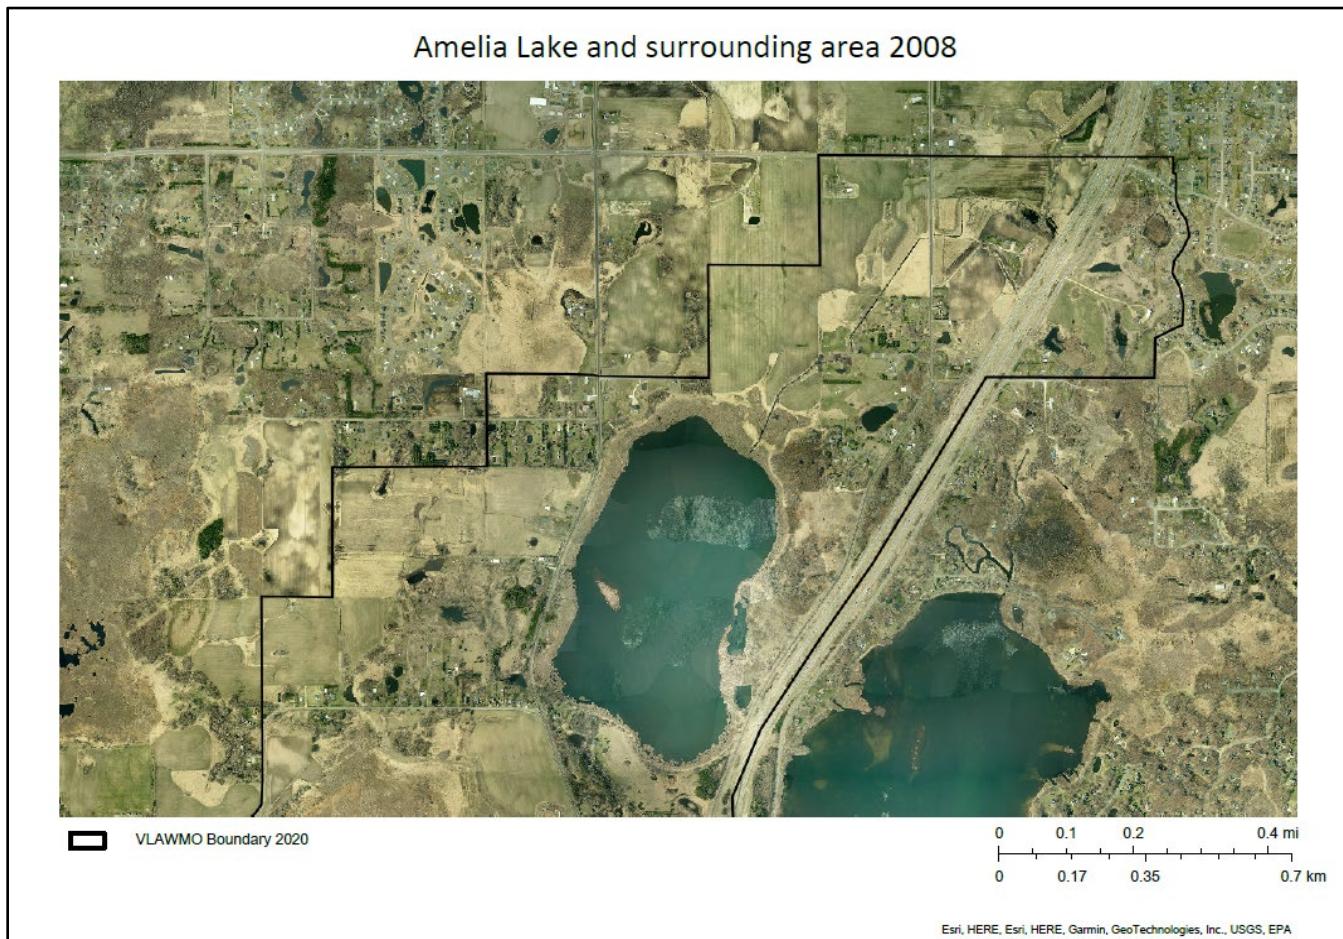
Figure 8: 2008 aerial photo of Amelia Lake

In 2008, agricultural fields and low-density residential development are dominant land cover types.

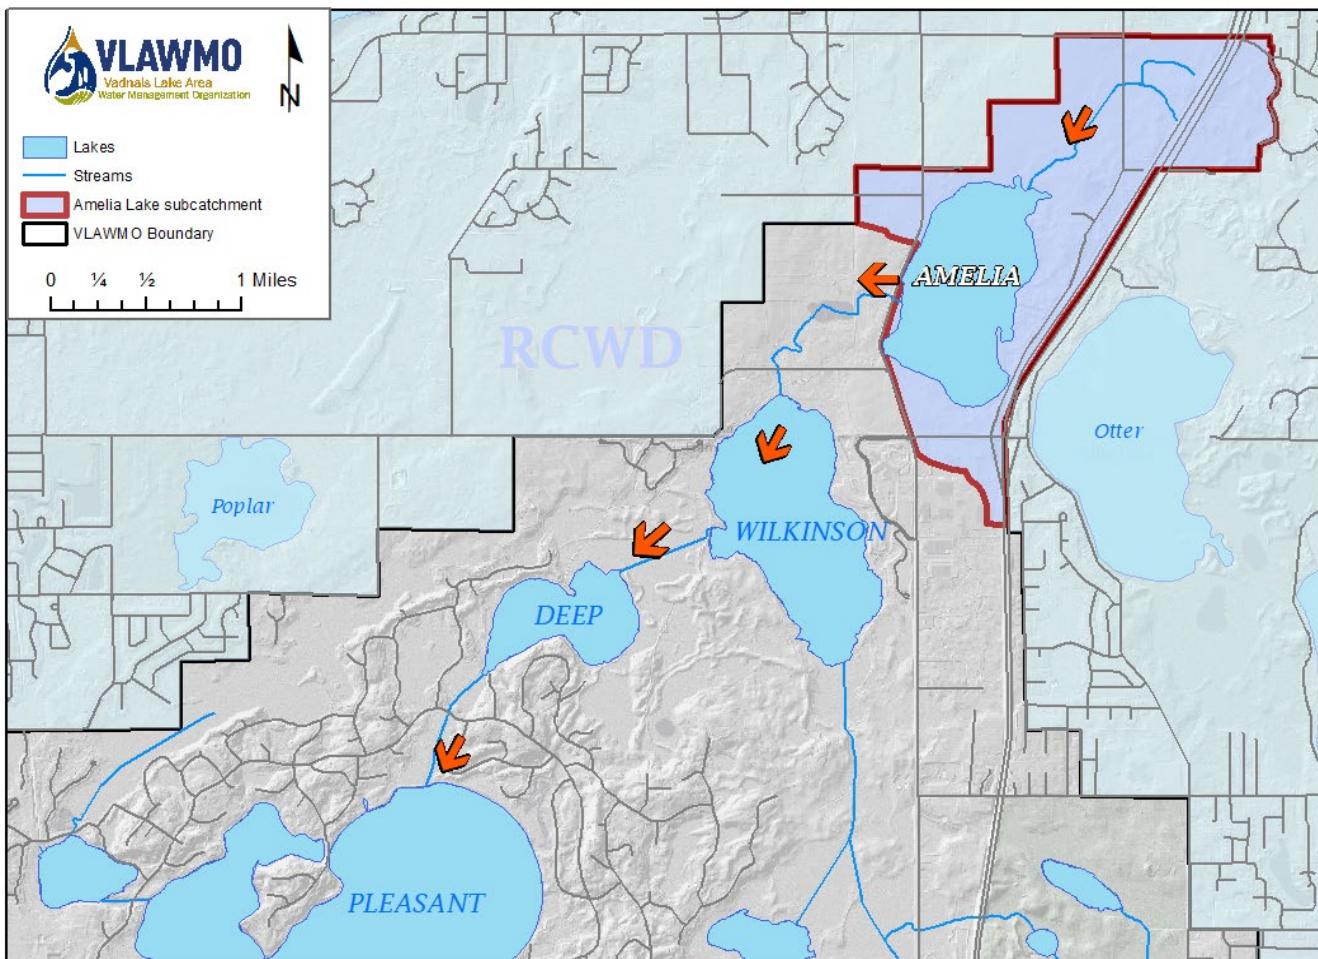
Figure 11: Amelia Lake drainage area and flow patterns

Amelia Lake has a surface area of 127 acres and a contributing subwatershed area of 691 acres. The subwatershed area is shown below, shaded in purple and outlined in red. The north and east sides of the subwatershed are outside of VLAWMO in the Rice Creek Watershed District (RCWD) boundary. Drainage in Amelia Lake flows south into Wilkinson Lake in North Oaks and continues south to ultimately reach East Vadnais Lake.

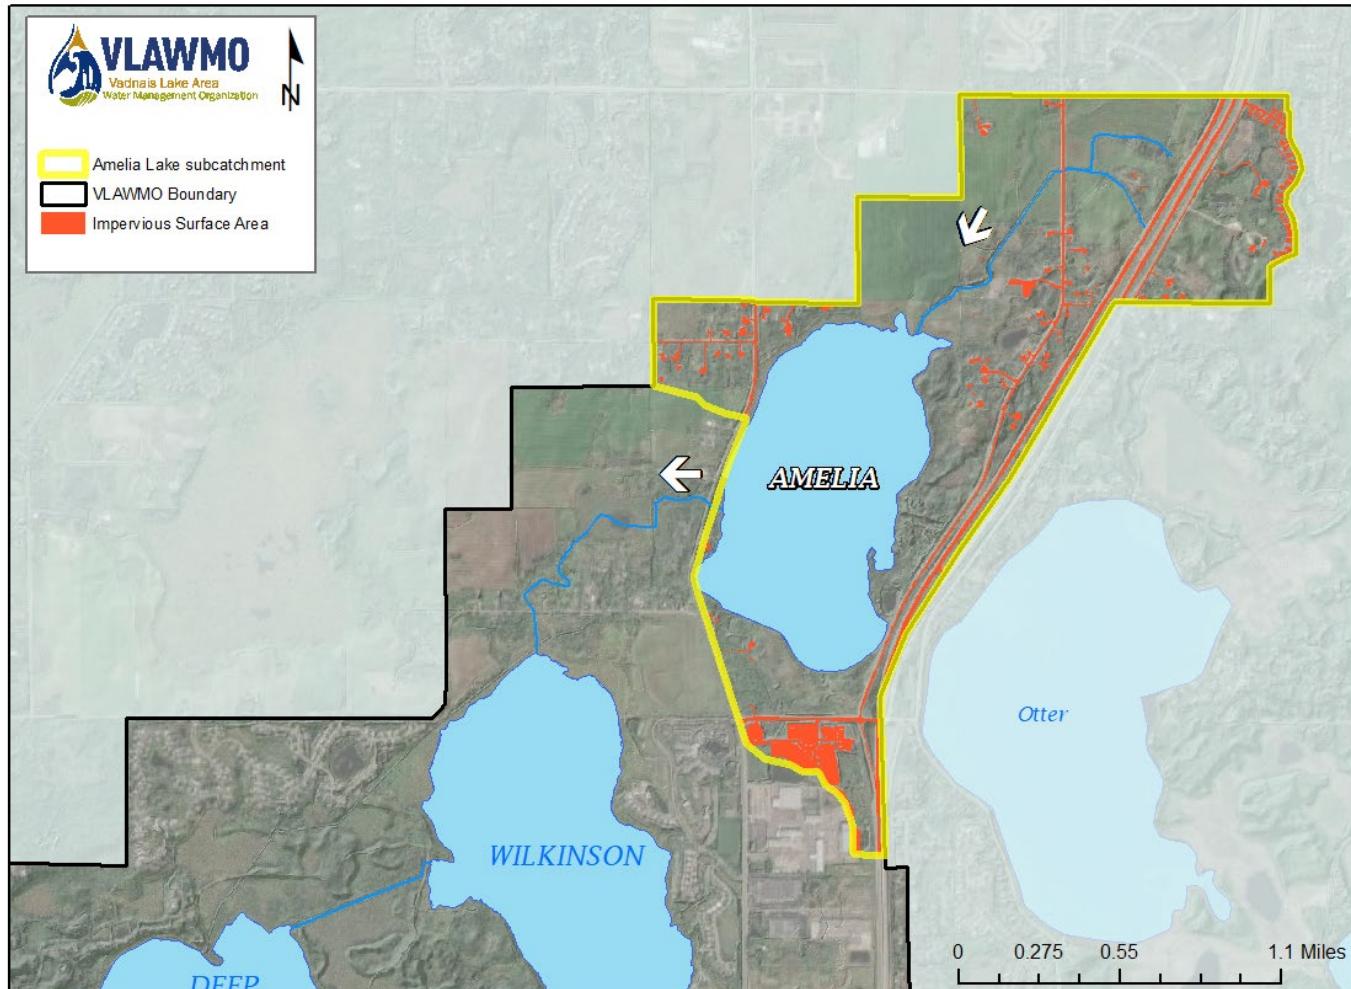
Figure 12: Impervious surfaces in Amelia Lake drainage area

A low amount of land cover in the Amelia Lake subwatershed is developed. A majority of land cover is undeveloped space and agricultural land. Impervious surfaces make up about 54 acres of total land area (8%) within the Amelia Lake subwatershed, including water surface area and terrestrial surface area. Not including Amelia Lake's surface water area, impervious surface area comprises 9.5% of the 564 acres of terrestrial land cover. The majority of precipitation that falls on these impervious surfaces moves rapidly into the downstream wetlands and Amelia Lake instead of soaking into the ground.

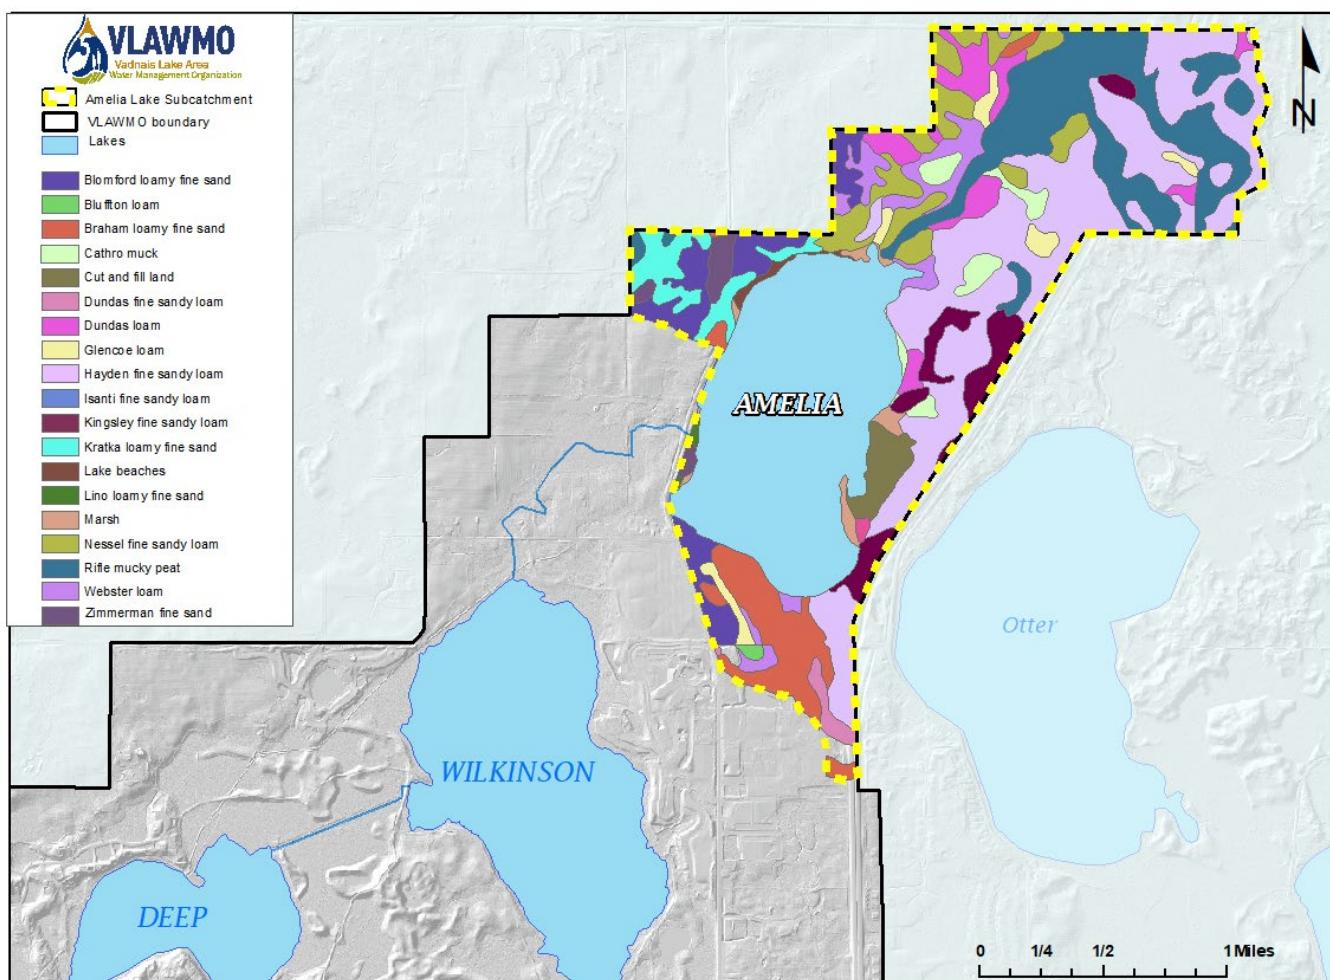
Figure 13: Amelia Lake area soils

Soils in the Amelia Lake subwatershed drainage area are comprised of loams, loamy fine sands, fine sandy loams, and muck/marshland soils. Over half of the area on the northeast side are fine sandy loam soils. Fine sandy loam soils are deep and well-drained. These soils allow precipitation and water runoff to soak into the ground relatively quickly. They were formed from moraines and till left from receding glaciers. They are classified as moderate-to-average permeable soils. Unlike urban soils and muck/marshland soils with limited permeability, fine sandy loam soils allow precipitation to enter the ground more readily, to reach the water table and recharge shallow groundwater. A medium amount of runoff still occurs, especially with significant precipitation events, which is diverted into nearby waterbodies.

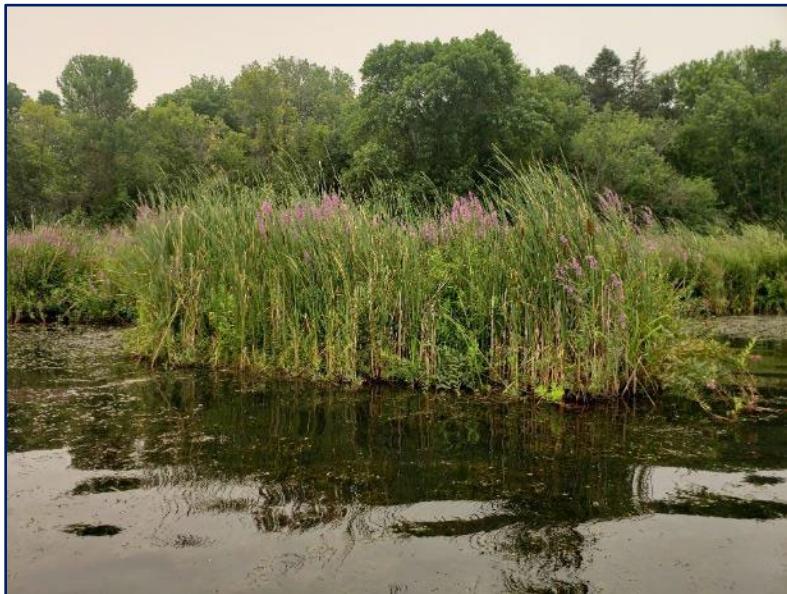
**Figure 14:** Example of a floating mat of vegetation in Amelia Lake from 2021. The photo was taken when large wild fires were burning in other parts of the country, which resulted in the visible haze.

Amelia Lake is very shallow and has historically been, at times, fully covered by cattails and other vegetation. As of the lake survey that was conducted in 2021, the average depth in the main basin of the lake, excluding the deep hole that remains from the gravel mining operation, was only 2.3 feet. The lake itself has large, floating mats of vegetation that often break off and relocate themselves in new areas around the lake (Figure 14).

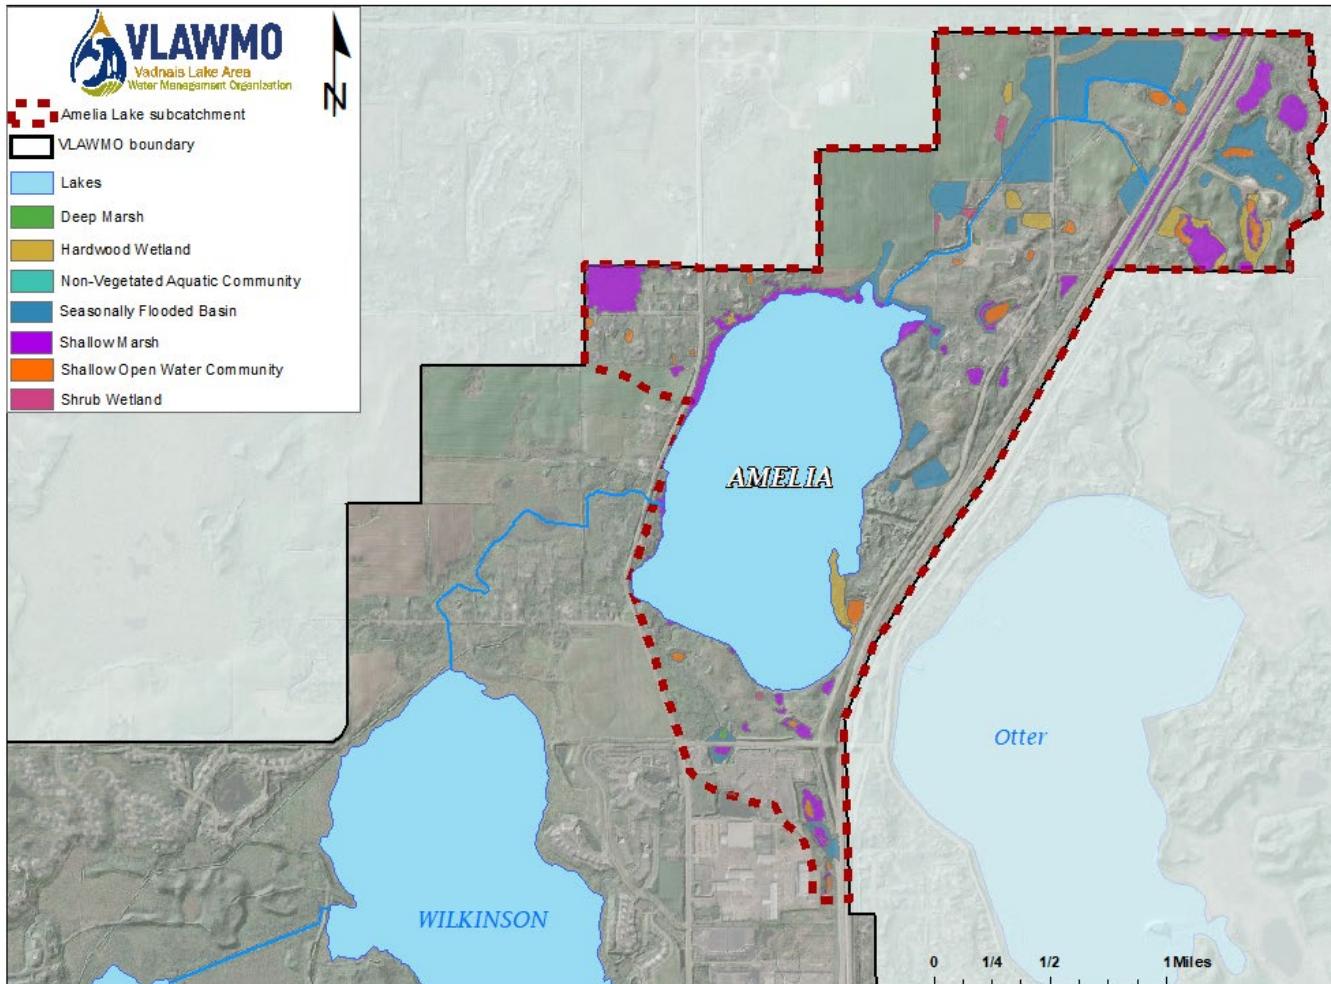
**Figure 15:** National Wetland Inventory (2015) Wetland areas in and around Amelia Lake, Circular 39 Classification System.

Wetland areas are abundant in and around Amelia Lake. The National Wetland Inventory (2015) shows delineated areas (Figure 15). More detail is also available as part of the wetland delineation that was done for a current construction project on the east side of the lake.

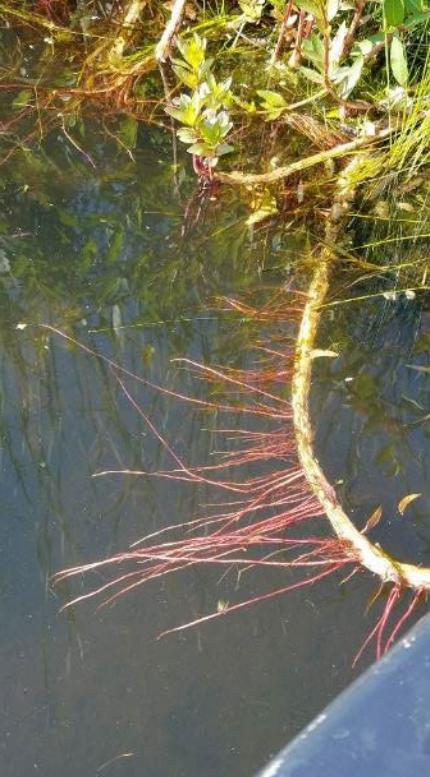
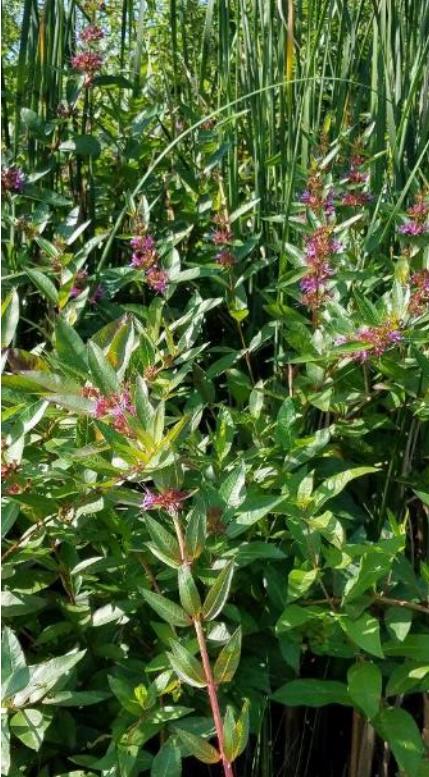
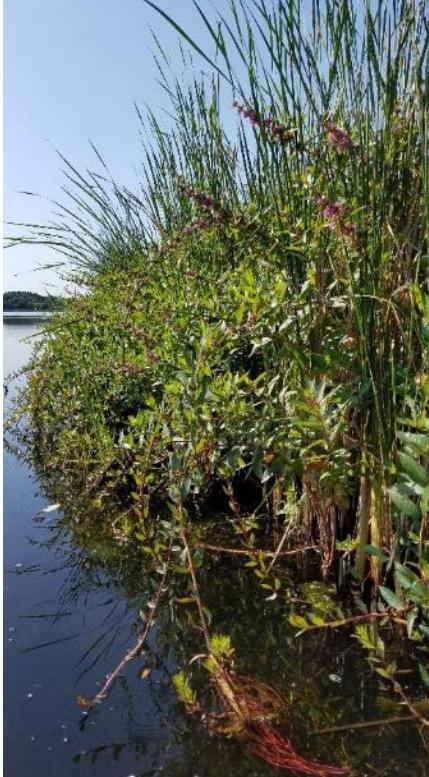
Figure 16: Swamp loosestrife (*Decodon verticillatus*) on Amelia Lake

Swamp loosestrife has an intricate root structure that helps to stabilize shoreline areas	Blooming Swamp loosestrife plants on the Amelia shoreline	Shoreline vegetation dominated by Swamp loosestrife along the waterline

A rare plant that is widely present along the shoreline of the lake is Swamp loosestrife/Water willow (*Decodon verticillatus*) (Figure 15). This plant should be protected where possible.

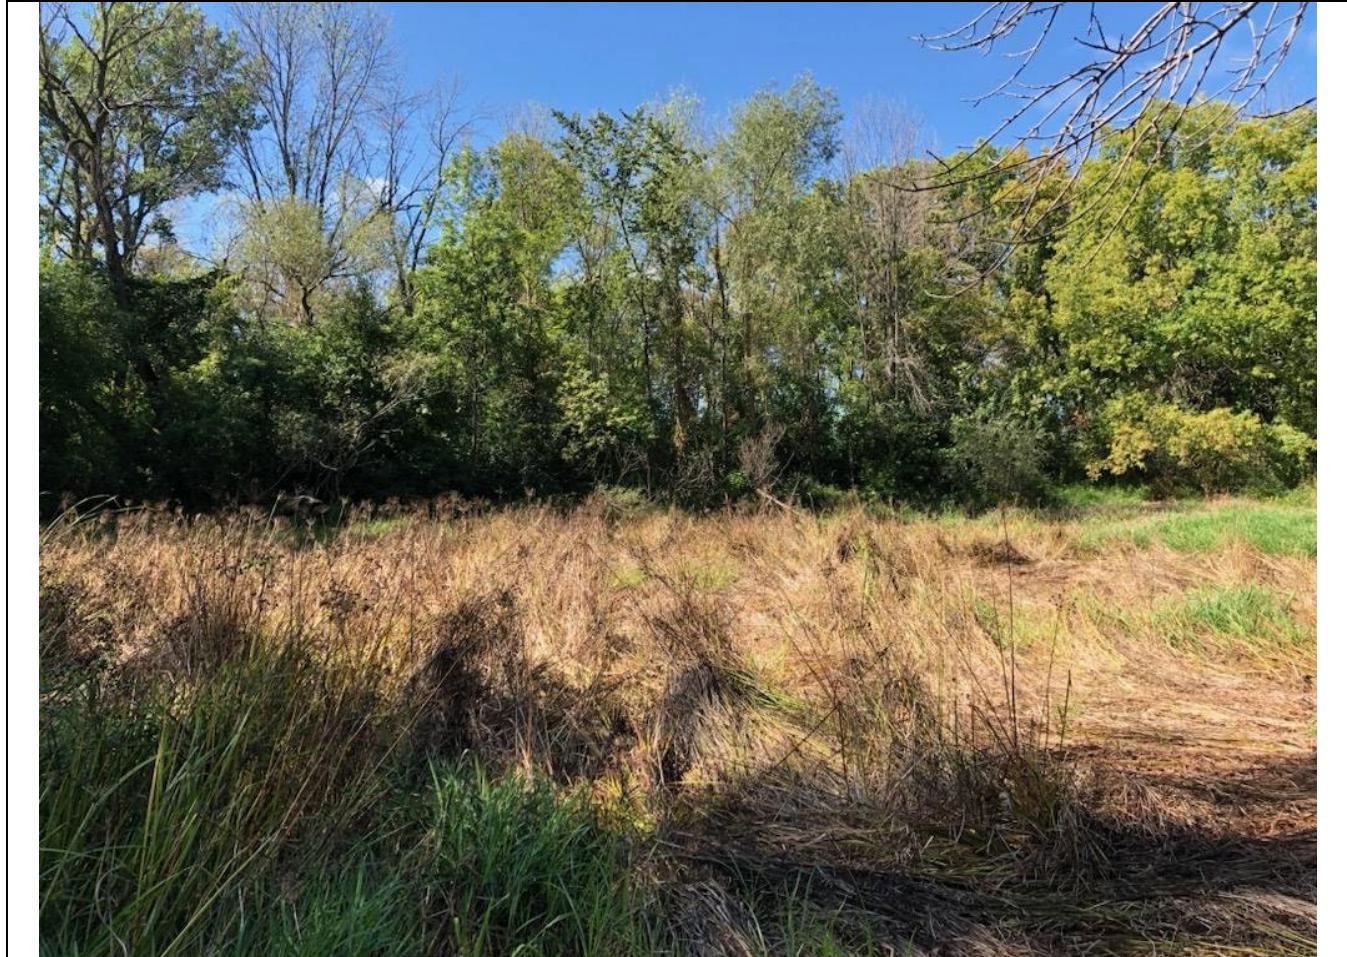
Treatment conducted by RCSWCD in 2023

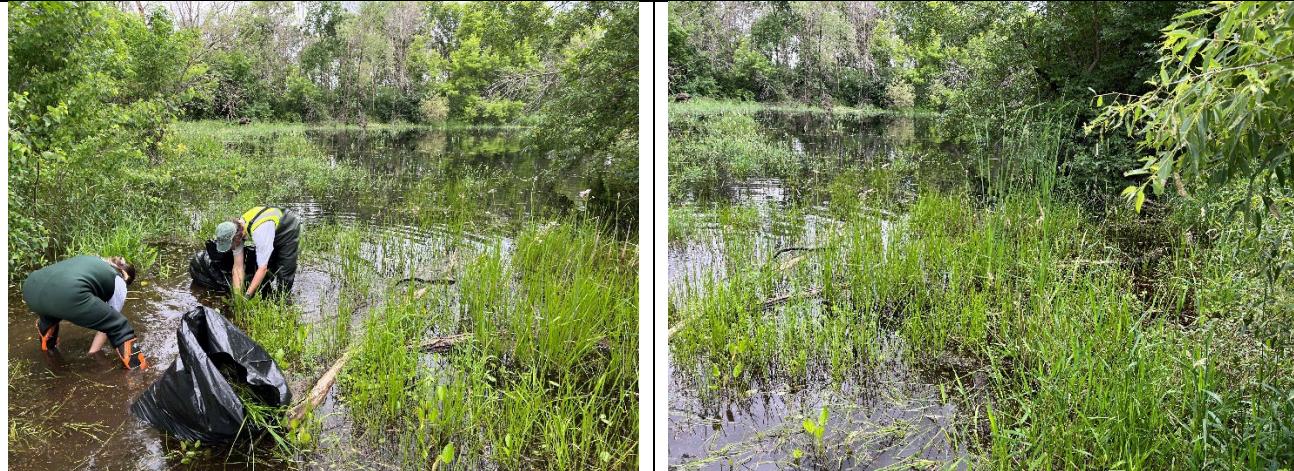
Handpulling by RCSWCD in 2024

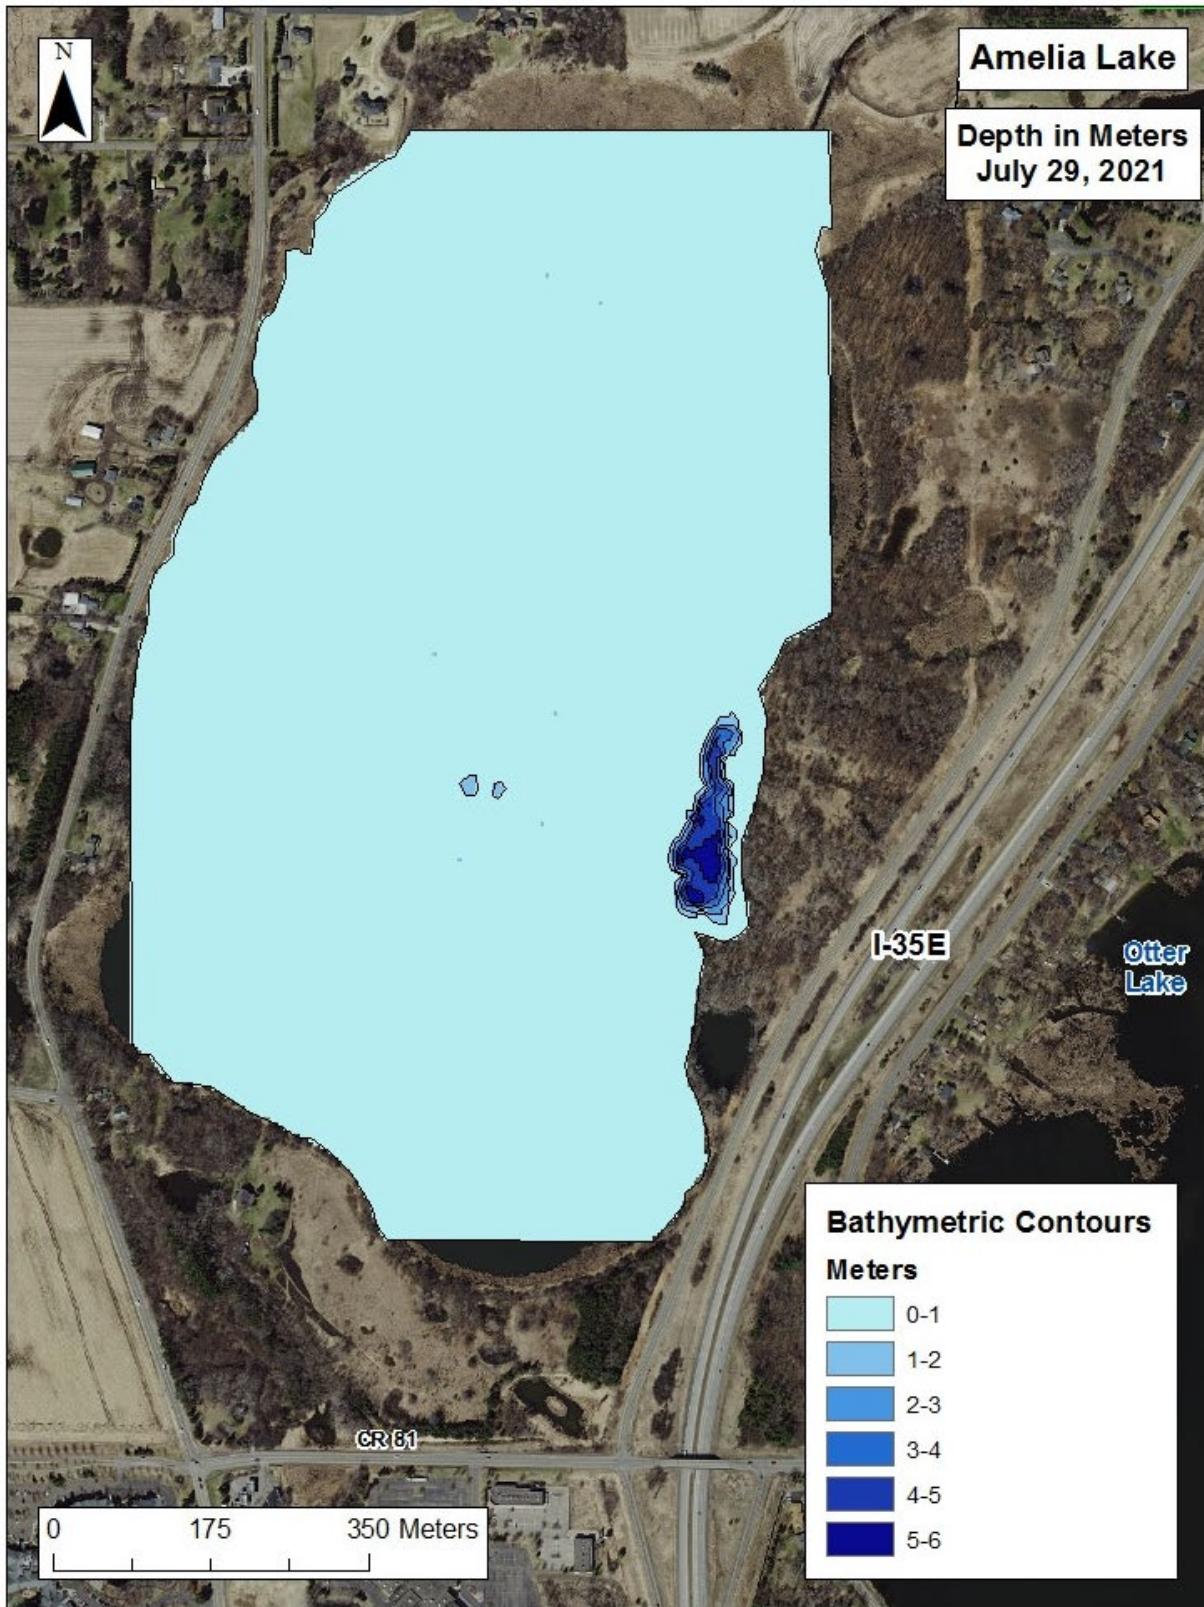
Figure 18: Amelia Lake depths with 1-meter contours

A bathymetry survey was completed by RCSWCD on July 29, 2021, to develop a map of the bottom and determine lake depths. The deepest location detected by sonar was 6.3 m (20.7 ft) in a hole on the eastern side of the lake, and the average was 0.7m (2.3 ft). The lake overall was quite uniform in depth and very shallow, with the exception of the hole on the eastern side of the lake. Bottom hardness is represented as soft, medium, or hard; with soft bottoms characterized as muck, loose silt or sand, and medium to harder bottoms characterized as compacted sand, gravel, or rock. Amelia has a primarily medium lake bottom.

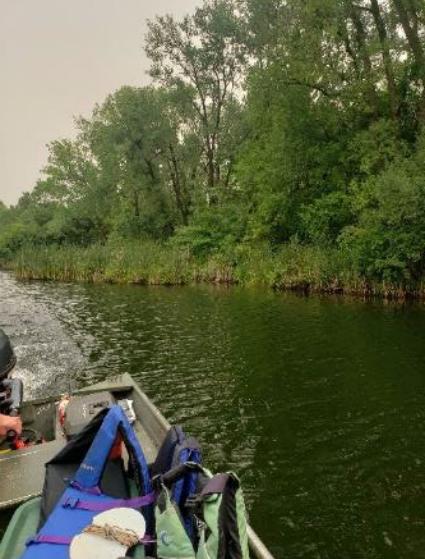
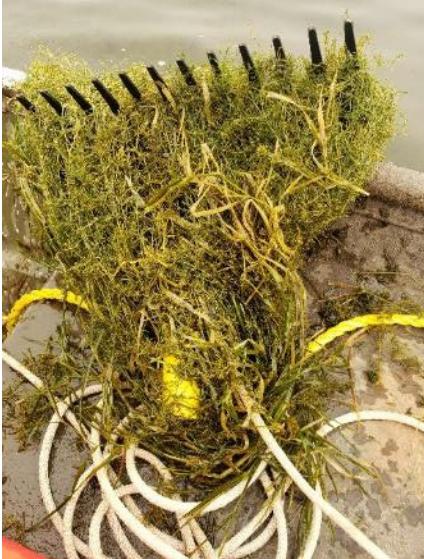
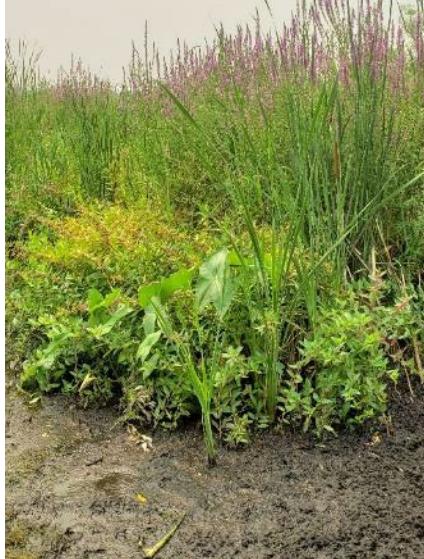
**Figure 20:** Macrophyte sampling with RCSWCD and VLawMO staff. Note the hazy sky is because major fires were burning in other parts of the country at the time

Boat, supplies, and shoreline vegetation	The sampling rake with a high amount of <i>Chara</i> , which is dominant in some parts of the lake	The survey was conducted at a time of low water. The shoreline is visible with arrowhead and Swamp loosestrife in the foreground and invasive Purple loosestrife in the background

For the aquatic macrophyte survey, 90 evenly spaced (40 m) georeferenced points were surveyed using the metal portion of a rake/tines tied to a rope. Aquatic macrophytes were found at 88 of 90 points surveyed. The two most common species observed were Flat-stem pondweed (*Potamogeton zosteriformis*) and *N. mucronata* (*Nitella mucronata*). Other species observed included Canada waterweed (*Elodea canadensis*), Coontail (*Ceratophyllum demersum*), Eurasian watermilfoil (*Myriophyllum spicatum*), Filamentous algae (*Spirogyra/Cladophora spp.*), Muskgrass (*Chara spp.*), Sago pondweed (*Stuckenia pectinata*), and Slender naiad (*Najas flexilis*). Although not collected on the rake, field staff observed Northern watermilfoil in the northern and southern areas of the lake.

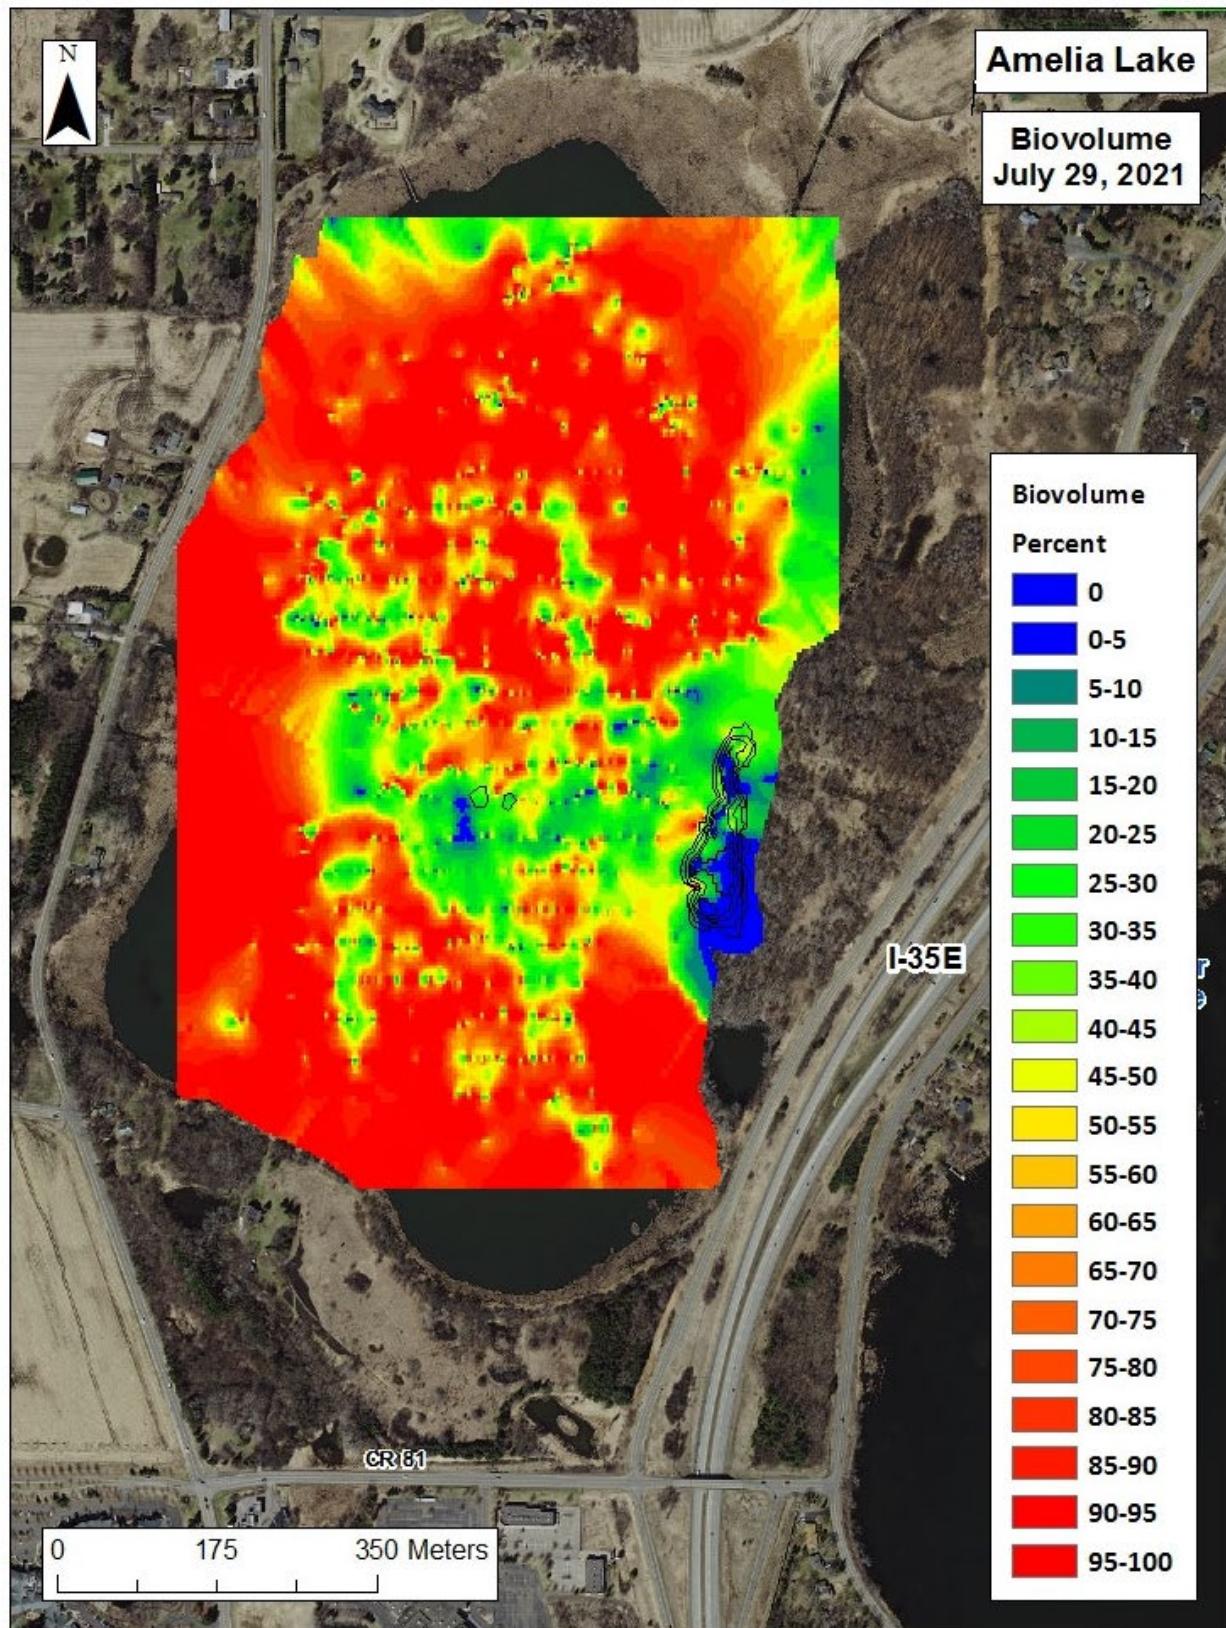
Figure 22: Amelia Lake biovolume

RCSWCD conducted a biovolume and aquatic vegetation survey on July 29, 2021, in Amelia Lake. Biovolume measures the density of plant life within the lake. Blue signifies 0% plant life, and red signifies 100% plant life. At depths greater than 4-6 feet, there is commonly no plant life in Minnesota lakes. Plant growth is limited because the sun does not penetrate the water column below those depths enough to allow photosynthesis to occur.

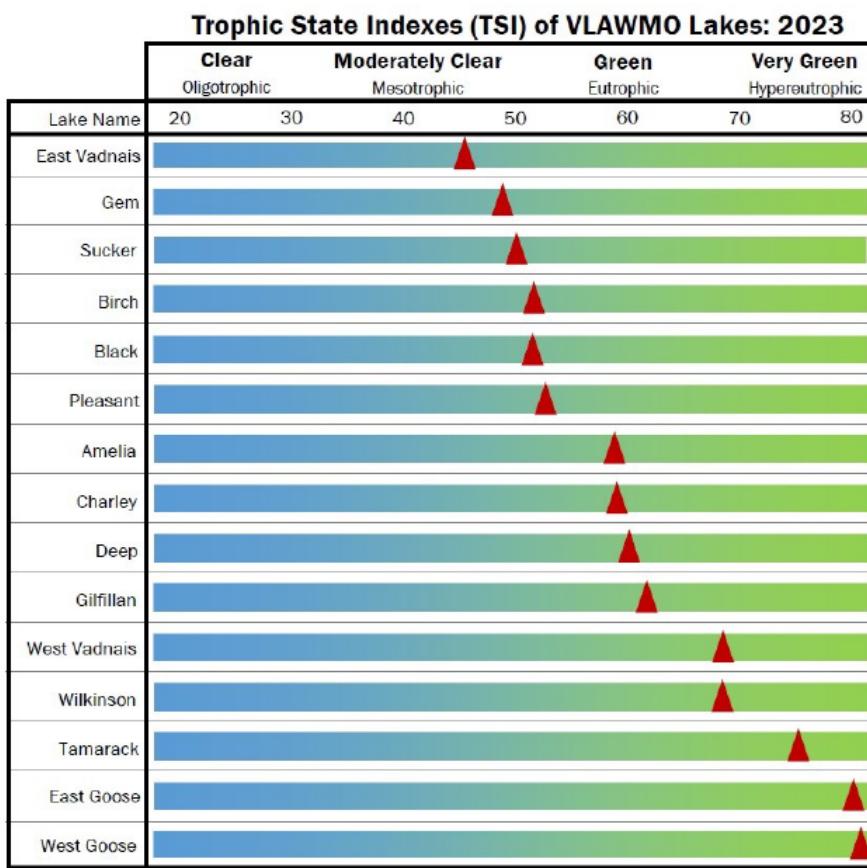
Figure 26: TSI scores for VLAWMO lakes

Amelia Lake is shallow and falls in the area of green/eutrophic on the Carlson Scale Trophic State Index (TSI) (shown below). Amelia Lake had a score of 59 in 2023, 59 in 2022, and 58 in 2021. Note: A higher number corresponds to poorer water quality, but trends are not detectable from a small sample of only a couple to a few years. Trends should be based on a larger, continuous dataset of approximately 10 years, as recommended by the MPCA. More information can be found in the annual VLAWMO Monitoring Report.

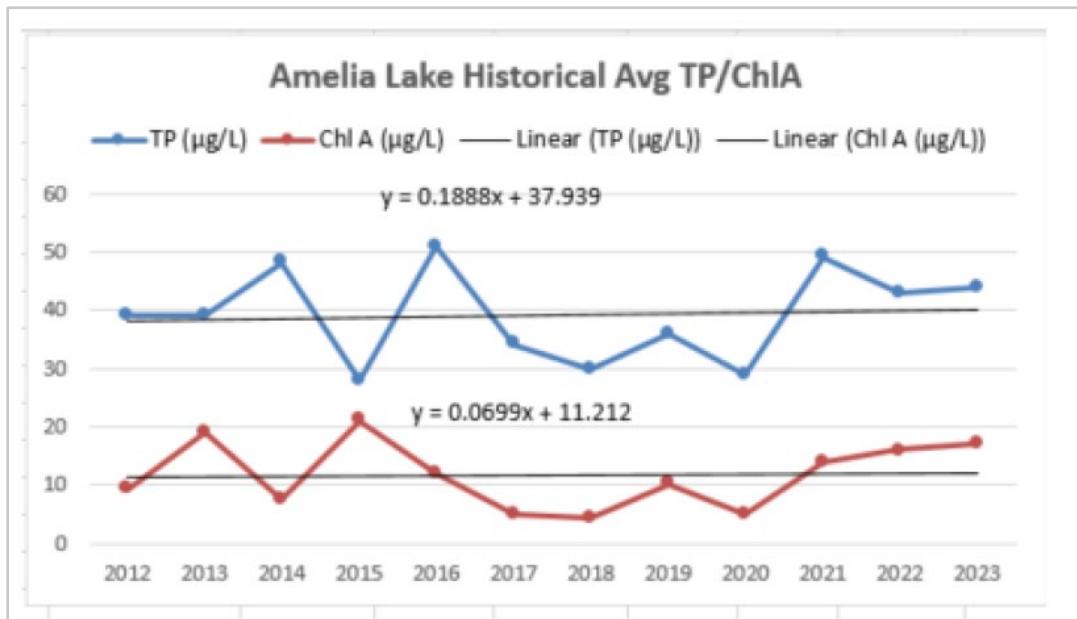
Figure 27: Water quality trends in Amelia Lake

VLAWMO has collected water quality (WQ) data on Amelia Lake since 1997. VLAWMO staff collects WQ data and water samples biweekly, May-September, for water clarity (secchi disk), nutrients (TP, Chl-a, SRP, nitrogen), and chemistry (temperature, conductivity, dissolved oxygen, and potential hydrogen [pH]). Total Phosphorus (TP) and Chlorophyll A (Chl-a) analyses are conducted by a contracted lab.
