**VADNAIS LAKE AREA WATER MANAGEMENT ORGANIZATION**  
**Amelia Lake Review,**  
**Ramsey County, MN**

**2024**

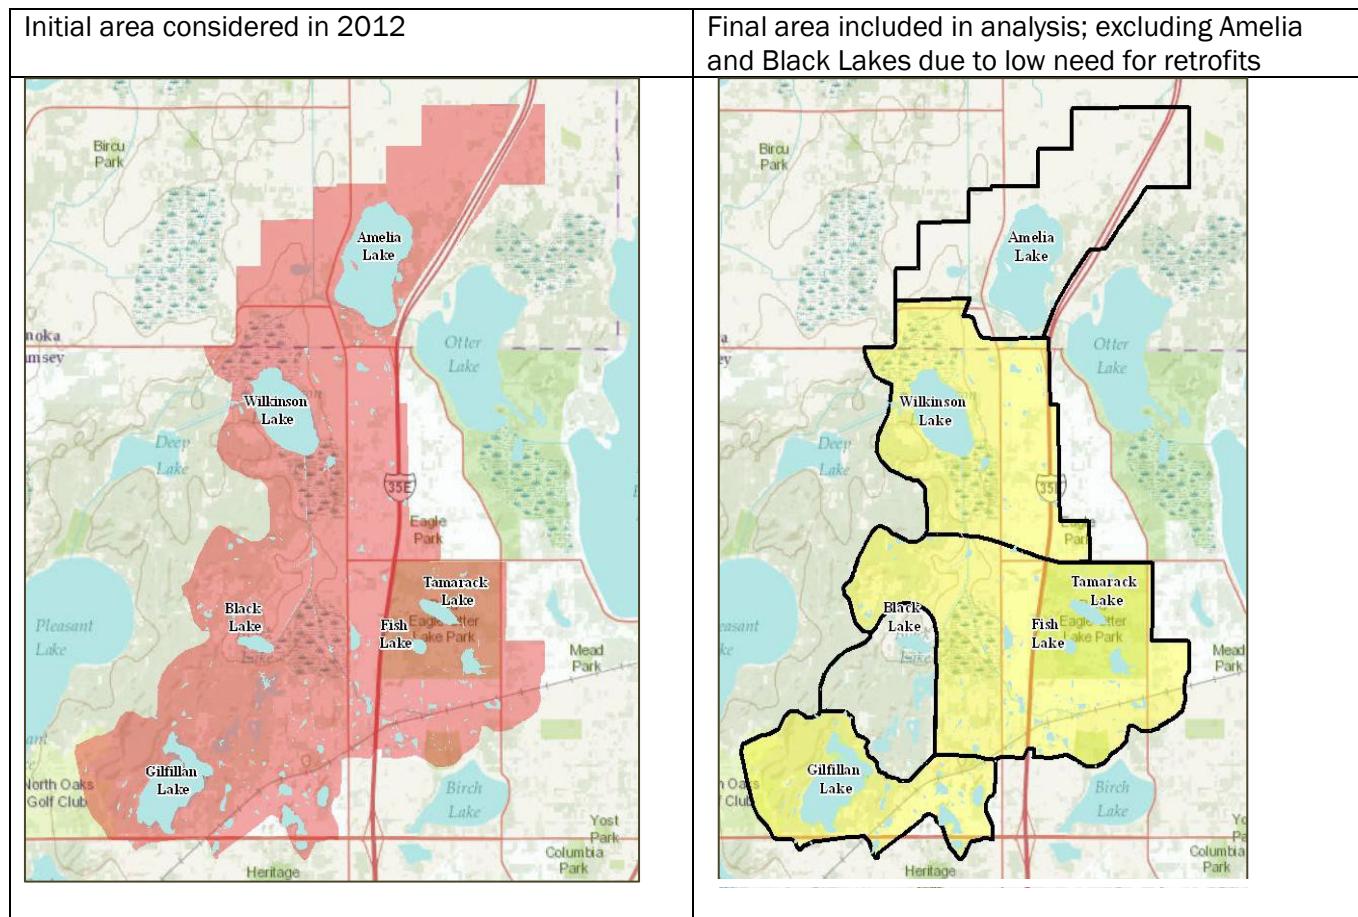
In 2012, the Ramsey Conservation District, now Ramsey County Soil and Water Conservation Division (RCSWCD), completed a Retrofit Report for the Gilfillan, Black, Wilkinson, Amelia, Fish and Tamarack Lake chain of waterbodies. This was part of a larger effort to assess the full watershed and subwatershed scales and identify optimal locations for BMPs. Although Amelia was considered in early development for the project, this lake was not included in the final analysis. As stated in the report at that time:

**Figure 28:** Initial and final areas considered for retrofit analysis
