**VADNAISS LAKE AREA WATER MANAGEMENT ORGANIZATION
Sustainable Lake Management Plan
Deep Lake, Ramsey County, MN**

**Prepared by Tyler Thompson and Dawn Tanner
December 2018**

VADNAIS LAKE AREA WATER MANAGEMENT ORGANIZATION SUSTAINABLE LAKE MANAGEMENT PLAN – DEEP LAKE DECEMBER 2018

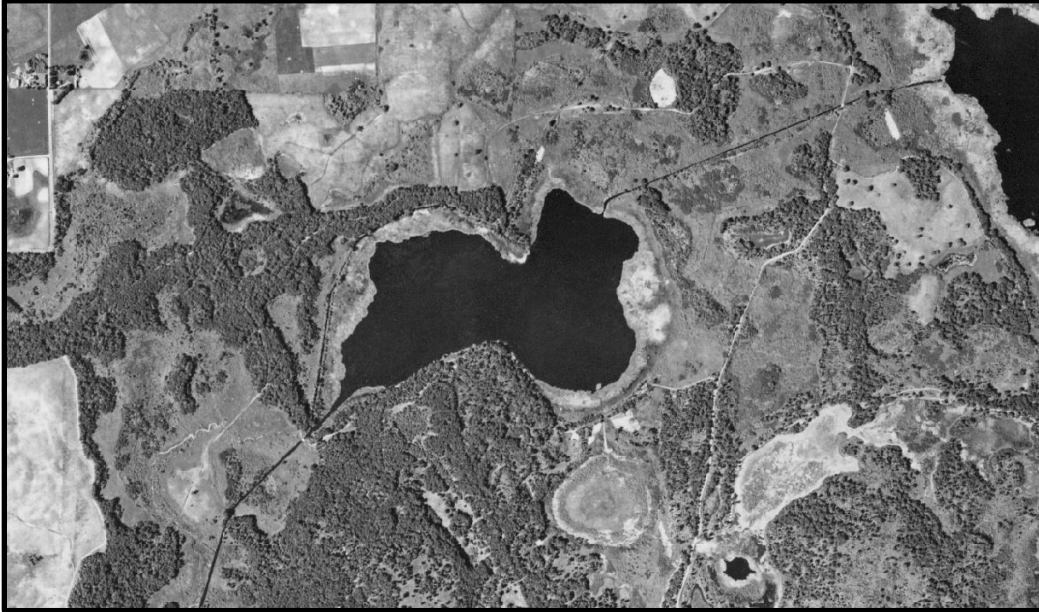
Figure 2: 1940 aerial photo of Deep Lake

In 1940, residential development had not yet begun in the area. However, hydrology and hydraulics had been modified by the St. Paul Water Department in the late 1800s to provide water from Centerville Lake for St. Paul drinking water.

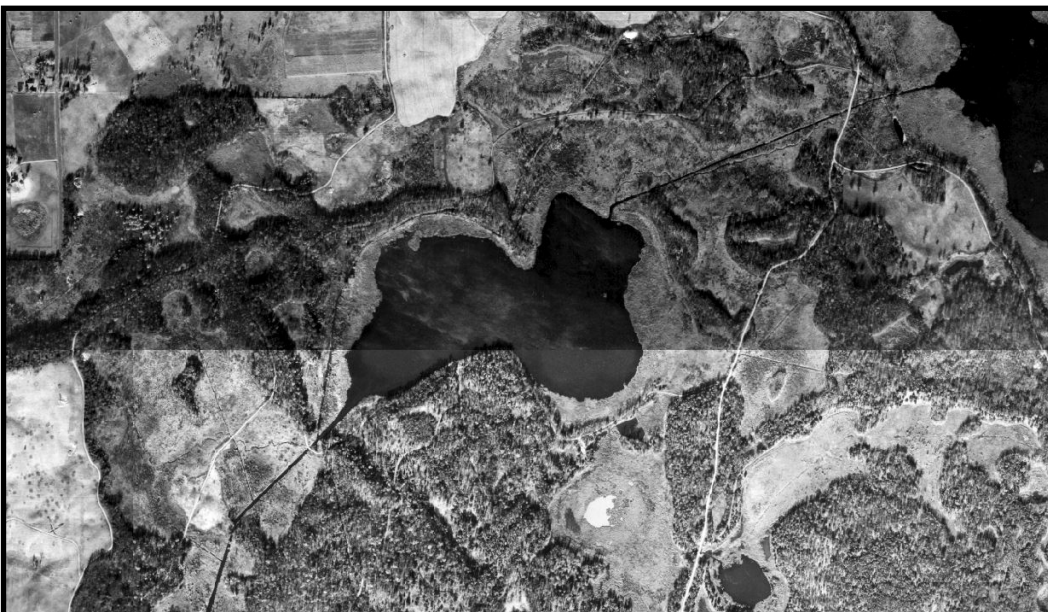
Figure 3: 1953 aerial photo of Deep Lake

In 1953, North Oaks was soon to be developed. In areas south and west of Deep Lake, most of the original James J. Hill farm and barn structures still existed. Trails and paths primarily used by the water utility are visible around Deep Lake.

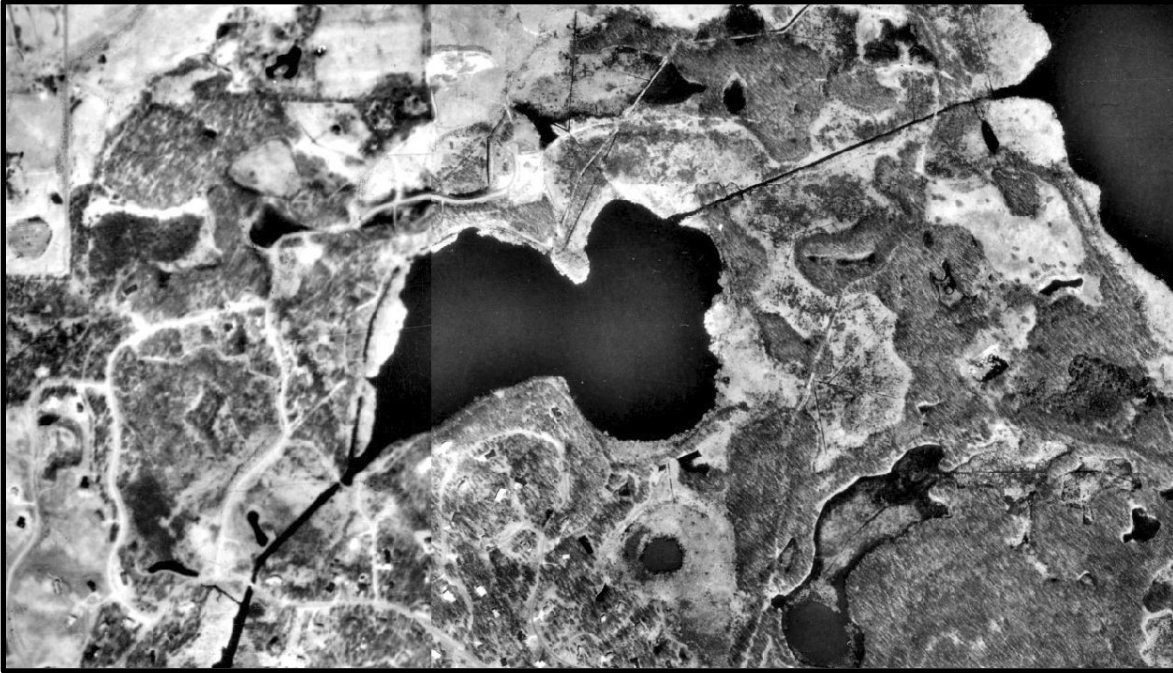
Figure 4: 1974 aerial photo of Deep Lake

In 1974, residential development of North Oaks is visible. Homes are present on the south shore of the lake. Development has begun on the south and west areas of the lake.

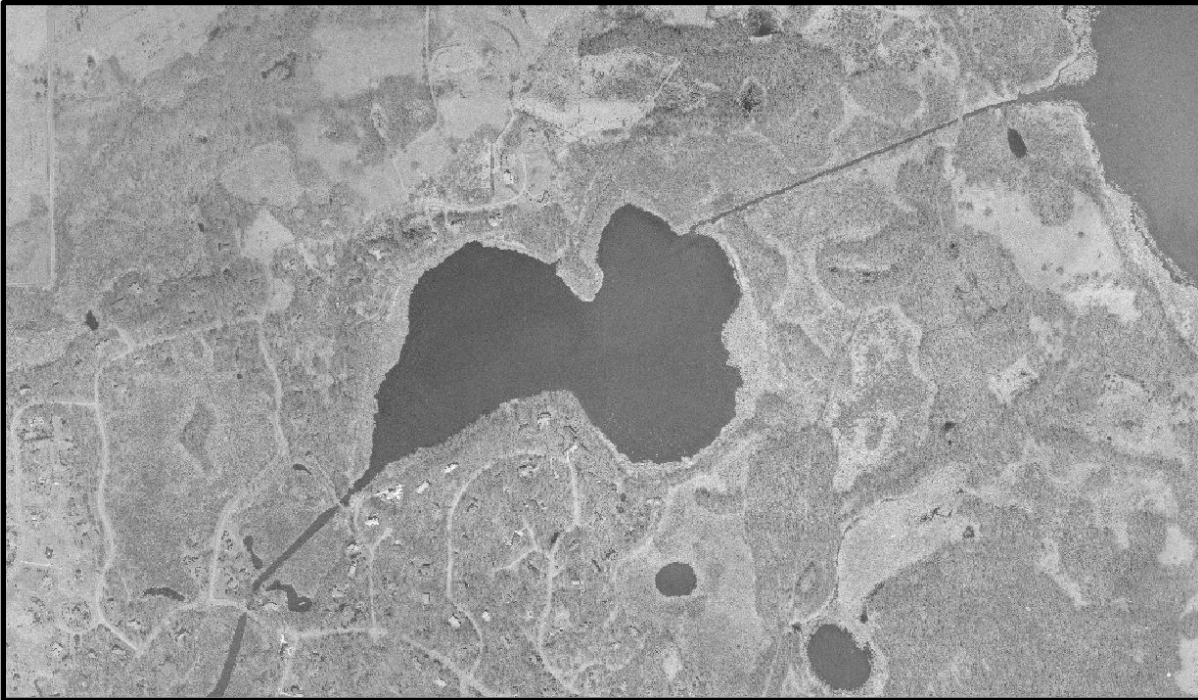
Figure 6: 1991 aerial photo of Deep Lake

In 1991, the first-phase residential development is complete around the lake and in the subcatchment.

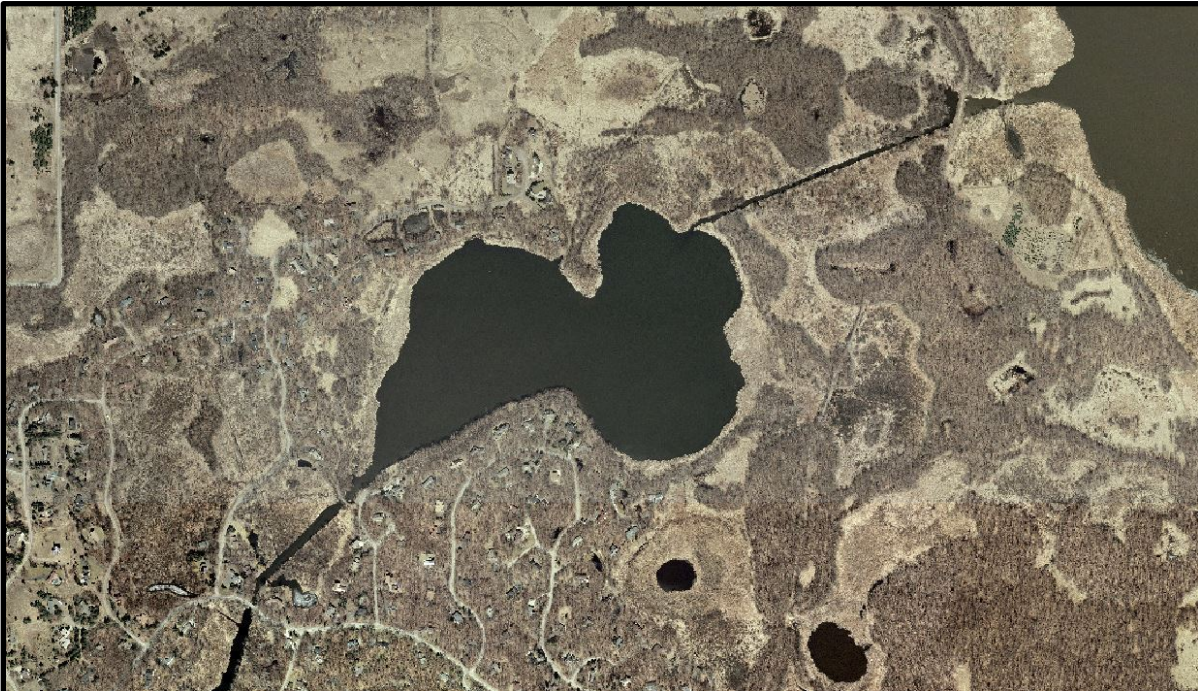
Figure 7: 2006 aerial photo of Deep Lake

In 2006, a few more houses are present in the north neighborhood of Deep Lake. It is not visible in this image, but the nearby Rapp Farm residential development has begun.

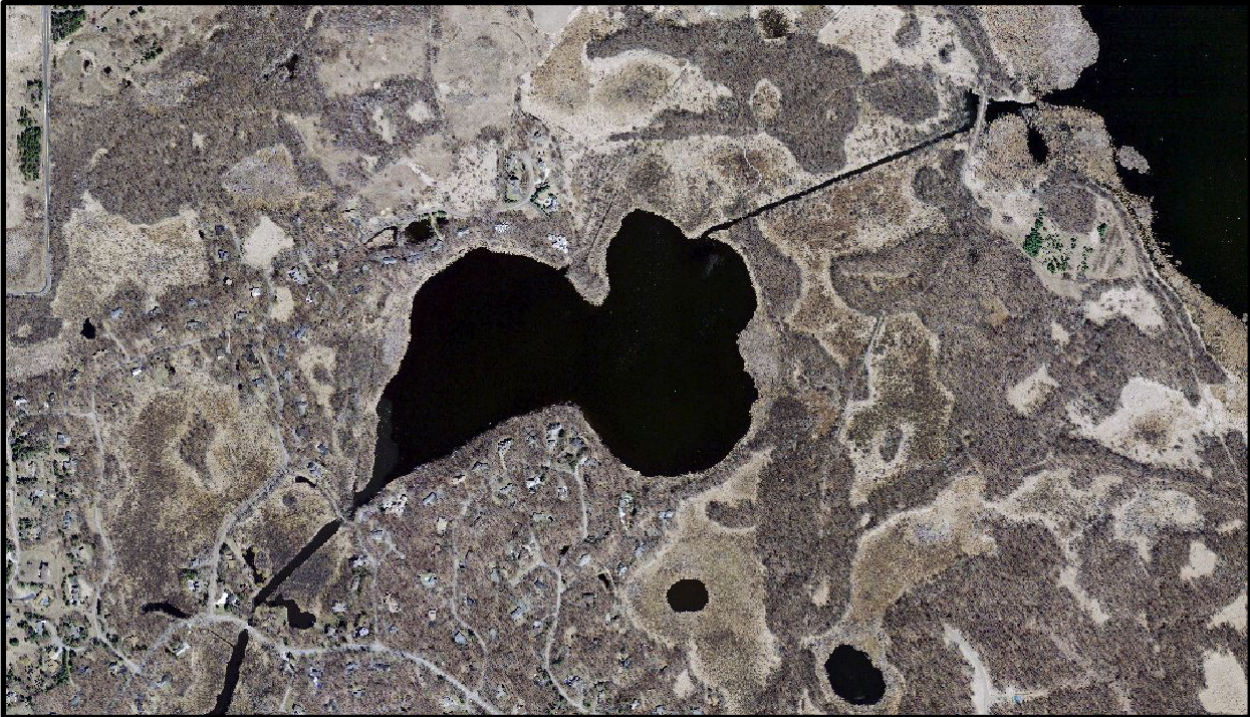
Figure 8: 2009 aerial photo of Deep Lake

In 2009, little has changed since the 2006 aerial.

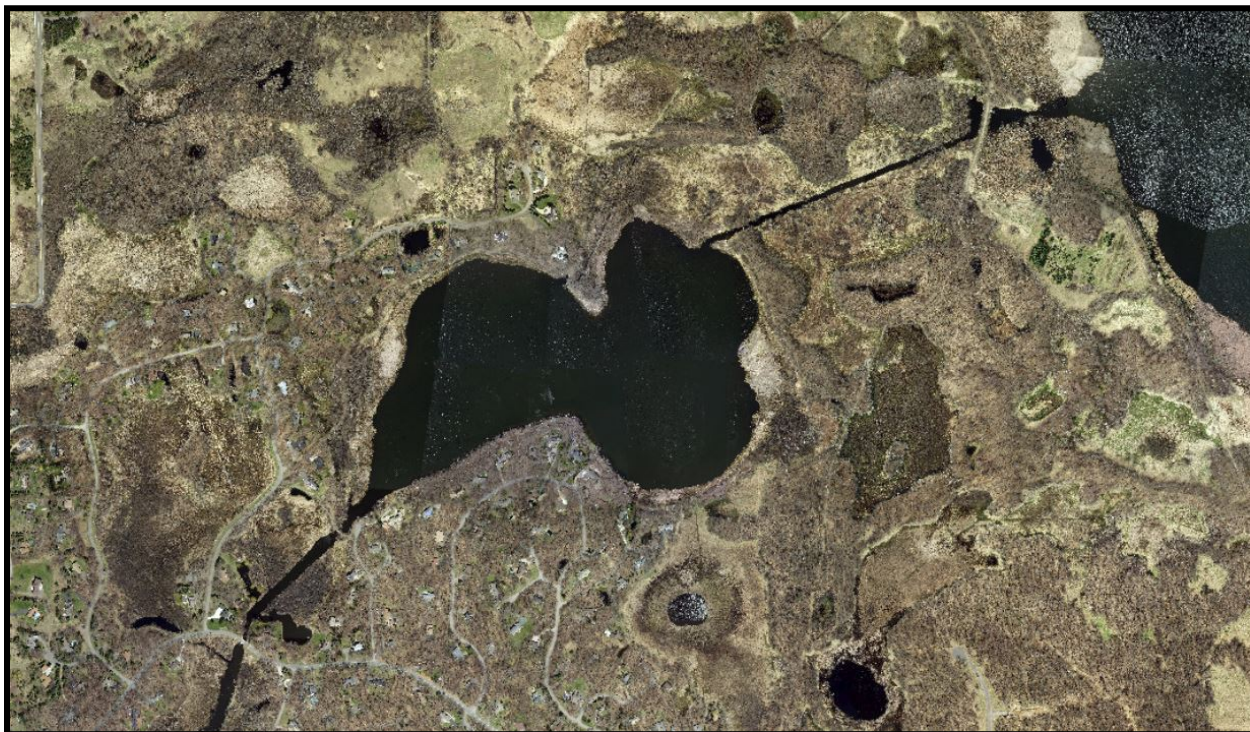
Figure 9: 2011 aerial photo of Deep Lake

In 2011, little has changed since the 2009 aerial.

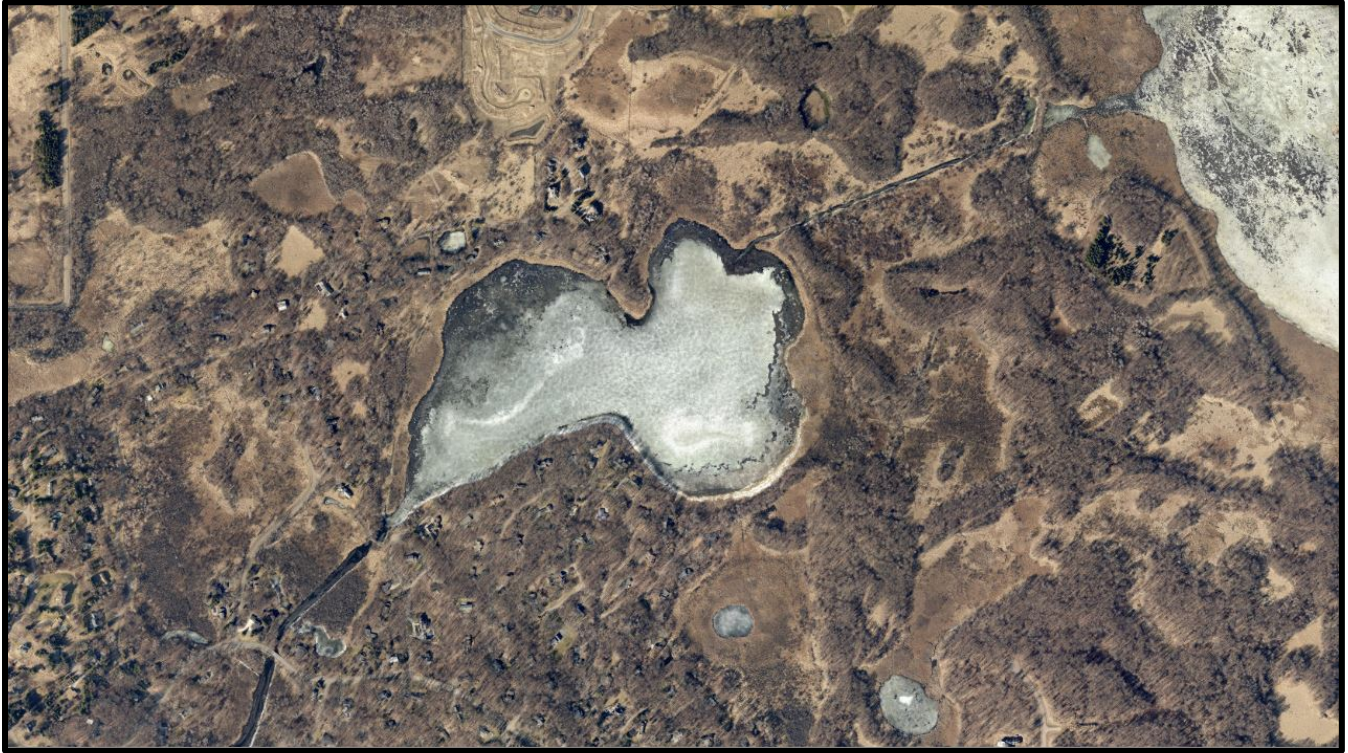
Figure 10: 2015 aerial photo of Deep Lake

In 2015, the Rapp Farm development has expanded to its furthest southern extent and is visible in the central top section of the aerial. The Rapp Farm development does not directly contribute runoff into Deep Lake, but it does lie within the lake's subcatchment area.

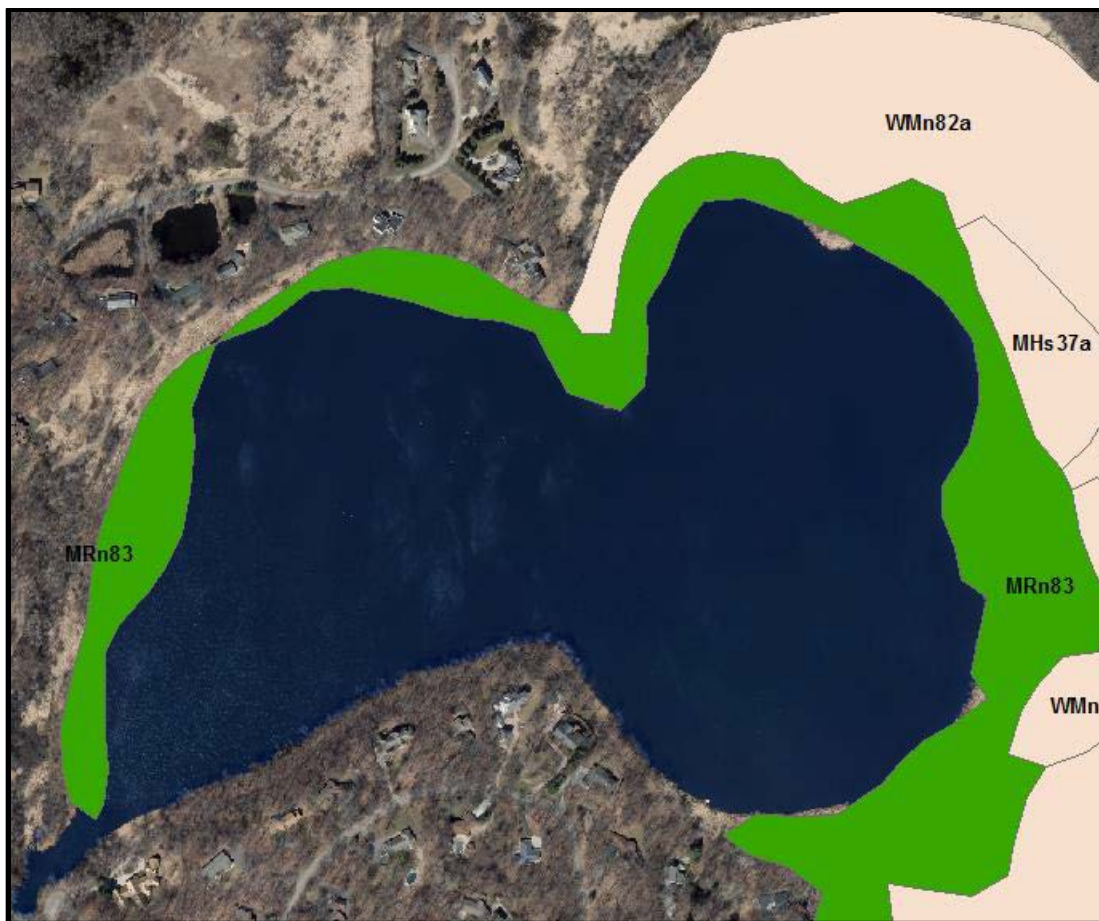
Figure 15: Deep Lake Shoreline Classification by Native Plant Community (left) as MRn83, or Northern Mixed Cattail Marsh, (Source: MNDNR Native Plant Community shapefile)

About 2/3 of the shoreline of Deep Lake is classified as Northern Mixed Cattail Marsh (MRn83) (Figure 15), (MN DNR, 2014). The remaining 1/3 of the shoreline is in the more developed and higher-elevation southern/southwestern perimeter of the lake. Wetlands in the Deep Lake Drainage are less disturbed than would typically be found in other developed areas because of the low-density development. Deep Lake wetlands provide habitat for native wildlife.

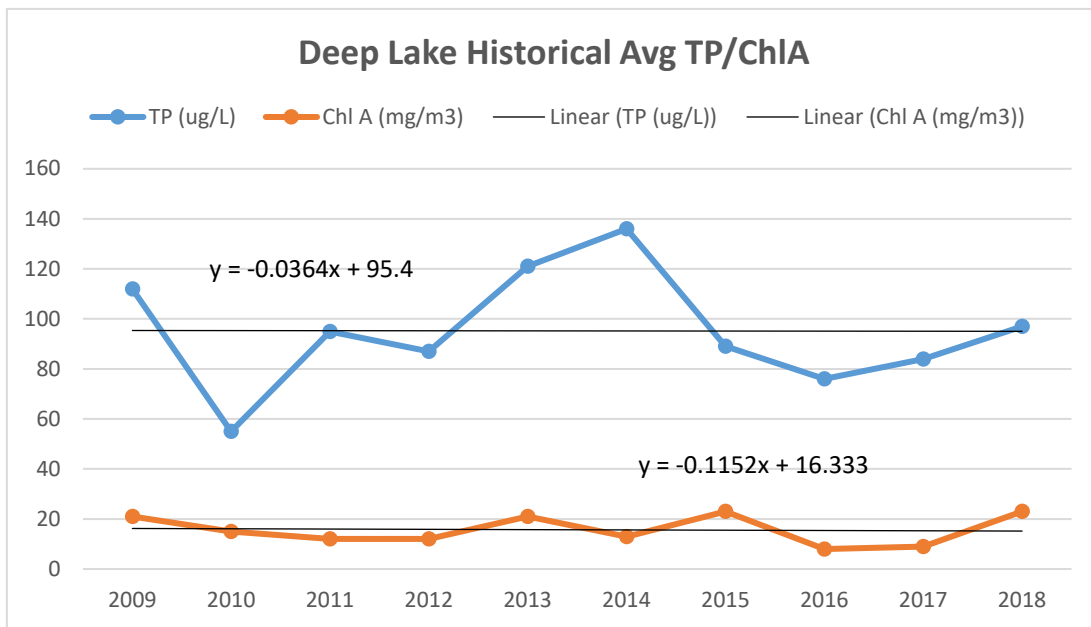
Figure 21: Historical Water Quality Averages in Deep Lake 2009-2018

Figure 21: The graph shows results of TP/Chl-a with a linear trend through time. TP levels consistently exceed the State Standard (60µg/L). Chl-a hovers around the value of 20µg/L. Water in Deep Lake is dependent upon SPRWS pumping rates, so any plans to improve nutrient levels need to consider the input of Mississippi River water. Some nutrient loading is likely also a product of receiving water from Wilkinson Lake upstream.
