LAMBERT CREEK

QUICK FACTS

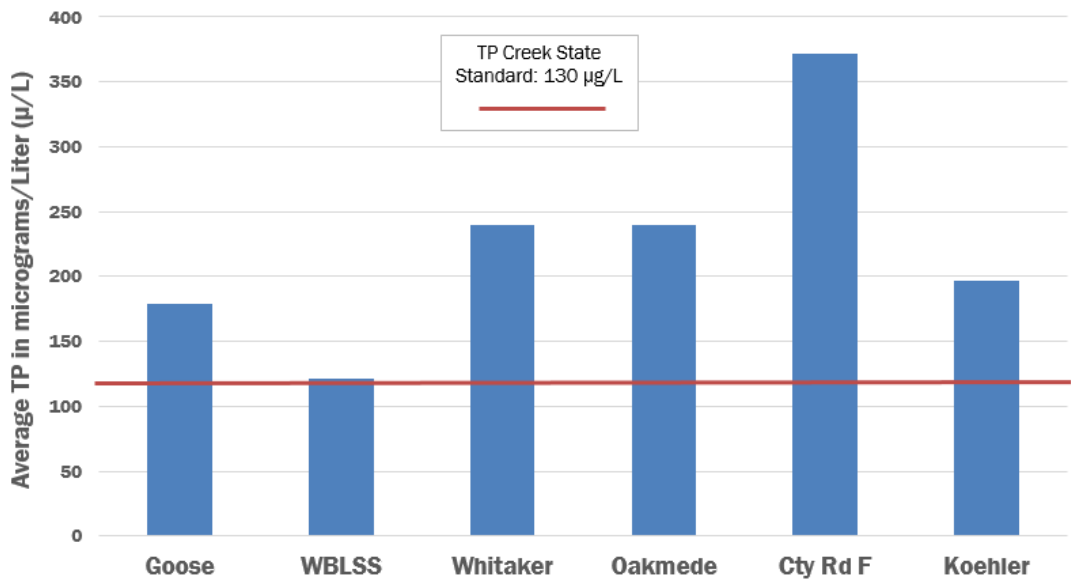
Average Total Phosphorus (TP) of each Lambert Creek Monitoring Site: 2010 - 2019

While TP in Lambert Creek is above State standards, nutrients levels show to have dropped over the last 20 years. The creation of multiple best management practices (BMPs) likely contribute to this progress. Lower phosphorus levels in Lambert Creek can support East Vadnais Lake and in turn the water treatment process at the Saint Paul Regional Water Services (SPRWS).

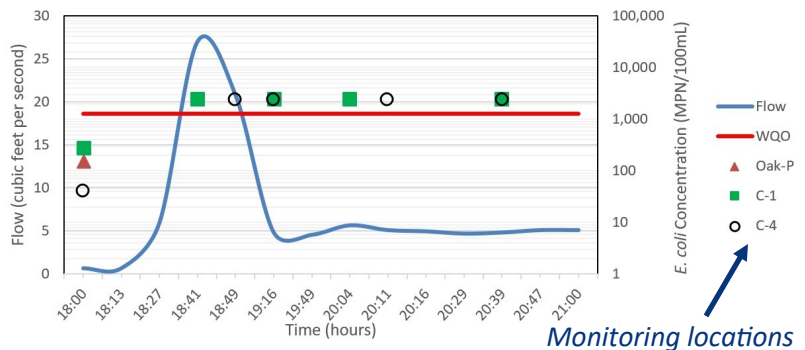
Lambert Creek Bacteria Levels at Oakmede: July, 2016

Water quality samples taken during a rain event indicate that pollutants wash into the creek during rain events with high flow rates (blue line). Bacteria levels remain above the state standard (red line) after the flow drops.

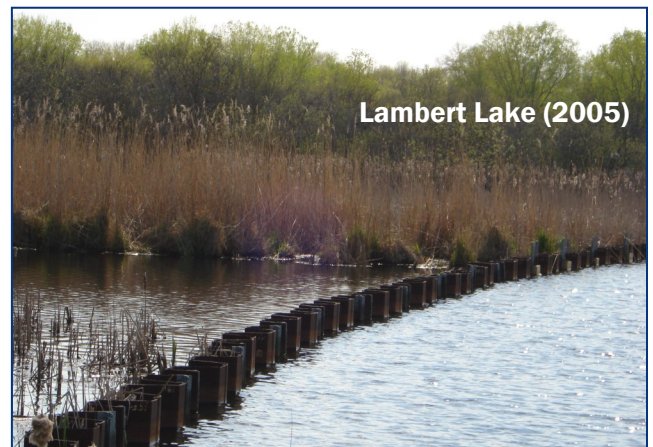
Three weirs have been constructed along Lambert Creek at sites of former shallow lakes and wetlands. The weirs restore water storage that has been lost from drainage and ditch creation. They also provide a space for sediment to settle out, which reduces sediment loading in the main Lambert Creek channel. Weirs also provide space for wetland functions, which includes storage, a space for water level fluctuations, and groundwater recharge. VLAWMO monitors and maintains these wetland complexes annually to ensure that they're functioning properly and to assess sediment accumulation.

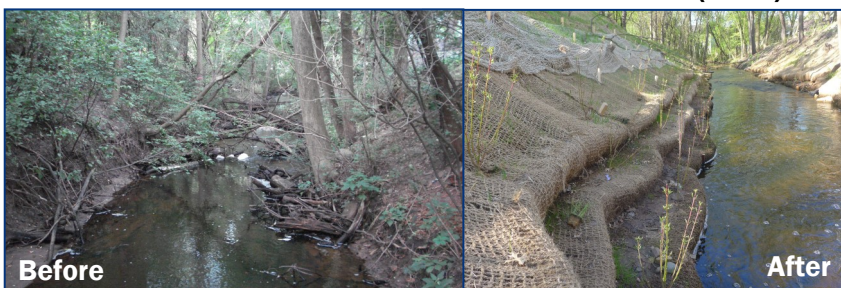
Lambert Creek bank restoration at Kohler Road (2017)

Three bank restorations have taken place from 2011-2017. These projects stabilize worn and degraded spots along the creek. The result is reduced erosion and nutrient input, which keeps the creek flowing efficiently and helps improve the water quality.
