History of WHITAKER POND

Subwatershed Size 640 acres
Average Depth 1 ft

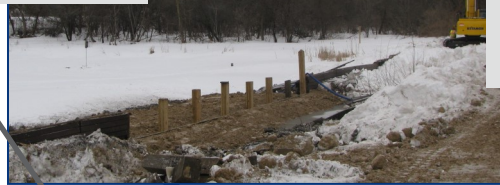
Weir #2 Install: 2010

Bags of sand/iron material were installed within a new weir. With Lambert Creek being impaired for high nutrients, this measure strived to reduce levels.

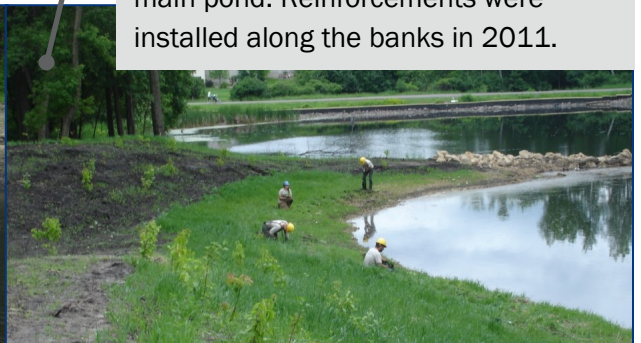
Forebay Construction: 2010

A forebay was built upstream from the main pond to provide a space for sediment to settle out. This reduces sedimentation in Lambert Creek and makes maintenance easier than in the main pond. Reinforcements were installed along the banks in 2011.

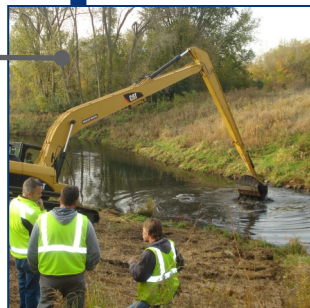
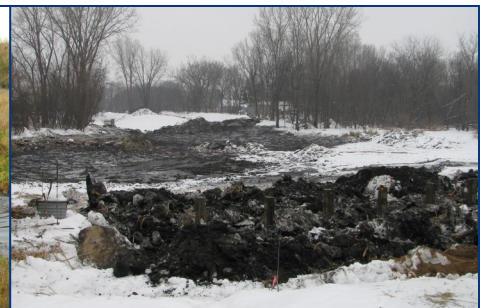
Dredging: 2015

Dredging took place in the main pond in 2010, and in the forebay in 2015. In 2015 80 cubic yards were removed, which was enough to fill 7 truck loads! The forebay is monitored each year by taking sediment core samples, and is dredged every few years to keep water storage optimal.

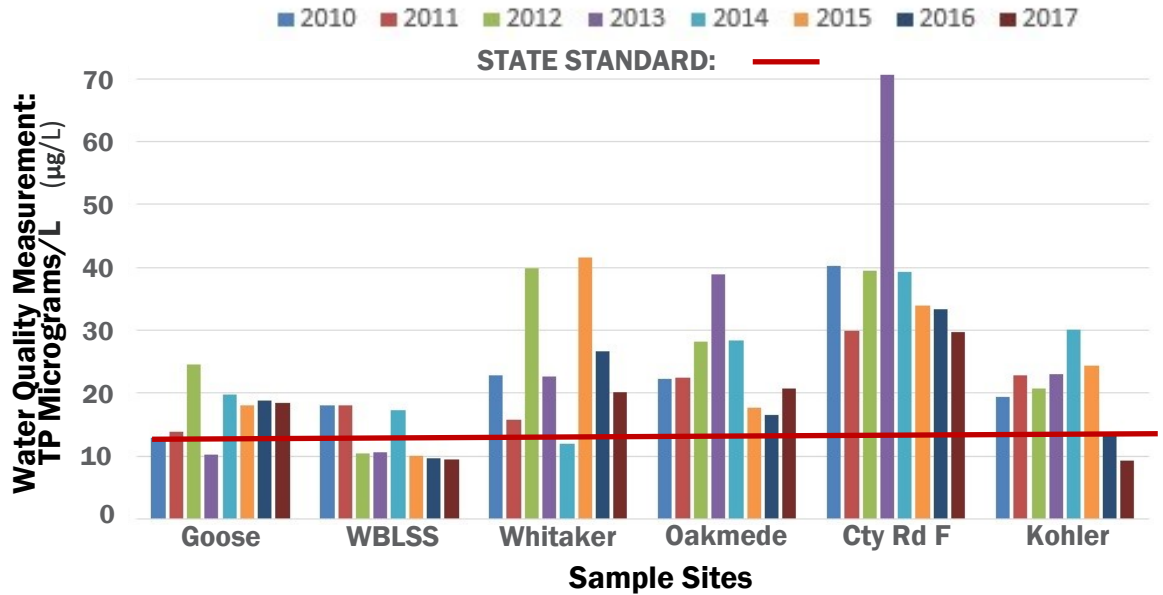
Lambert Creek Total Phosphorus (TP) Averages

Whitaker Pond is the start of Lambert Creek, which is an impaired water body. While TP in Lambert Creek is above State standards, nutrient levels show they're dropping over the last 20 years. The creation of multiple best management practices (BMP's) contribute to this progress. Lower phosphorus levels in Lambert Creek have a direct connection to cost savings for where Lambert Creek ends up; Vadnais Lake and the Saint Paul Regional Water Services (SPRWS).

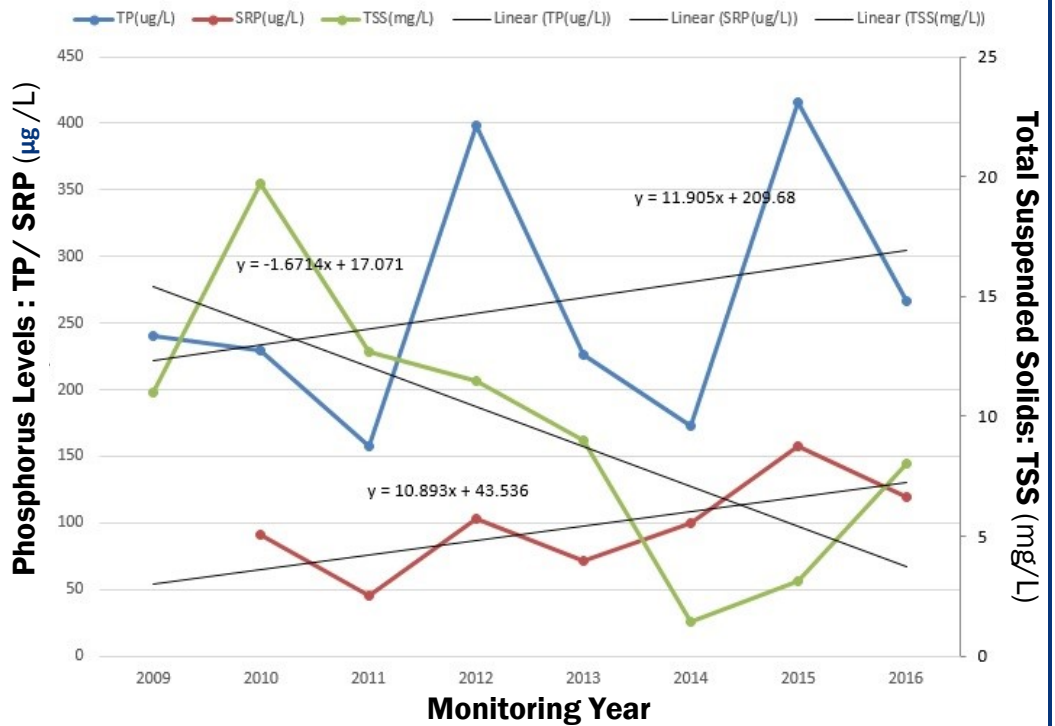
Whitaker Pond Historical Water Quality

The nature of the pond is dramatic, with high and low flashes depending on rainfall. Total Phosphorus (TP) and Soluble Reactive Phosphorus (SRP) levels show an increase. Sediment levels continually rise but drop when dredging occurs.

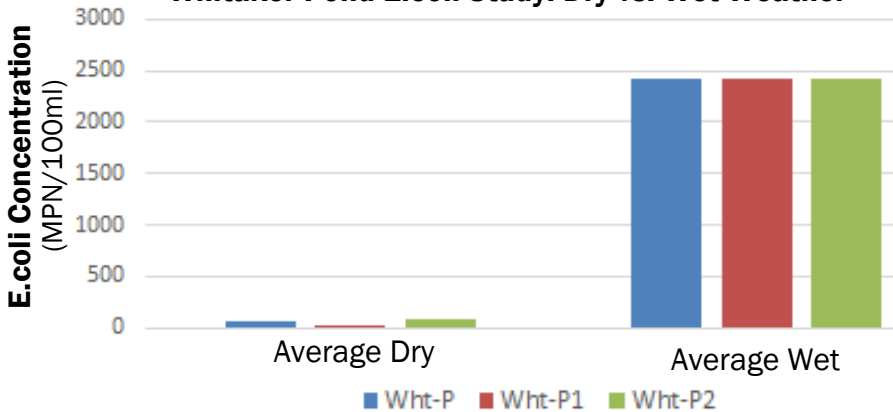
Whitaker Pond E.coli Study: Dry vs. Wet Weather

E.coli levels in the pond were studied in 2016-2017 comparing before (dry) and after (wet) rainfall. Results indicated from three sample locations that E.coli levels rise when surface runoff washes into Whitaker Pond after a rain event. DNA analysis showed that the E.coli levels are primarily avian and canine, with a small portion being human derived.
