VADNAIS LAKE AREA WATER MANAGEMENT ORGANIZATION
Gilfillan Lake Review
Ramsey County, MN

2024

Vadnais Lake Area Water Management Organization
800 County Road E East
Vadnais Heights, MN 55127
651-204-6070
www.vlawmo.org

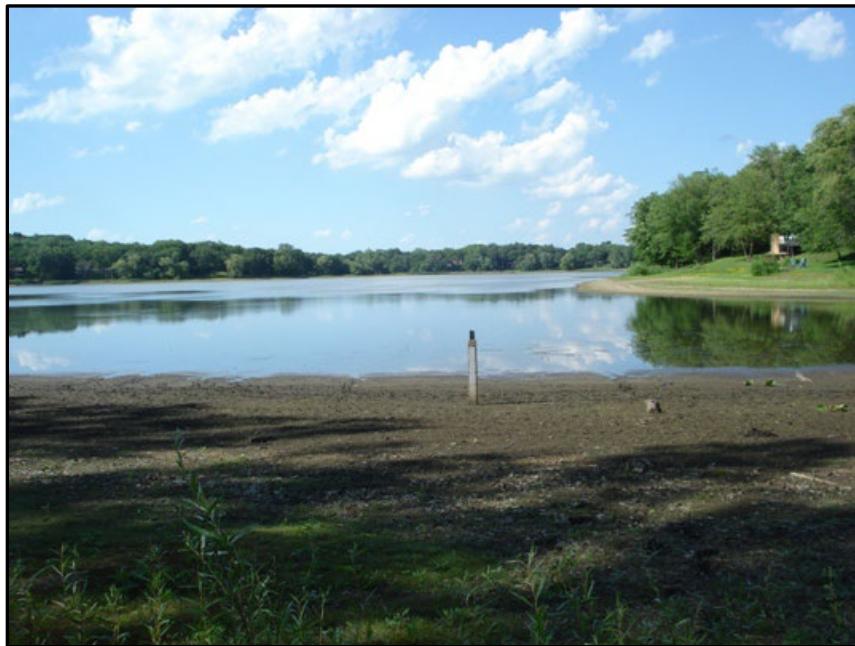
The photo below shows the exposed water level gauge and lake bottom in July 2009, when water levels were especially low.

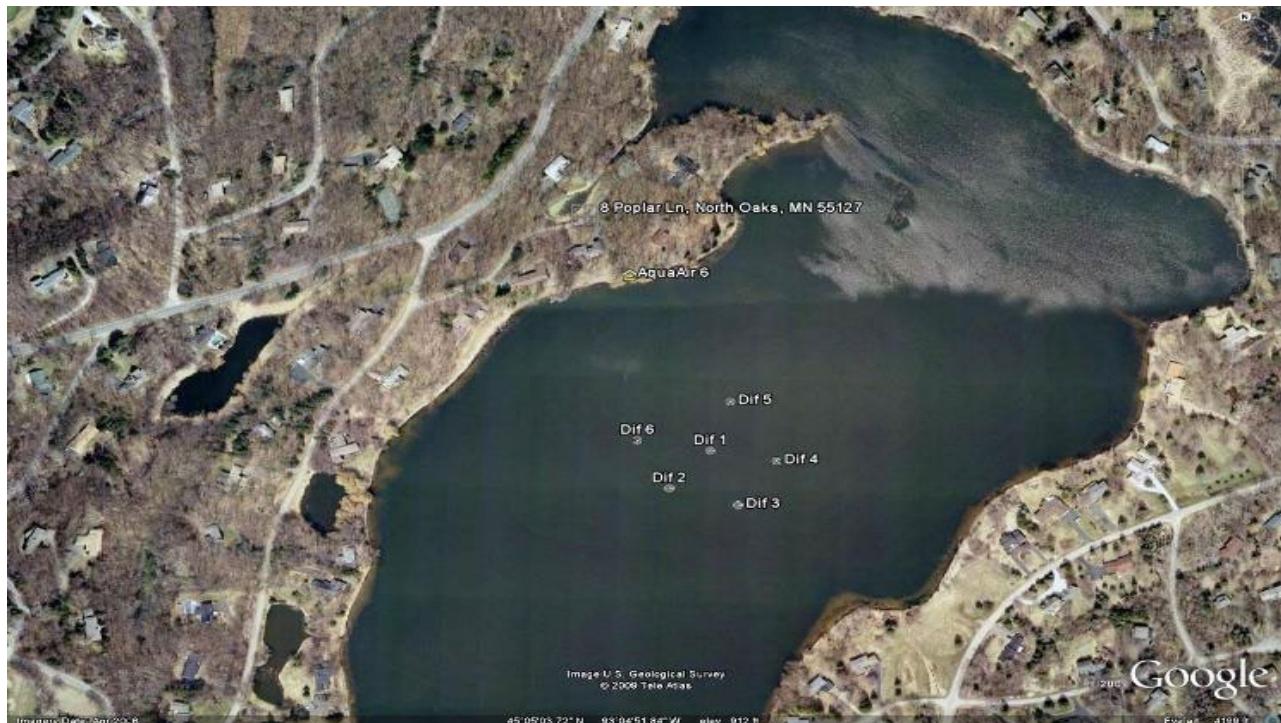
Figure 26: Aerator Location

In the fall of 2009, the Lake Gilfillan Watershed Association raised private funds to install an aeration system on the lake. The hope was that the aeration would keep the shallow lake well enough oxygenated and partially open through the winter to help limit the severity of potential fish kills. Also, the aeration will help with the mixing of the water table and may eventually help reduce the high chlorophyll levels in the lake by limiting the amount of time the chlorophyll is exposed to the sunlight. Below is a map showing the location of the unit.

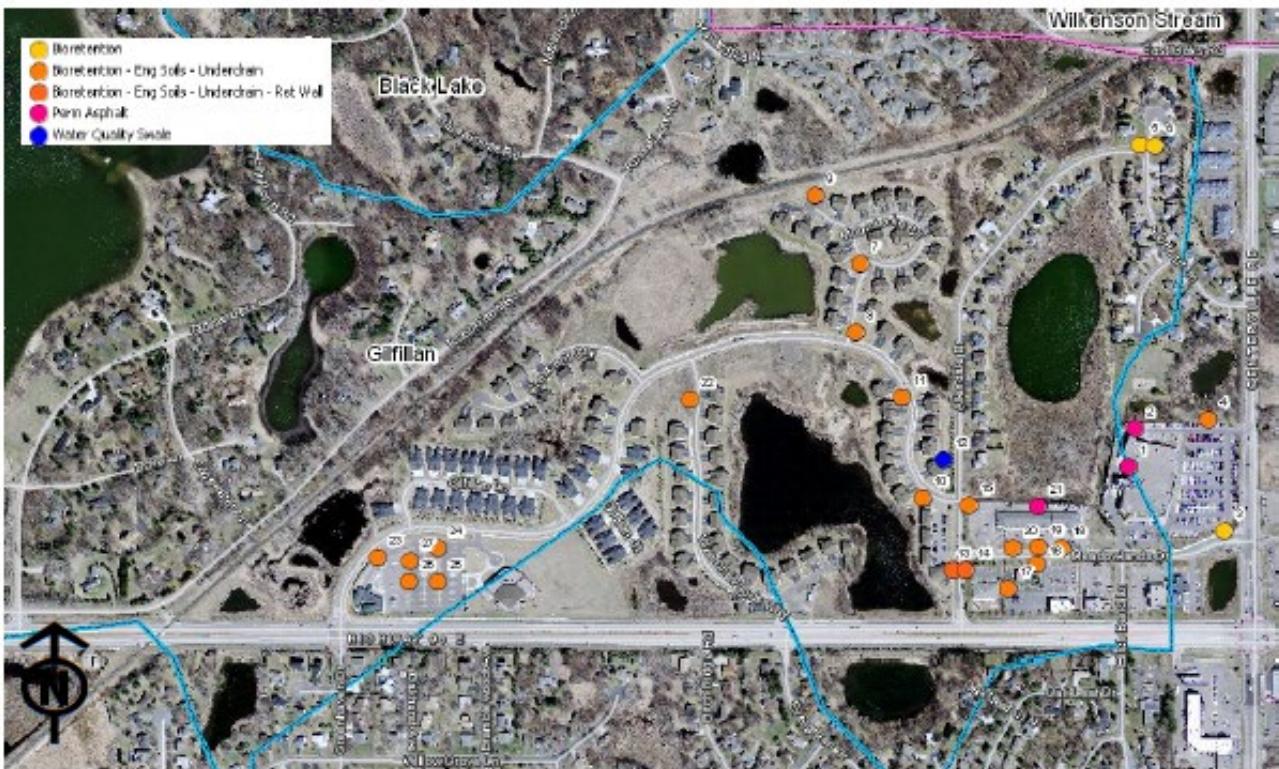
Figure 27: Gilfillan Lake Subwatershed: Locations recommended for retrofits with description in table below.

All of the retrofit locations were identified on the east side of the Gilfillan catchment, within the more urban area consisting of residential duplexes and commercial complexes, and include bioretention, dry swale and permeable asphalt. Sites identified were all on private land so cooperation of landowners will be required during the planning and installation of projects. As assumed bioretention basins capturing runoff more from roads combined with larger drainage areas were at the top of the list for installation. Twelve individual bioretention cells and 4 sites with multiple bioretention cell clusters were identified. The potential to install a water quality swale (dry swale) to capture runoff from a large grassy area and roof tops of several duplexes was identified in a current swale consisting of eroding turf grass. Options for permeable asphalt were identified in paved parking lot locations consisting of larger drainage areas with limited space for bioretention. If removing parking space/pavement to replace with bioretention is an option at these locations the bioretention would be a more efficient cost-effective retrofit alternative than the permeable asphalt. Site ID location 1,2,3,4 was a combination of the permeable asphalt and bioretention sites that were identified on the Cub Foods complex. These clusters were also modeled individually to compare options. It is suggested that retrofits proposed be considered from the top of the list down also taking in to account overall ease of installation. If all retrofit opportunities are installed 8.88 lbs of TP would be removed from the catchment resulting in a 2.5% decrease from the base load.

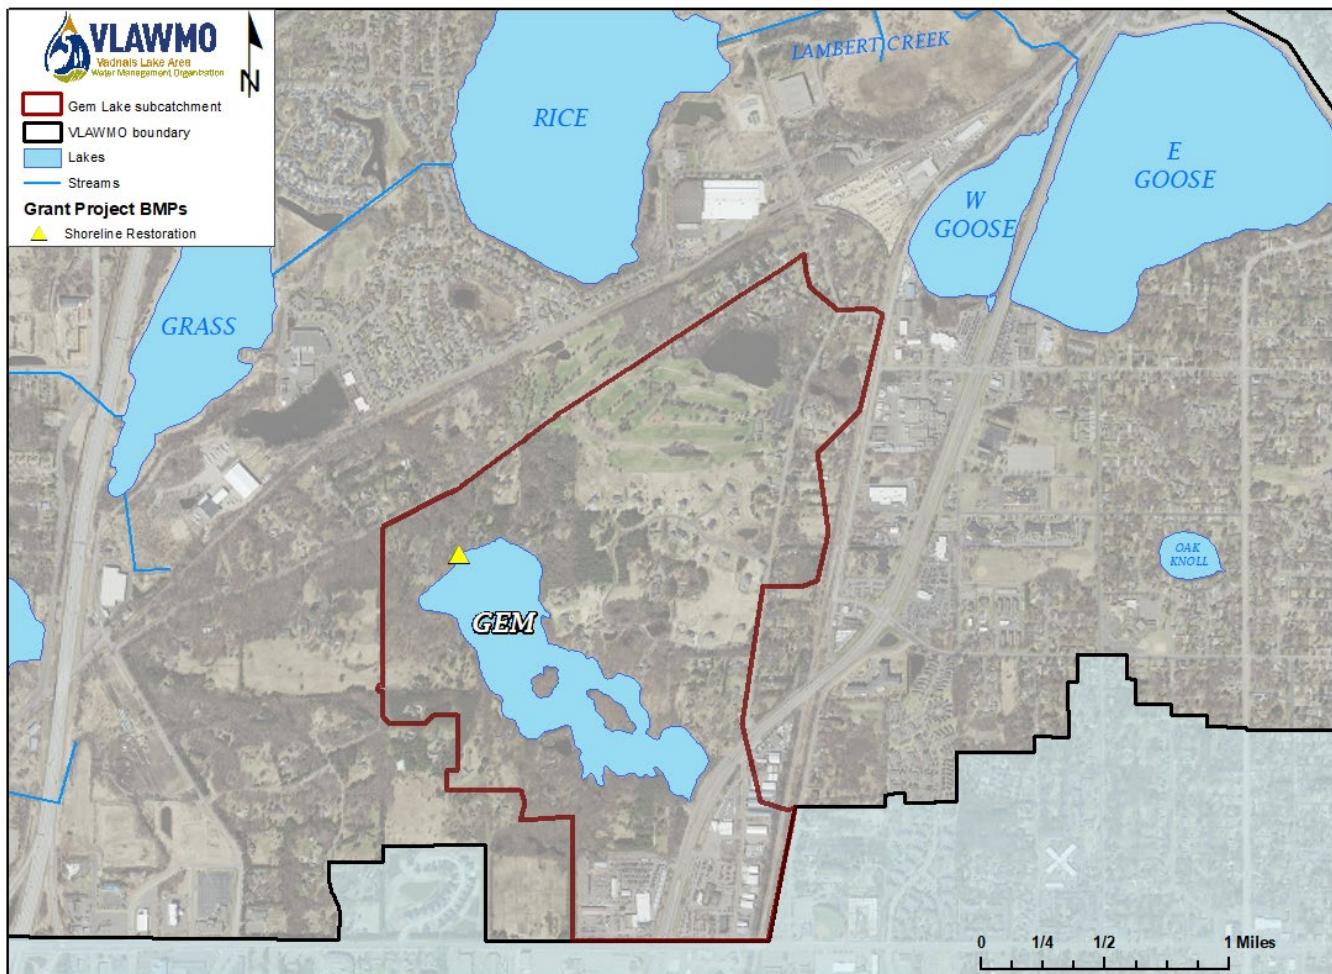
Figure 25: Gem Lake subwatershed implemented projects and BMPs.
