VADNAISS LAKE AREA WATER MANAGEMENT ORGANIZATION
Sustainable Lake Management Plan
Charley Lake, Ramsey County, MN

Prepared by Kristine Jenson, Tyler Thompson, and Dawn Tanner
December 2018

VADNAIS LAKE AREA WATER MANAGEMENT ORGANIZATION SUSTAINABLE LAKE MANAGEMENT PLAN: CHARLEY LAKE DECEMBER 2018

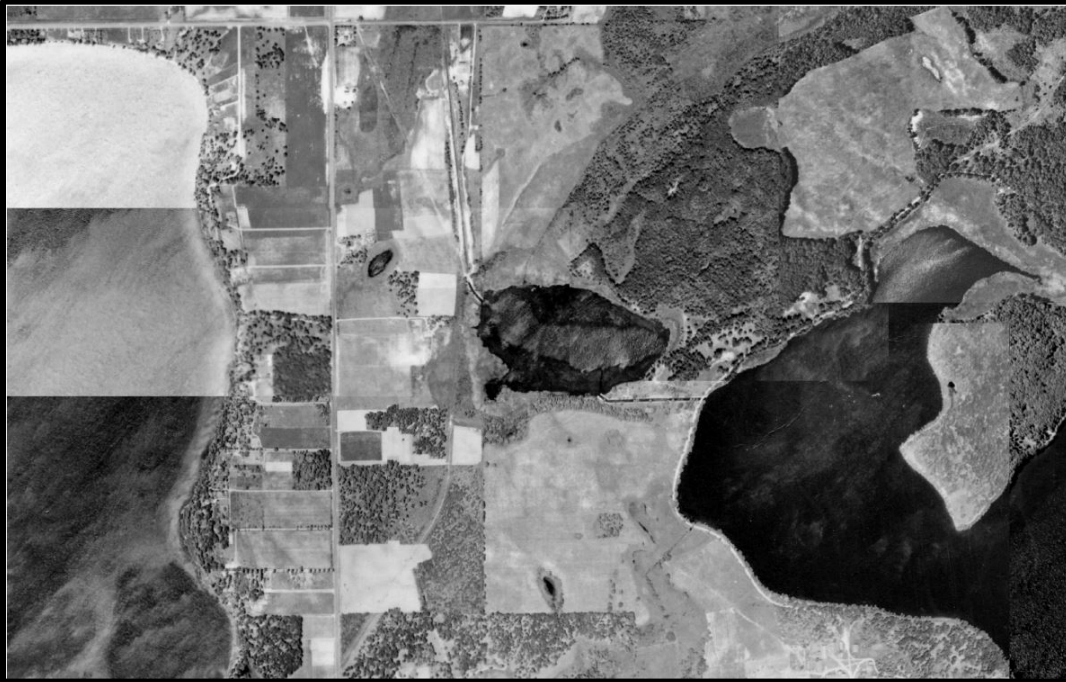
Figure 2: 1940 aerial photo of Charley Lake

In 1940, there are agricultural clearings and lake homes on Turtle Lake. The channel on the NW side of the lake appears to connect to Baldwin Lake. County Rd I and Hodgson Rd are present.

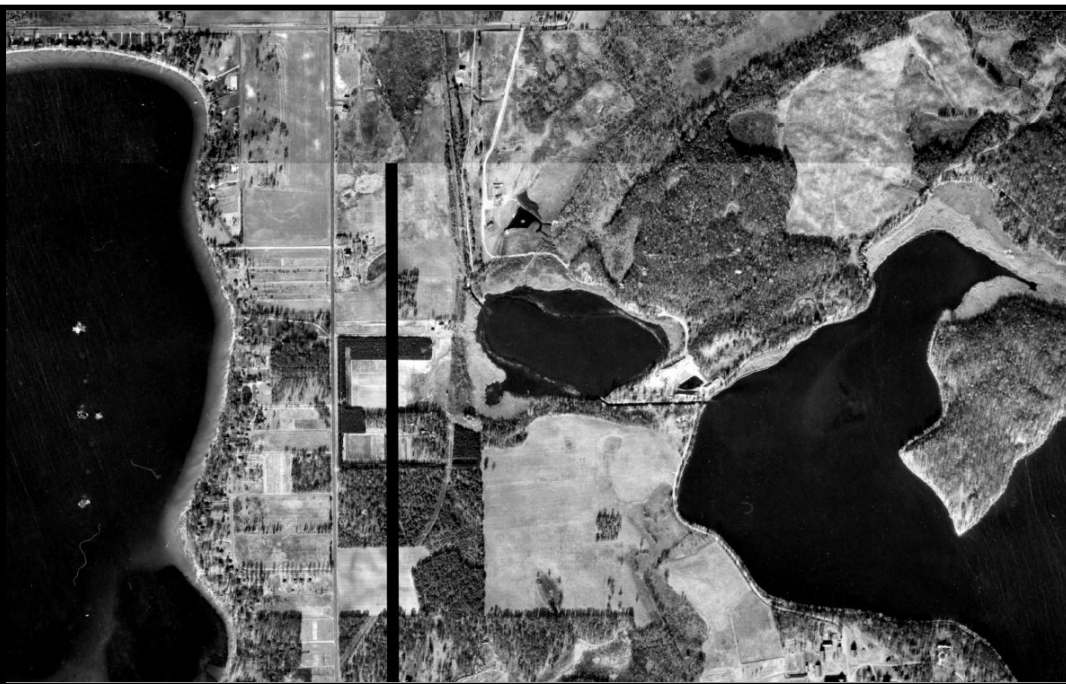
Figure 3: 1953 aerial photo of Charley Lake

In 1953, a road and a few buildings on the north side of the lake have been built.

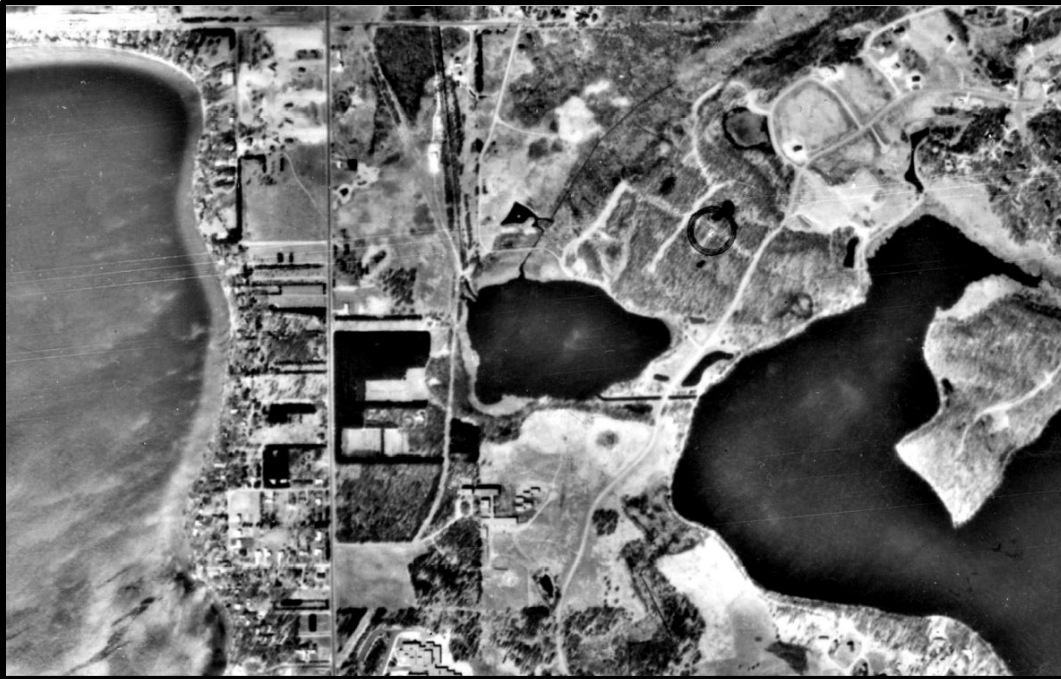
Figure 4: 1974 aerial photo of Charley Lake

By 1974, the residential development of North Oaks has begun, the convent south of Charley has been built, and the aqueduct pumping water from the Mississippi connects to the North Oaks chain of lakes by entering through Charley.

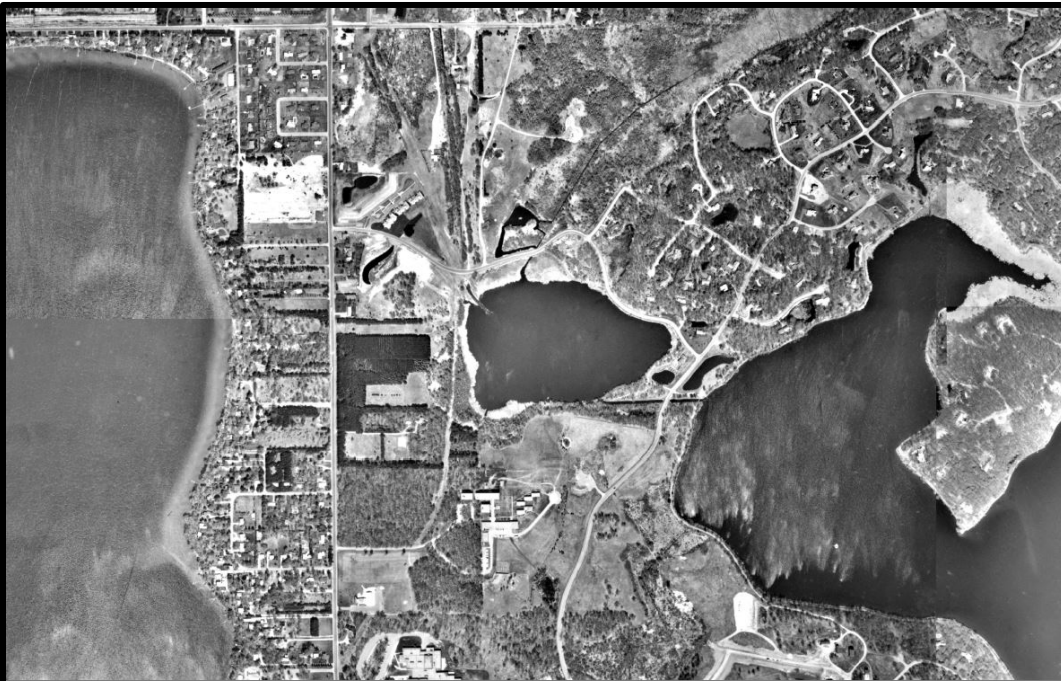
Figure 5: 1985 aerial photo of Charley Lake

In 1985, early residential development north of Charley is in place, some homes have been added off Hodgson Road, and residential development out of frame to the north has begun.

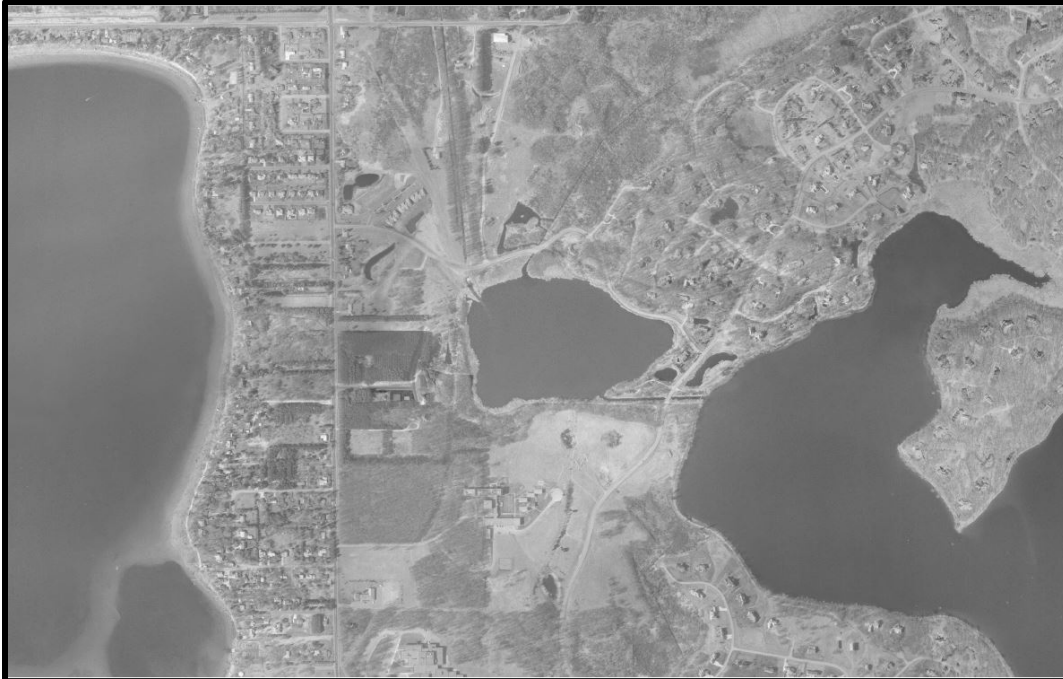
Figure 6: 1991 aerial photo of Charley Lake

In 1991, the first-phase development within the Charley subwatershed catchment has been completed.

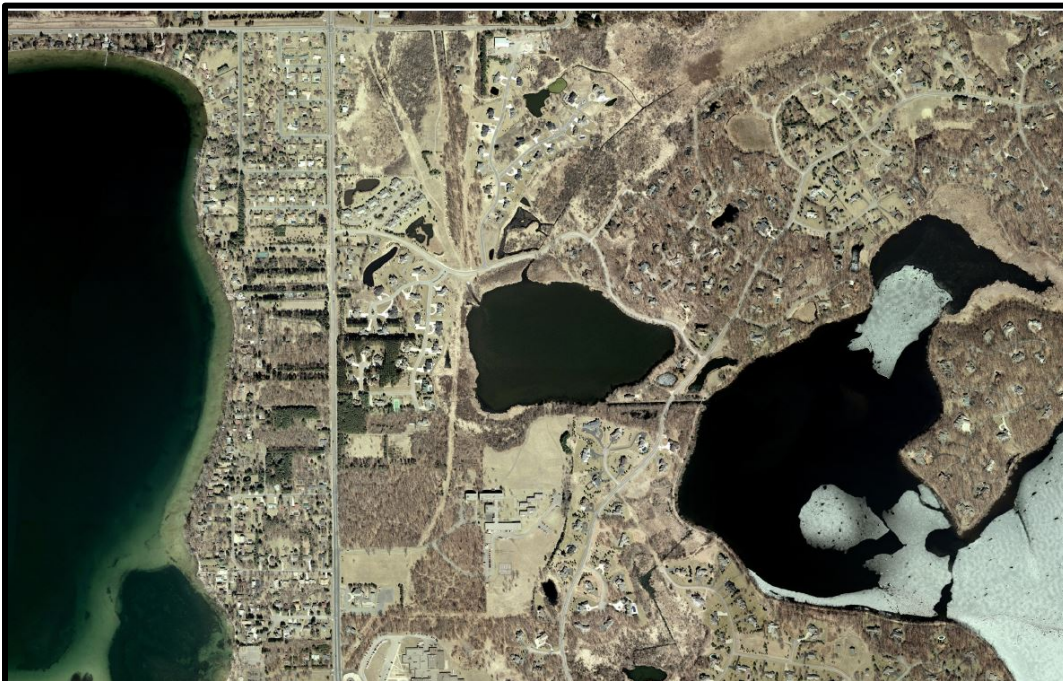
Figure 7: 2003 aerial photo of Charley Lake

In 2003, more development has been added to the north and west of Charley, and development is underway to the south of Charley Channel.

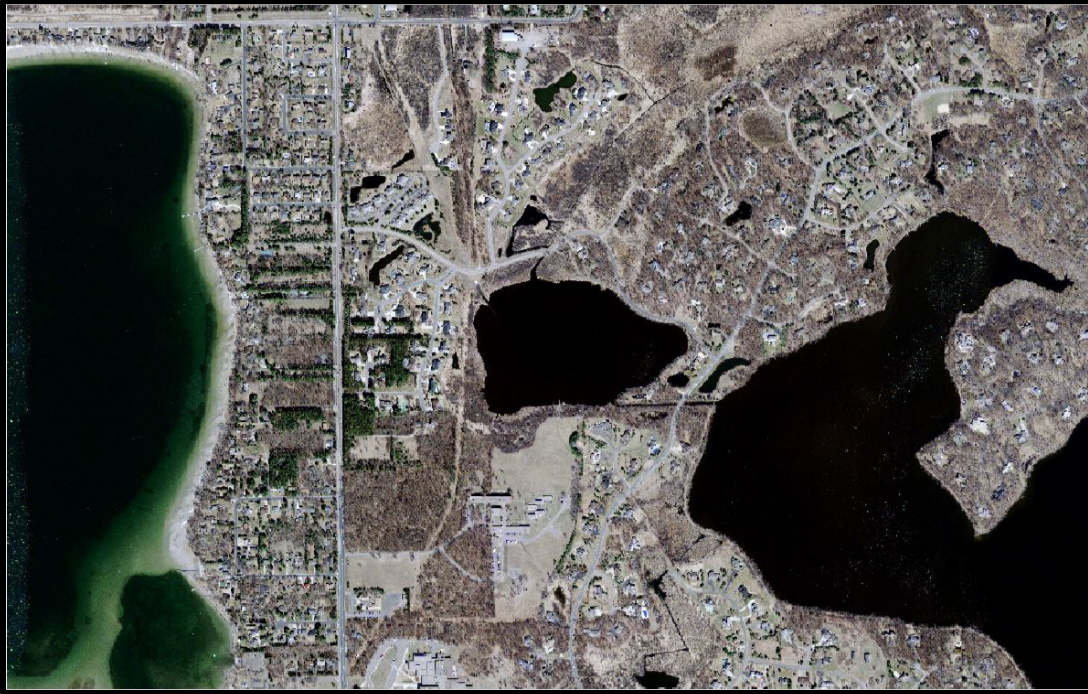
Figure 8: 2009 aerial photo of Charley Lake

In 2009, there is little has change since the 2003 aerial.

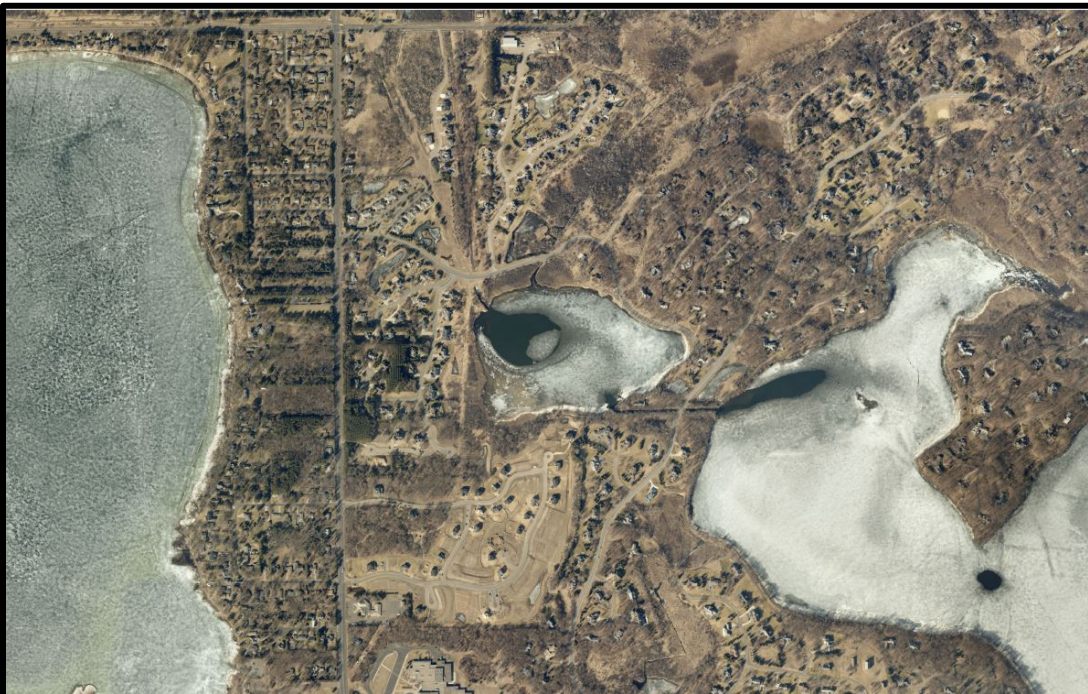
Figure 9: 2015 aerial photo of Charley Lake

In 2015, the convent south of Charley has been demolished, a new residential development has begun, and development has contributed to sediment and nutrient inputs into the lake.
